Evaluation of Physical Barriers – Riverside Downtown Station

Address: 4066 Vine St, Riverside, CA 92507

Evaluation Date: 07-26-2021

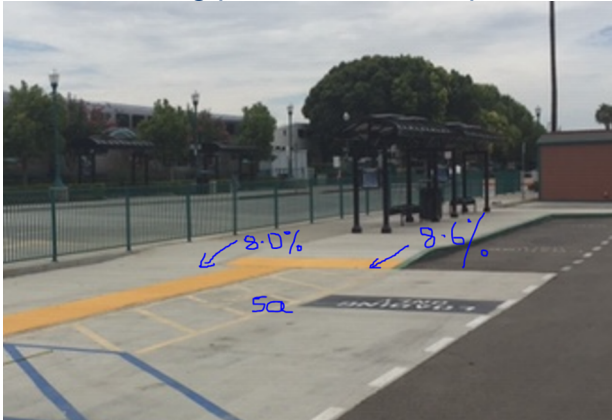
Issues/Barriers Identified	Recommendations	Comments /ADA Requirements
1. Curb Ramps 1a, 1b- Not on the accessible route 2a, 2b, 2d- OK 2c – trip hazard due to chipped concrete and open gaps between Detectable Warning Surface (DWS) and concrete 3a, 3b- OK 4a, 4b – Not on the accessible route 5a- Portion of ramp at the loading zone has a slope exceeding 8.33%. The remaining portion of the ramp is accessible.

Repair trip hazards and fill open gaps between DWS and concrete at 2c. Repair slope of the inaccessible portion of ramp	Curb ramps are labeled on the aerial view on page 1 See item 3 for ADA requirements This evaluation does not include curb ramps outside the RCTC boundary. RCTC is not responsible for maintaining the accessible routes outside of RCTC boundary. When repairs begin, use proper and precise instruments (4-foot smart level and 2-foot smart level) to fit within the curb ramp width and the adjacent gutter to measure ramp slopes, cross slopes, and counter slopes at all curb ramps (all stations). The long slope of ramp shall not exceed 1:12 (8.33%). Slope of flared sides shall not exceed 1:10 (10%), the gutter slope shall not exceed 1:20 (5%). Cross slope of the ramp and landing shall not exceed 1:50 (2%) Use smart level instruments, calibrated in accordance with manufacturer’s instructions before taking measurements.

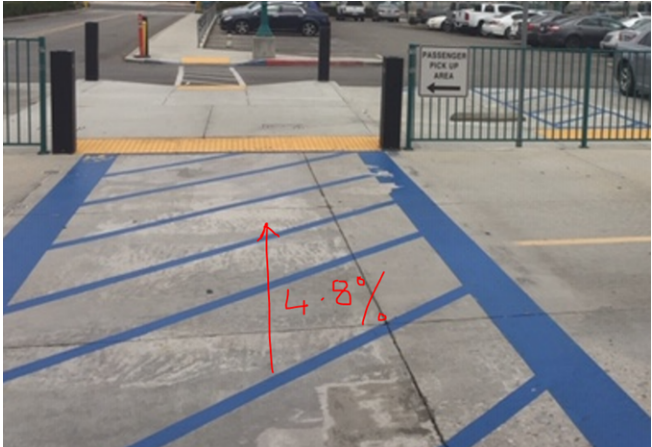
2. Pedestrian Road crossings No issues found at the main accessible pedestrian crossing 2a-2b, 2c 2d

No action by RCTC	
a) Pedestrian Push Button- No pedestrian pushbuttons are located within RCTC Boundary	No action by RCTC

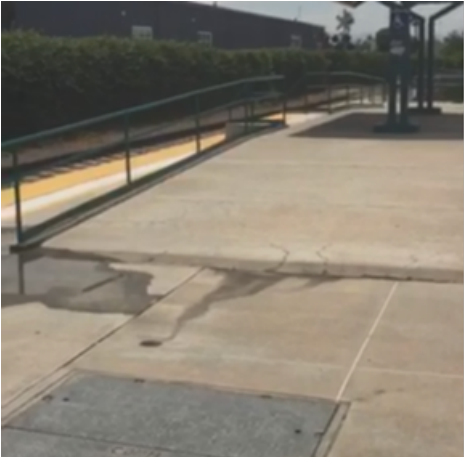
Issues/Barriers Identified	Recommendations	Comments /ADA Requirements
3. Accessible Routes		
a) Walking surface		
<p>i. General: At all walking surfaces including but not limited to ramps for mini high platforms and landing near the pedestrian bridge tower, there are uneven joints and cracks observed in the concrete walkway along the accessible route. Sealant/filler in some deep joints is missing. This causes trip hazards and creates openings deeper than ¼” and wider than ½ inch.</p>

<p>Examine all joints, cracks and level changes along the accessible route.</p> <p>Every joint in concrete deeper than ¼” and wider than ½” shall be filled.</p> <p>Every level change along the accessible route greater than ¼” and less than ½” height needs to be beveled (1:2) slope or repaired.</p> <p>Every level change greater than ½” needs to have a ramped surface (1:12) slope.</p>

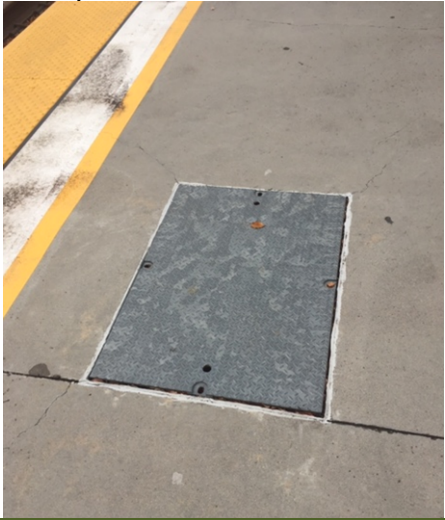
<p>ii. Diamond plate utility cover is unevenly installed and causes a trip hazard.</p>

<p>Reinstall all diamond plate covers with edges flush or no higher than ¼” and gaps no wider than ½”</p>

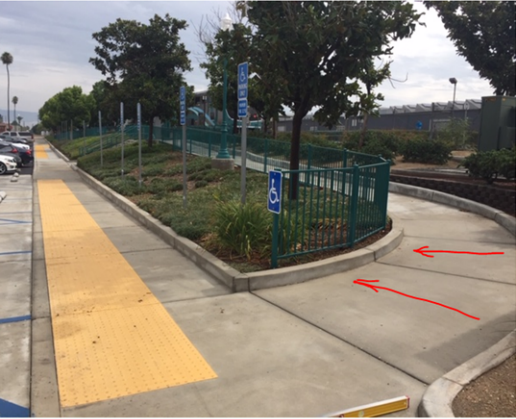
Issues/Barriers Identified	Recommendations	Comments /ADA Requirements
iii. On all three visits to the station, out of the two accessible routes, one route remained temporarily closed. The ramps on either side of the pedestrian rail crossing at this main entrance (closed route) are inaccessible. See Item e), Ramps, below.	Take prompt action to effect repairs, if the accessible route was closed for repairs.	206.4.1 Public Entrances. In addition to entrances required by 206.4.2 through 206.4.9, at least 60 percent of all public entrances shall comply with 404.
iv. Curved portion of the ramp near SOC may (or may not) have a cross slope exceeding 2% as it curves and continuously changes direction.

Measure to confirm that the cross slope is less than 2% using proper instruments. If cross slope is less than 2%, no action required. If cross slope exceeds, 2% repair the ramp to provide a level landing in the curved portion with a cross slope less than 2%.	Advisory 405.7 Landings. Ramps that do not have level landings at changes in direction can create a compound slope that will not meet the requirements of this document. Circular or curved ramps continually change direction. Curvilinear ramps with small radii also can create compound cross slopes and cannot, by their nature, meet the requirements for accessible routes. Note: Both the routes designated with ISA signage for “Accessible Route” do not seem to comply with accessibility requirements. Prompt repairs are needed to ensure accessibility.

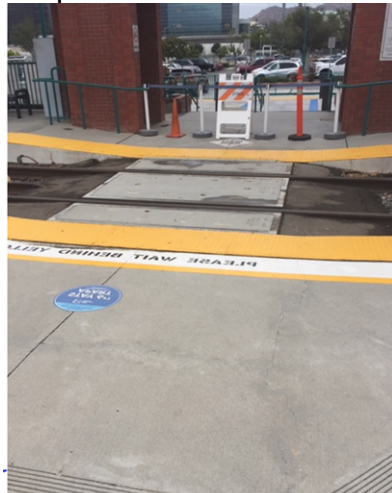
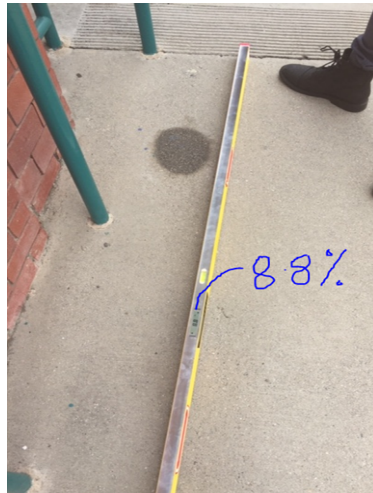
Issues/Barriers Identified	Recommendations	Comments /ADA Requirements						
<div><div><div>i.</div><div>At pedestrian rail crossing in the middle of North loading platform, the ramp slope exceeds 1:12 (8.33%). Slope measured as 8.8 % on one side and 9.6% on the other side. The route was kept closed on the day of evaluation. The ramp is 36 inches wide (not including DWS) with handrails only on one side. The rise is greater than 6 inches.</div><div>Existing ramps do not comply with the then applicable 1991 standards nor with current DOT or 2010 ADA standards for ramps.</div></div><div><div>

</div></div></div>	<div><div>Remove handrails and replace the ramps with walkways no more than 1:20 slope.</div><div>Note: Safe Harbor <u>does not</u> apply as the ramp slope requirements in 1991 and 2010 ADA standards are the same</div></div>	<div><div>DOT and 2010 ADA Standards: 405.2 Slope. Ramp runs shall have a running slope not steeper than 1:12. EXCEPTION: In existing sites, buildings, and facilities, ramps shall be permitted to have running slopes steeper than 1:12 complying with Table 405.2 where such slopes are necessary due to space limitations.</div><div><div>Table 405.2 Maximum Ramp Slope and Rise for Existing Sites, Buildings, and Facilities</div>

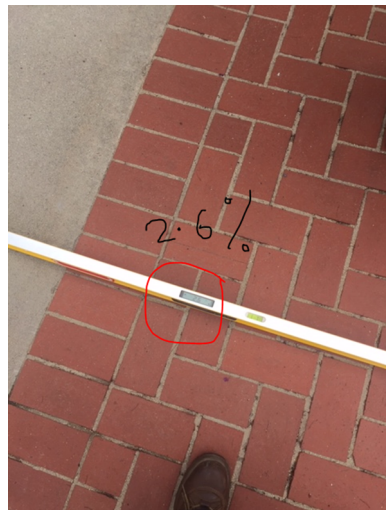
<div>1. A slope steeper than 1:8 is prohibited.</div></div><div><div>1991 Standards</div><div><div>4.8.2* Slope and Rise. The least possible slope shall be used for any ramp. The maximum slope of a ramp in new construction shall be 1:12. The maximum rise for any run shall be 30 in (760 mm) (see Fig. 16). Curb ramps and</div><div>ramps to be constructed on existing sites or in existing buildings or facilities may have slopes and rises as <i>allowed in 4.1.6(3)(a)</i> if space limitations prohibit the use of a 1:12 slope or less.</div><div><div>(3) Special Technical Provisions for Alterations to Existing Buildings and Facilities:</div><div><div>(a) Ramps: Curb ramps and interior or exterior ramps to be constructed on sites or in existing buildings or facilities where space limitations prohibit the use of a 1:12 slope or less may have slopes and rises as follows:</div><div>(i) A slope between 1:10 and 1:12 is allowed for a maximum rise of 6 inches.</div></div></div></div></div></div>	Slope ¹	Maximum Rise	Steeper than 1:10 but not steeper than 1:8	3 inches (75 mm)	Steeper than 1:12 but not steeper than 1:10	6 inches (150 mm)
Slope ¹	Maximum Rise							
Steeper than 1:10 but not steeper than 1:8	3 inches (75 mm)							
Steeper than 1:12 but not steeper than 1:10	6 inches (150 mm)							
<div><div>4. Platforms</div></div>								
<div><div><div>a.</div><div>Walking Surfaces</div></div></div>								
<div><div><div>i.</div><div>The cross slope towards the center portion of the platform exceeds 2%, (at brick paving features)</div></div><div><div>

</div></div></div>	<div><div>Repair cross slopes at paving features on accessible walking route or provide barriers at the inaccessible portions of the platform while ensuring alternate accessible routes</div></div>	<div><div>403.3 Slope. The running slope of walking surfaces shall not be steeper than 1:20. The cross slope of walking surfaces shall not be steeper than 1:48 (2%)</div></div>

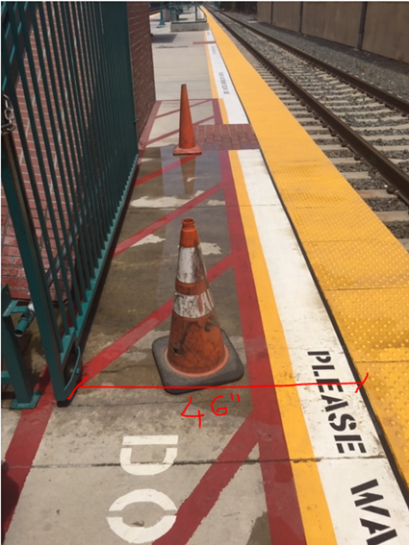
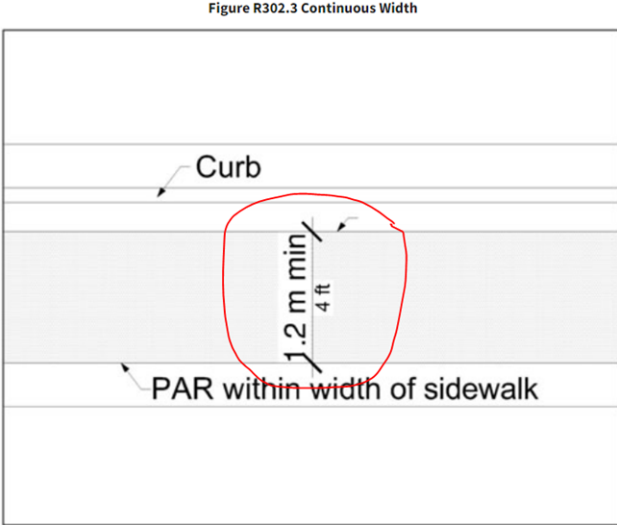
Issues/Barriers Identified	Recommendations	Comments /ADA Requirements
<p>ii. The wheel of rolling gate in open position on the platform protrudes into the circulation width, reducing it to 46 inches from the DWS. This is more than the 36 inches required by the 1991, DOT and 2010 ADA Standards. However, ponding water was observed due to rains.</p>

<p>Replace gate or gate hardware with one that allows at least 48 inches circulation width in compliance with PROWAG R302.3</p> <p>Maintain accessible routes to permit safe ambulation.</p>

<p>The continuous clear width requirements in PROWAG R302.3 apply to sidewalks and other pedestrian circulation paths.</p> <p>405.10 Wet Conditions. Landings subject to wet conditions shall be designed to prevent the accumulation of water.</p> <p>302.1 General. Floor and ground surfaces shall be stable, firm, and slip resistant and shall comply with 302</p>

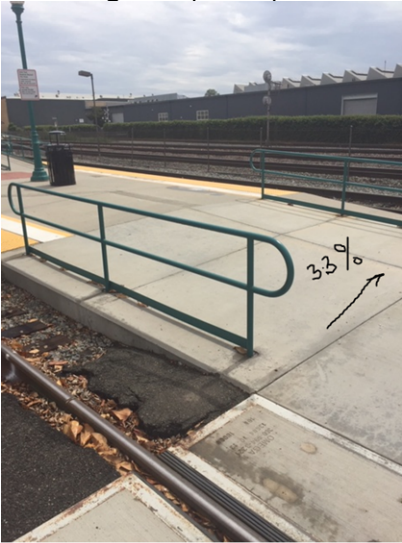
<p>b. Mini High Platforms</p>		
<p>i. The wide ramp at rail crossing (towards SOC) has a cross slope exceeding 2% (3.3%)</p>

<p>Repair cross slope.</p>	<p>403.3 Slope. The running slope of walking surfaces shall not be steeper than 1:20. The cross slope of walking surfaces shall not be steeper than 1:48 (2%)</p>

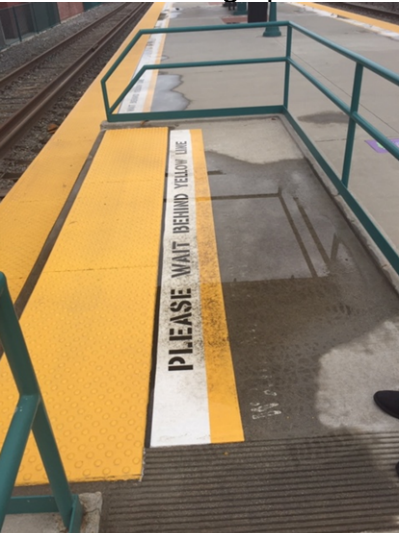
Issues/Barriers Identified	Recommendations	Comments /ADA Requirements
<p>ii. Ponding rainwater was observed on the platforms in several locations and also on mini high platforms.</p>

<p>Repair slopes and where required, provide scuppers to allow water to drain away.</p>	<p>405.10 Wet Conditions. Landings subject to wet conditions shall be designed to prevent the accumulation of water.</p>
<p>5. Pedestrian Rail Crossings</p>		
<p>a) Detectable Warning Surface (DWS) is missing at all rail crossings.</p>

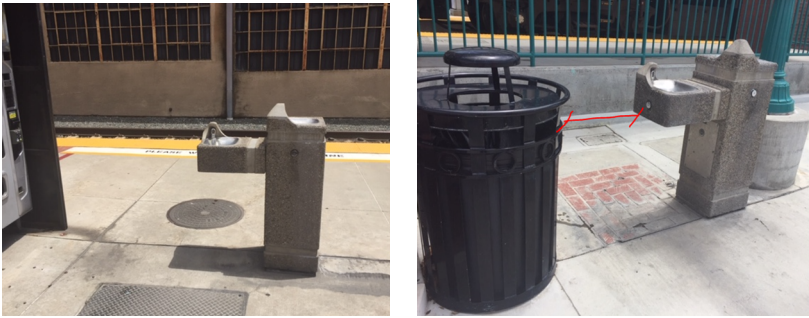
Issues/Barriers Identified	Recommendations	Comments /ADA Requirements
<p>b) Drinking Fountains</p> <p>i. Water flow in drinking fountain needs to be adjusted.</p> <p>ii. Near the main entrance, clear space for an existing fountain is blocked by a trash can.</p> <div data-bbox="121 338 891 641">

</div>	<p>Adjust waterflow and Relocate trash can.</p>	<p>602.6 Water Flow. The spout shall provide a flow of water 4 inches (100 mm) high minimum and shall be located 5 inches (125 mm) maximum from the front of the unit. The angle of the water stream shall be measured horizontally relative to the front face of the unit. Where spouts are located less than 3 inches (75 mm) of the front of the unit, the angle of the water stream shall be 30 degrees maximum. Where spouts are located between 3 inches (75 mm) and 5 inches (125 mm) maximum from the front of the unit, the angle of the water stream shall be 15 degrees maximum.</p>

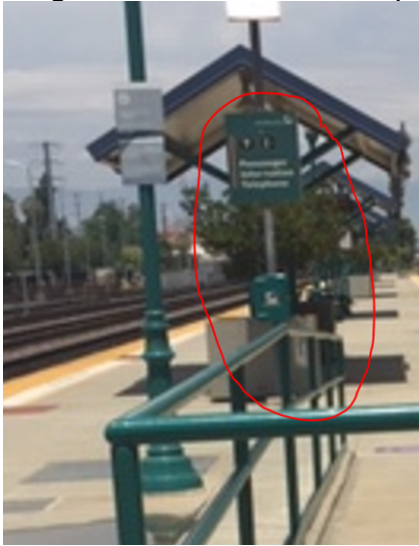
<p>c) Telephones/ Communication Systems</p> <p>i. Passenger Information Phone: Clear space and reach ranges are found to be compliant.</p> <div data-bbox="285 830 683 1350">

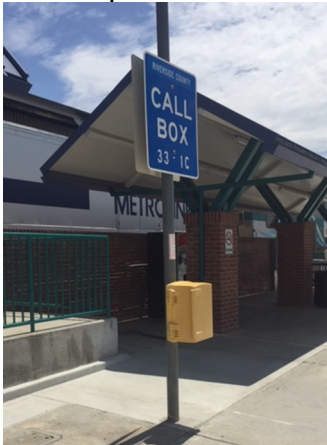
Issues/Barriers Identified		Recommendations	Comments /ADA Requirements
<div>iii. Yellow call box. Clear space and reach ranges are found to be compliant.</div> <div>

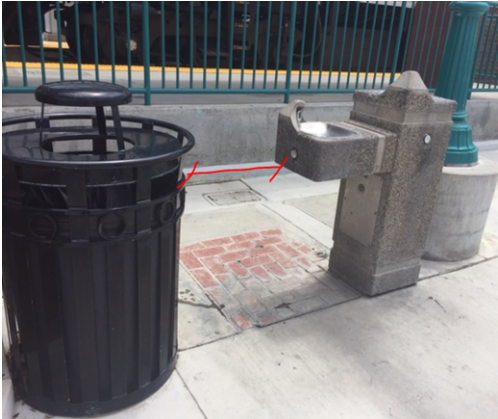
</div>			
d) Trash cans			
<div>No issues found with the height of trash can</div> <div>

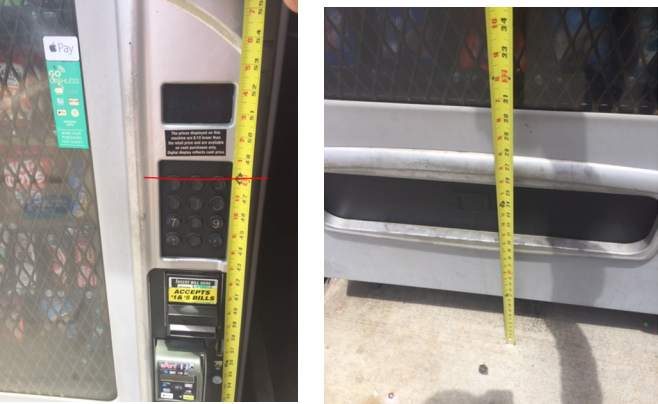
</div>		No action by RCTC	
e) Vending Machines			Not under RCTC's authority.
<div>No issues found with heights of operable components.</div> <div>

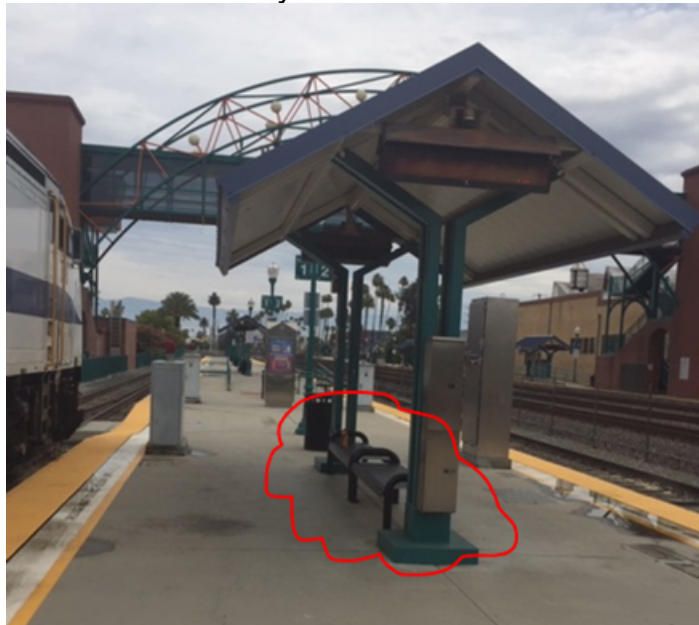
Issues/Barriers Identified		Recommendations	Comments /ADA Requirements
f) Benches			
<div><div>i.</div><div>Back less benches do not comply with ADA Section 903 as there are no back supports. However, Section 903 applies to indoor benches only.</div><div>

</div></div>	<div><div>It is a recommendation to apply Section 903 standards to benches in outdoor public environments, in order to ensure seating opportunities for people of all mobility.</div></div>	<div><div>

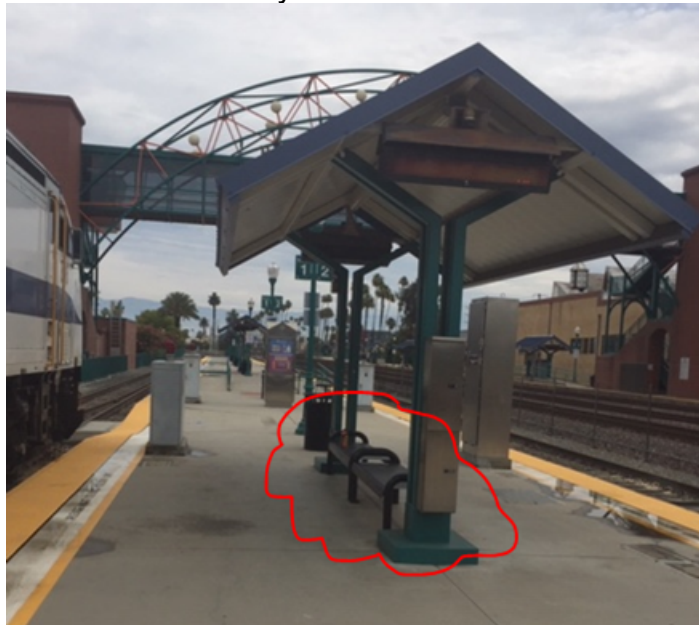
Issues/Barriers Identified		Recommendations	Comments /ADA Requirements																																																	
<div>iii.</div> <div>Back less benches do not comply with ADA Section 903 as there are no back supports. However, Section 903 applies to indoor benches only.</div> <div>

</div>	<div>It is a recommendation to apply Section 903 standards to benches in outdoor public environments, in order to ensure seating opportunities for people of all mobility.</div>	<div>

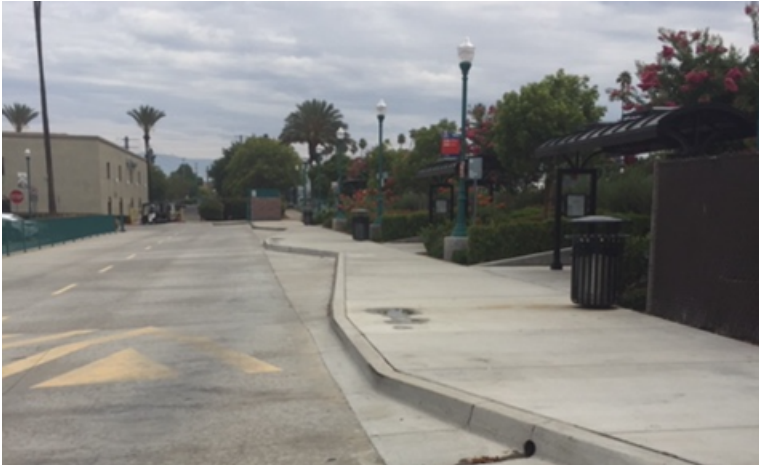
<p>8. Bus Stop</p>		
<p>No issues found</p>

<p>Maintain accessible routes to permit safe ambulation to all stops.</p>
<p>9. Signage</p>		
<p>a) Post mounted signs in the accessible route were evaluated to confirm minimum/ maximum projections and minimum clearances from the finished floor. Standard station signage is required to comply with SCRRRA /Metrolink standard details (ES 3000) found at this link. https://metrolinktrains.com/globalassets/about/engineering/3000-stations.pdf</p>	<p>No action BY RCTC. Signage is by SCRRRA/Metrolink</p>	<p>810.6 Rail Station Signs. Rail station signs shall comply with 810.6. EXCEPTION. Signs shall not be required to comply with 810.6.1 and 810.6.2 where audible signs are remotely transmitted to hand-held receivers, or are user- or proximity-actuated.</p> <p>SCRRRA/Mertolink is responsible for the signage.</p>

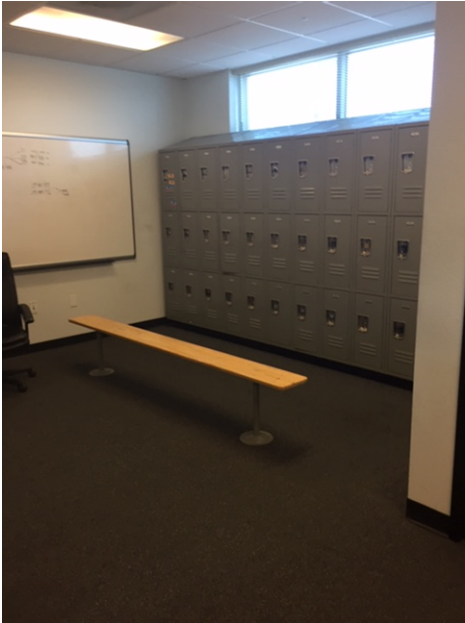
11. Staff Facilities		
a) <u>SOC</u>		SOC is a restricted entry building, designed for ADA compliance except for the items noted below.
i. <u>Bench in SOC</u> : The long bench in locker area does not comply with 903 and does not allow turning space in front of lockers.

Provide an ADA compliant bench and provide turning space for wheelchairs.	803 Dressing, Fitting, and Locker Rooms 803.4 Benches. A bench complying with 903 shall be provided within the room. 803.2 Turning Space. Turning space complying with 304 shall be provided within the room. 903.3 Size. Benches shall have seats that are 42 inches (1065 mm) long minimum and 20 inches (510 mm) deep minimum and 24 inches (610 mm) deep maximum. 903.4 Back Support. The bench shall provide for back support or shall be affixed to a wall. Back support shall be 42 inches (1065 mm) long minimum and shall extend from a point 2 inches (51 mm) maximum above the seat surface to a point 18 inches (455 mm) minimum above the seat surface. Back support shall be 2½ inches (64 mm) maximum from the rear edge of the seat measured horizontally.

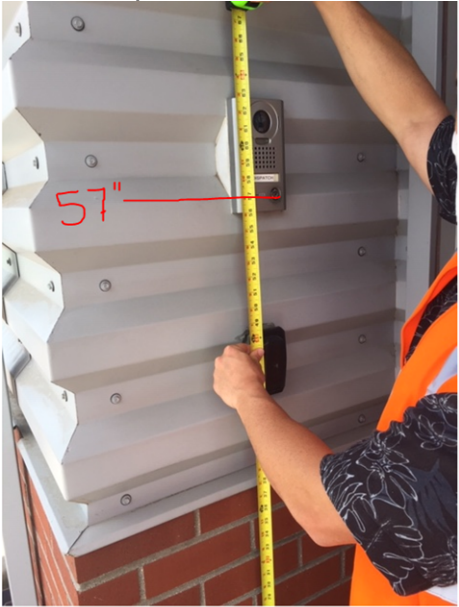
Issues/Barriers Identified	Recommendations	Comments /ADA Requirements
<p>ii. SOC Entrance Call Button for Telephone is higher than 48 inches and is not compliant with the reach range requirement.</p>

<p>Replace with a compliant system with operable parts no higher than 48 inches per 308.3.1 and/ or 308.2.1.</p> <p>Confirm that two-way communication System complies with 708.</p>	<p>230.1 General. Where a two-way communication system is provided to gain admittance to a building or facility or to restricted areas within a building or facility, the system shall comply with 708.</p> <p>708 Two-Way Communication Systems</p> <p>708.1 General. Two-way communication systems shall comply with 708.</p> <div data-bbox="1613 364 2772 451" style="border: 1px solid black; padding: 5px;"> <p>Advisory 708.1 General. Devices that do not require handsets are easier to use by people who have a limited reach.</p> </div> <p>708.2 Audible and Visual Indicators. The system shall provide both audible and visual signals.</p> <div data-bbox="1613 526 2772 647" style="border: 1px solid black; padding: 5px;"> <p>Advisory 708.2 Audible and Visual Indicators. A light can be used to indicate visually that assistance is on the way. Signs indicating the meaning of visual signals should be provided.</p> </div> <div style="display: flex; justify-content: space-around; align-items: flex-end;"> <div data-bbox="1547 667 1961 1070" style="text-align: center;">

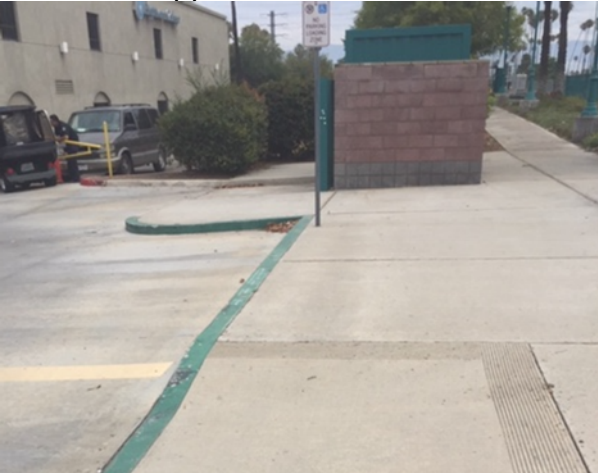
Issues/Barriers Identified	Recommendations	Comments /ADA Requirements
<p>b) <u>Trash / Dumpster Enclosure</u></p> <p>i. The gate at trash dumpster is not on an ADA compliant route and gate does not appear to be accessible.</p>

<p>Provide an accessible gate to the dumpster enclosure on an accessible route.</p>	<p>203.9 Employee Work Areas. Spaces and elements within employee work areas shall only be required to comply with 206.2.8, 207.1, and 215.3 and shall be designed and constructed so that individuals with disabilities can approach, enter, and exit the employee work area.</p> <p>1991 Standards. 4.1.1 (3) (3)* Areas Used Only by Employees as Work Areas. Areas that are used only as work areas shall be designed and constructed so that individuals with disabilities can approach, enter, and exit the areas. These guidelines do not require that any areas used only as work areas be constructed to permit maneuvering within the work area or be constructed or equipped (i.e., with racks or shelves) to be accessible</p>

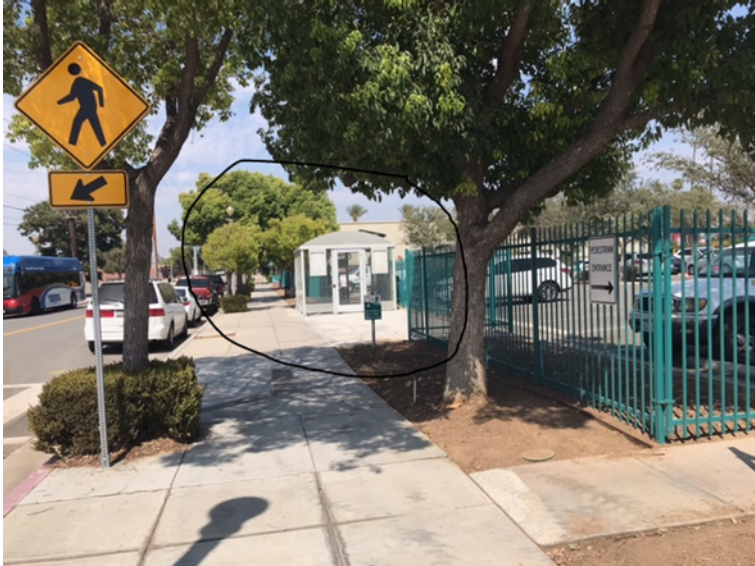
<p>c) <u>Security Staff Facilities</u></p> <p>The guard booth is provided as a shelter against weather and for use during breaks by security staff, who are expected to walk around the station site and physically address emergency situations.</p>

<p>Inform all contractors of their ADA obligations</p>	<p>Station Security services are contracted out and an ADA evaluation of the facilities used by the station security was not conducted as it is not Public Accessible and the Security Contractor requirements require the guards to be able to walk around the station site and physically address emergency situations.</p>
