Address: South Perris Blvd, Perris, CA 92570 Evaluation Date: 08-06-2021

Year of Construction: Station- 08/19/2011

Applicable ADA Standards: DOT's ADA standards (2006), and DOJ 2010 ADA Standards.

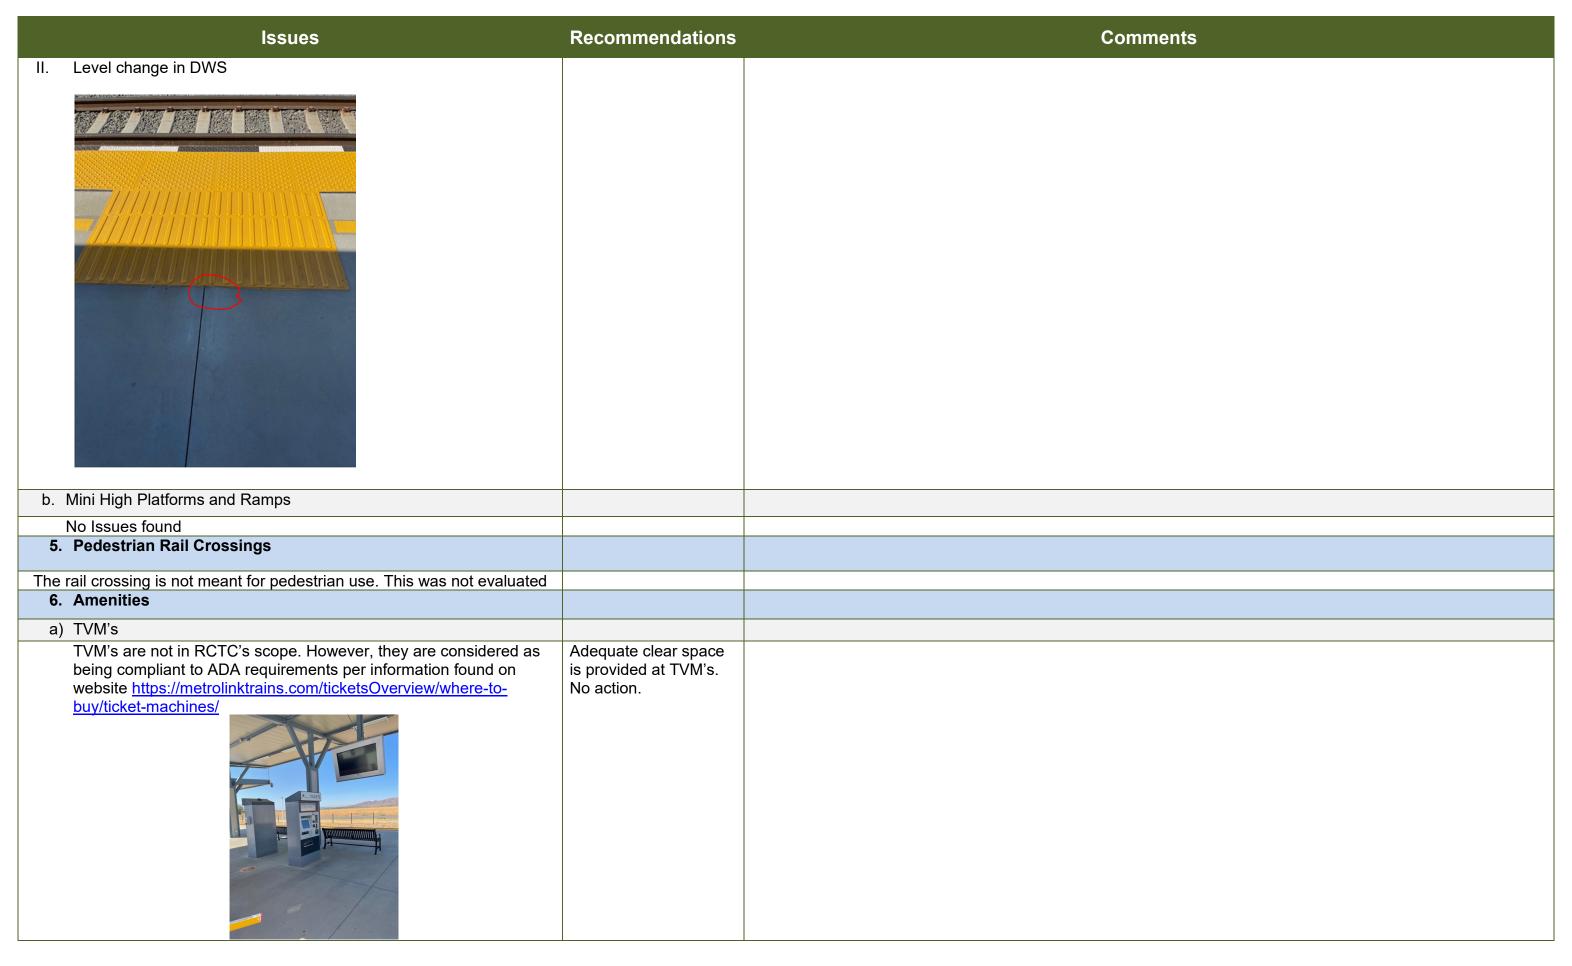
Issues	Recommendations	Comment	s
b) Elevator			
Not Applicable			
c) Pedestrian Bridge			
Not Applicable			
d) Stairs			
Not Applicable			
e) Ramps			
Not Applicable			
4. Platforms			
a. Walking Surfaces			
General: Joints and gaps in concrete to be repaired or maintained for compliance with 302.3, 303.2, and 303.3.	Examine all pedestrian routes and repair all cracks. Every joint in concrete deeper than ½" and wider than ½" shall be filled. Every level change along the accessible route greater than ½" and less than ½" height needs to be beveled (1:2) slope or repaired. Every level change greater than ½" needs to have a ramped surface (1:12) slope.	long dimension perpendicular to dominant direction of travel 13 Figure 302.3 Elongated Openings in Floor or Ground Surfaces 14 max 6.4 Figure 303.2 Vertical Change in Level	Figure 303.3 Beveled Change in Level
