Evaluation of Physical Barriers – North Main Corona

Address: East Blaine St, Corona, CA 92880 Evaluation Date: 07-21-2021

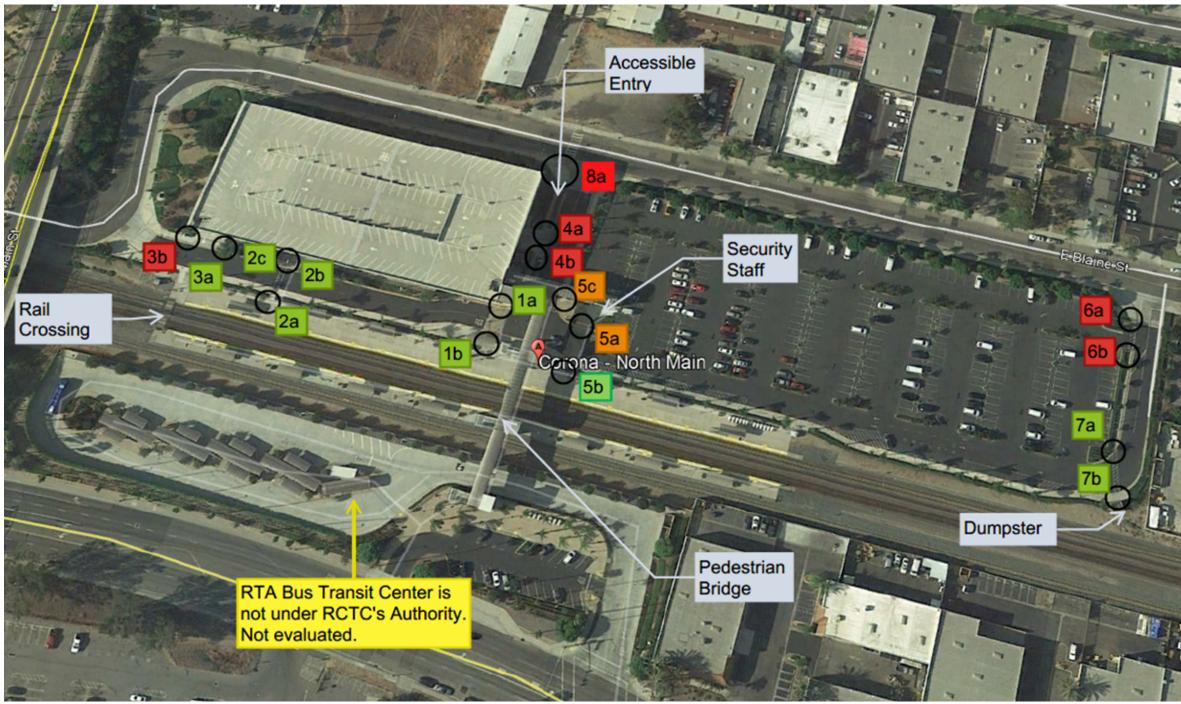
Issues/ Barriers Identified	Recommendations	Comments/ ADA Requirements
	Recommendations	Comments/ ADA Requirements
1a, 1b- OK 2a - OK 2b, 2c- Not an accessible route due to curved ramps. Gate remains closed. 3a, 3b Not a required accessible route. 3a Landing is less than 36 inches. 4a, 4b- Cross slope of ramps exceeds 2 % 5a, 5c- Not a required accessible route. 5b - OK 6a Not an accessible route due to barrier arm in closed position blocking access to/from the city sidewalk. 6b- Ramp is not compliant due to uneven pavement, level changes in excess of 1/4" and excessive slope. 7a, 7b- OK, but not a required accessible route. 8a - Slope of flared side of the curb ramp is more than 1:10. Curb ramp is not in RCTC's scope.	3a- When used for providing access in the future, the landing shall be increased to be at least 48 inches deep and it shall join an accessible route. 4a, 4b. Repair cross slope. 6b. Remove the trip hazard and provide flush transitions adjacent to curb ramps if this is a designated marked crossing. See item 2. Provide signage designating the accessible pedestrian	This evaluation does not include curb ramps outside the RCTC boundary. RCTC is not responsible for maintaining the accessible routes outside of RCTC boundary. When repairs begin, use proper and precise instruments (4-foot smart level and 2-foot smart level) to fit within the curb ramp width and the adjacent gutter to measure ramp slopes, cross slopes, and counter slopes at all curb ramps (all stations). The long slope of ramp shall not exceed 1:12 (8.33%). Slope of flared sides shall not exceed 1:10 (10%), the gutter slope shall not exceed 1:20 (5%). Cross slope of the ramp and landing shall not exceed 1:50 (2%) Use smart level instruments, calibrated in accordance with manufacturer's instructions before taking measurements.
