**Riverside County Transportation Commission (RCTC)  
ADA Transition Plan – Third Year Update  
June 2025**

## RCTC ADA Transition Plan - Third Year Update June 2025

# ADA Transition Plan –Updates - June 2025

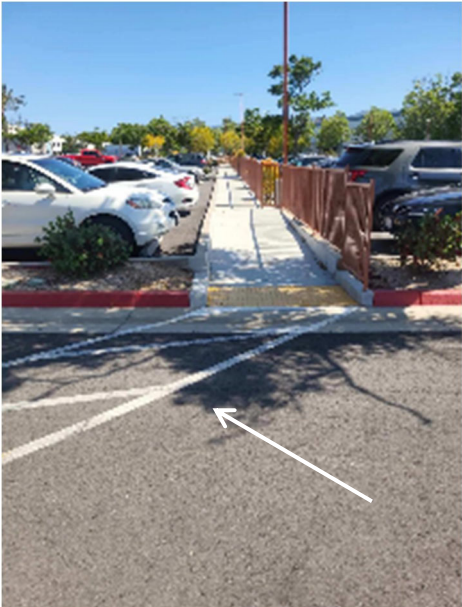
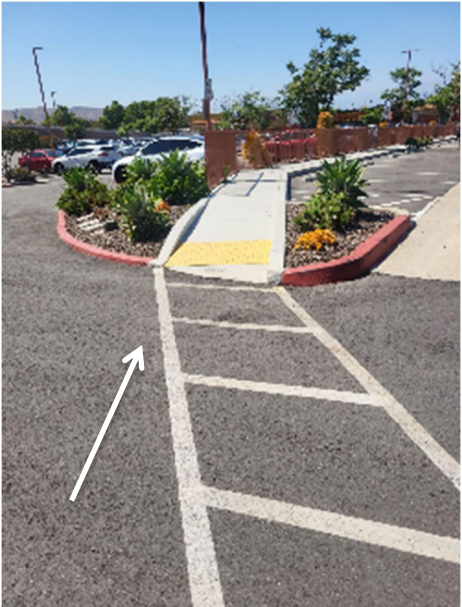
1. Pedestrian Entry	The slope of the sidewalk at the pedestrian entry is measured at 9.6% which makes it an inaccessible route.	<div>a. Provide an alternate accessible pedestrian entry route including five feet wide concrete sidewalk and marked road crossings</div> <div>b. Provide signage for the designated accessible route.</div>	An alternate route through the parking area is possible and should be considered.	<div>A. Complete</div> <div>An accessible path was constructed from the street to the parking lot. Measurements were taken and were compliant to ADA standards.</div> <div>

</div> <div>B. In Progress</div>

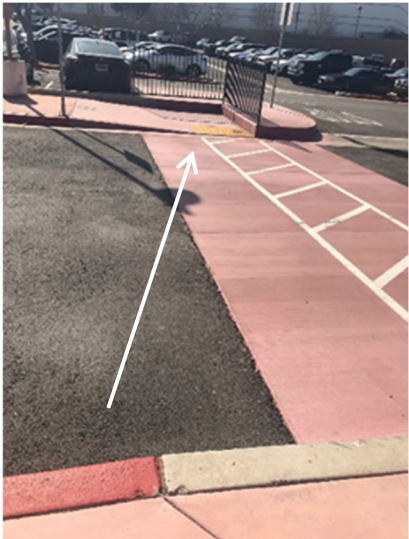
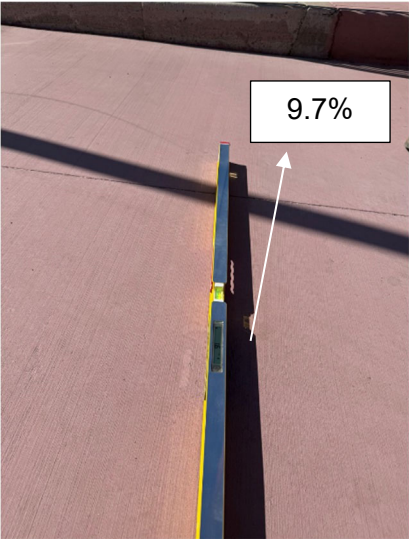
2. Curb ramp 1b	Flared side exceeds 1:10 slope (11.6%)	Repair flared sides of curb ramps to comply with 1:10 slope requirement or replace entire curb ramp. This will include placement of DWS.	<div>When repairs begin, use proper and precise instruments (4-foot smart level and 2-foot smart level) to fit within the curb ramp width, and the adjacent gutter to measure ramp slopes, cross slopes, and counter slopes.</div> <div>Use smart level instruments, calibrated in accordance with manufacturer's instructions before taking measurements.</div>	<div>Complete</div> <div>The curb ramp was reconstructed to be ADA standard.</div>

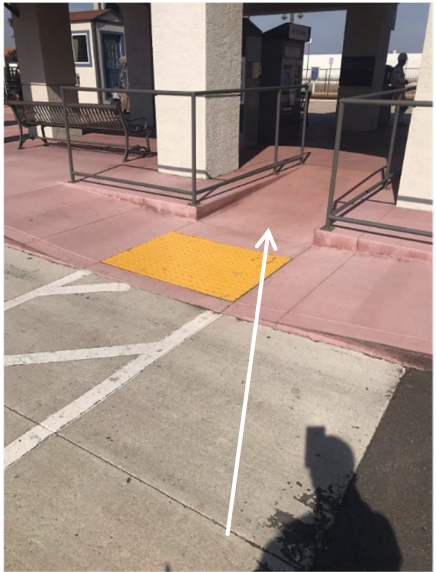
</div>
3. Curb ramp 2a	Sloped portion of ramp takes up the entire sidewalk in front of the main entrance.	Provide signage for the accessible route along the sidewalk leading to level walking route under the canopy	The landing for the curb ramp is under the station canopy is compliant. So, no structural changes are needed to this curb ramp or landing.	<div><p>Complete</p><p>This slope portion of the ramp was reconstructed to meet ADA standards. Signage is no longer required.</p>

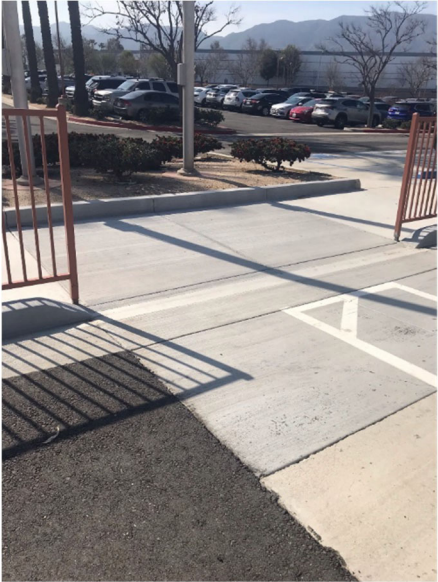
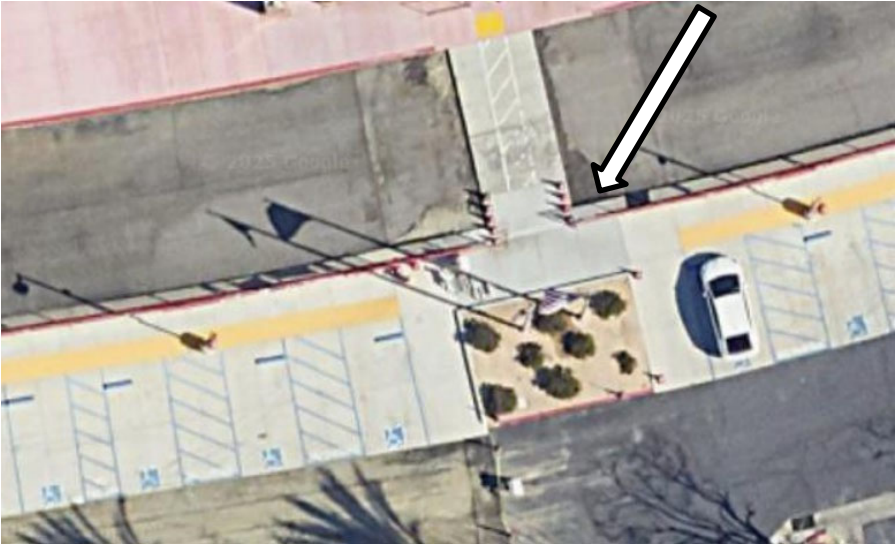
</div>
4. Curb ramp 2b	Gutter slope exceeds 1:20 (9.1%). Flared side exceeds 1:10	Remove and replace flared sides of the curb ramp, portions of the	See comment for item 2.	<div><p>In Progress</p></div>

Facility/Area	Access Issue	Solution	Comments	Resolution Status
West Corona Station			See Attachment 6A for curb ramp locations, images of barriers, recommendations, and ADA requirements.	
	slope (12.2%). uneven level changes and trip hazard.	gutter to make slopes compliant Replace entire curb ramp. Repair uneven level changes and trip hazards. This will include placement of DWS.

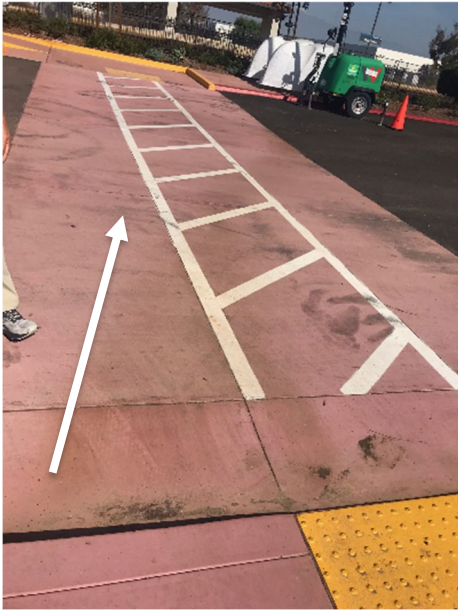
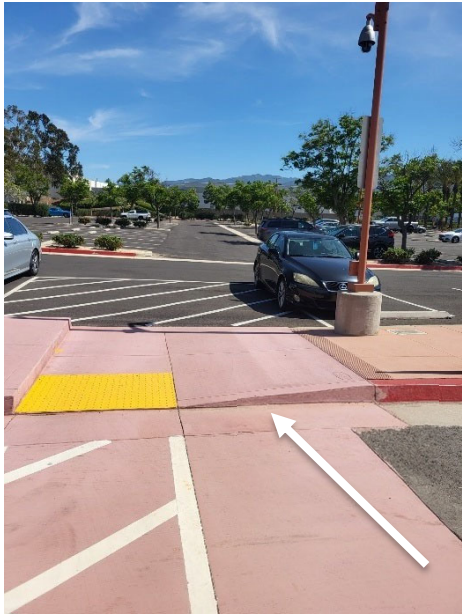
5. Curb ramp 3b	Gutter slope exceeds 1:20 (9.1%). There are uneven level changes and trip hazards.	Remove and replace portions of the gutter to make slopes compliant Replace entire curb ramp. Repair uneven level changes and trip hazards. This will include placement of DWS.	See comment for item 2.	Complete  The area has been reconstructed to meet ADA standard.

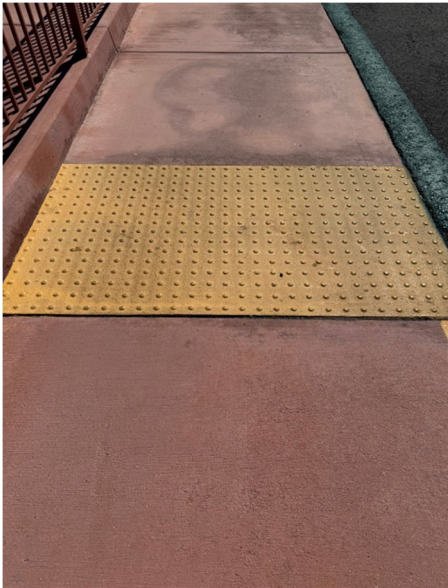
</div>
6. Curb ramp 4a	Trip hazard at DWS	Repair uneven level changes and trip hazards. Remove and reapply DWS. Provide beveled transition at DWS and adjacent concrete as required		<div><p>Complete</p><p>The curb ramp has been reconstructed with DWS to ADA standards.</p>

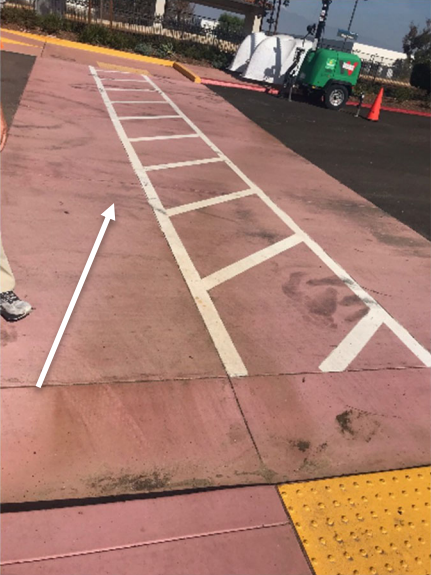
7. Pedestrian road crossing 3a-3b	Multiple cracks and gaps in excess of ½” wide and ¼” deep.	Repair cracks, gaps, uneven level changes and trip hazards within the marked pedestrian crossing. Every joint deeper than ¼” and wider than ½” shall be filled with concrete and crack fillers as required.		<div>Complete</div> <div>The walkway has been reconstructed to meet ADA standards.</div> <div>

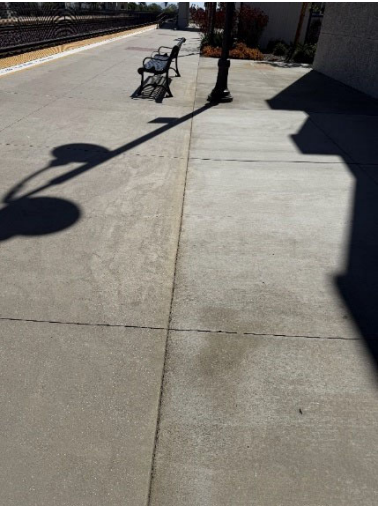
8. General Accessible Paths	There are uneven joints and cracks observed in the concrete on the platforms and along accessible route. Sealant/filler in some deep joints is missing.	<div>Repair cracks, gaps, uneven level changes and trip hazards within the accessible route.</div> <div>Every joint deeper than ¼” and wider than ½” shall be filled with concrete and crack fillers as required.</div> <div>Every level change along the accessible route greater than ¼” and less than ½” height needs to be beveled (1:2 slope) or repaired using</div>	Create a maintenance plan for ongoing routine inspections and repairs of all components of the accessible route.	<div>Complete</div> <div>Repairs were conducted on the general access path to meet ADA standards.</div> <div>

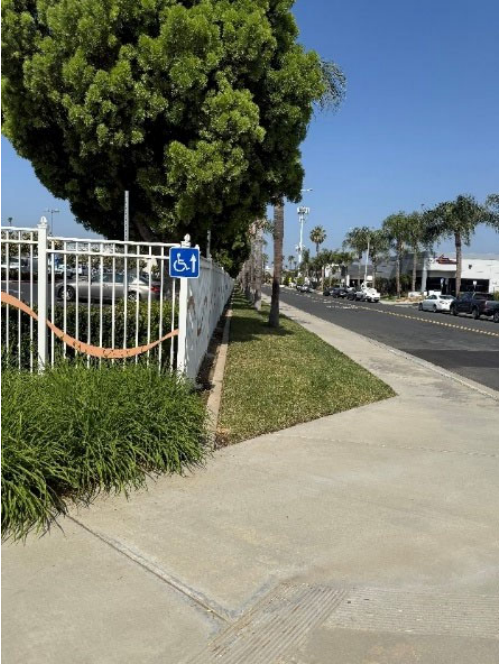
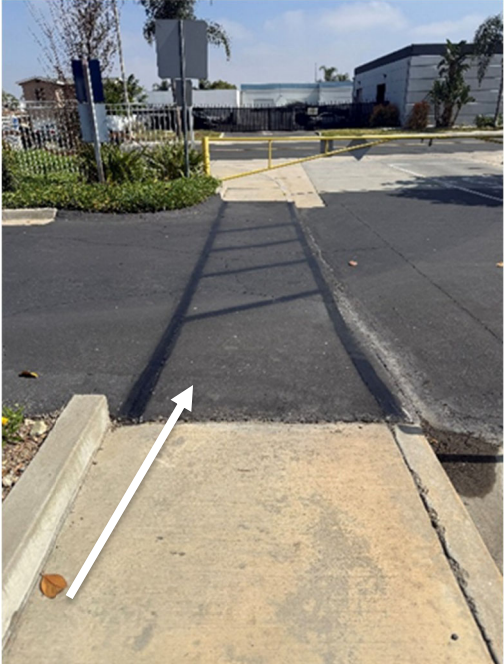
21. Pedestrian Entry	Marked crossing 6A-6B is not accessible and is also blocked by the arm barrier gate in the closed position.	<p>Remove the crosswalk markings if the pedestrian route is now closed to public and other pedestrians.</p> <p>Provide signage for the alternate accessible route if this route is closed to the public.</p>		<p>Complete</p> <p>Cross walk pavement markings have been removed and signage has been placed directing to the alternate accessible route.</p> <div>

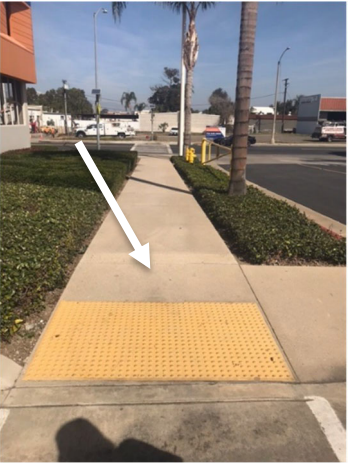
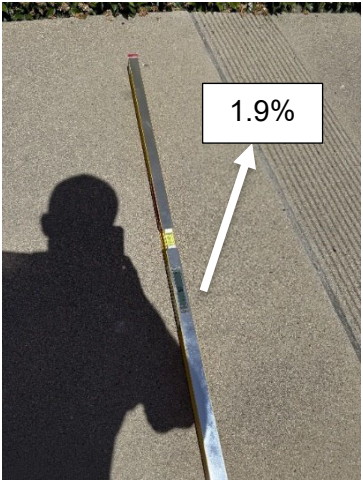
22. Curb ramp 4a	Cross slope of the ramp exceeds 2 %	Repair cross slope or replace entire curb ramp. This will include placement of DWS.	<p>When repairs begin, use proper and precise instruments (4-foot smart level and 2-foot smart level) to fit within the curb ramp width, and the adjacent gutters to measure ramp slopes, cross slopes, and counter slopes.</p> <p>Use smart level instruments, calibrated in</p>	Complete

Facility/Area	Access Issue	Solution	Comments	Resolution Status
North Main Corona Station			See Attachment 6B for curb ramp locations, images of barriers, recommendations, and ADA requirements.	
			accordance with manufacturer's instructions before taking measurements.	<p>Cross slopes were re-examined and were found to meet ADA standards. Measurements were at 1.9%, which is less than the 2% maximum standard.</p> <div>

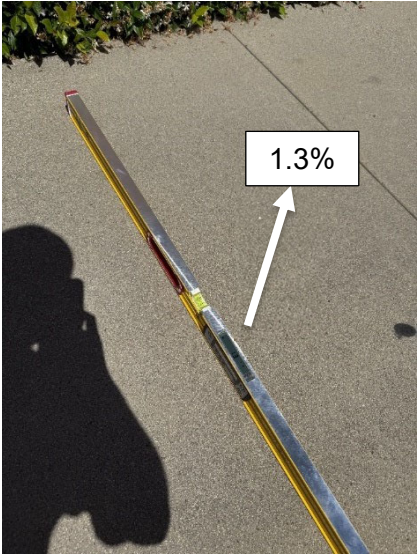
23.Curb ramp 4b	Cross slope of the ramp exceeds 2 %	Repair cross slope or replace entire curb ramp. This will include placement of DWS.	Same as above	<p>Complete</p> <p>Cross slopes were re-examined and were found to meet ADA standards. Measurements were at 1.3%, which is less than the 2% maximum standard.</p> <div>

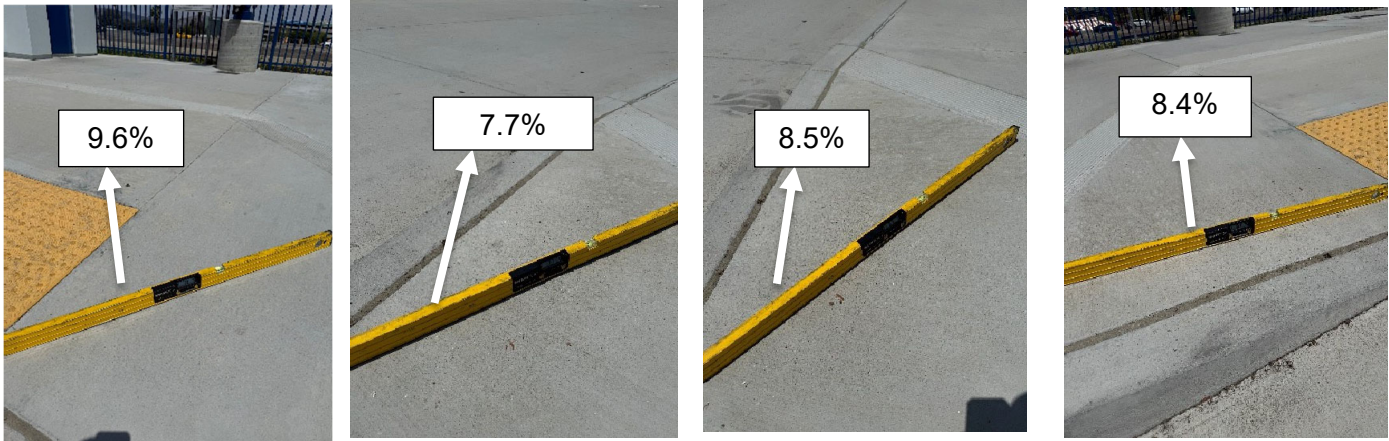
37.Curb ramp 2a	Slope of the flared sides exceeds 10%	Repair slope of the flared sides or Replace entire curb ramp. This will include placement of DWS.	<p>When repairs begin, use proper and precise instruments (4-foot smart level and 2-foot smart level) to fit within the curb ramp width, and the adjacent gutters to measure ramp slopes, cross slopes, and counter slopes.</p> <p>Use smart level instruments, calibrated in accordance with manufacturer's instructions before taking measurements.</p>	<p>Complete</p> <p>Curb ramp has been reconstructed with DWS to meet the ADA standards.</p>

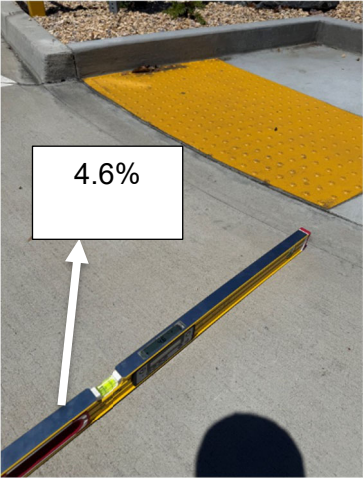
39.Curb ramp 6a	Gutter slope appears to be more than 5%.  Extent of DWS along the curved segment does not match Case CM of CA standard plan A88B.	Repair gutter slope.  Reapply DWS in dominant direction of travel in entirety as shown for Case CM of CA Standard plan A 88B.	Same as above	Complete

Facility/Area	Access Issue	Solution	Comments	Resolution Status
La Sierra Station			See Attachment 6C for curb ramp locations, images of barriers, recommendations, and ADA requirements.	
				<p>Curb ramp and gutter was reconstructed to meet the ADA standards.</p>

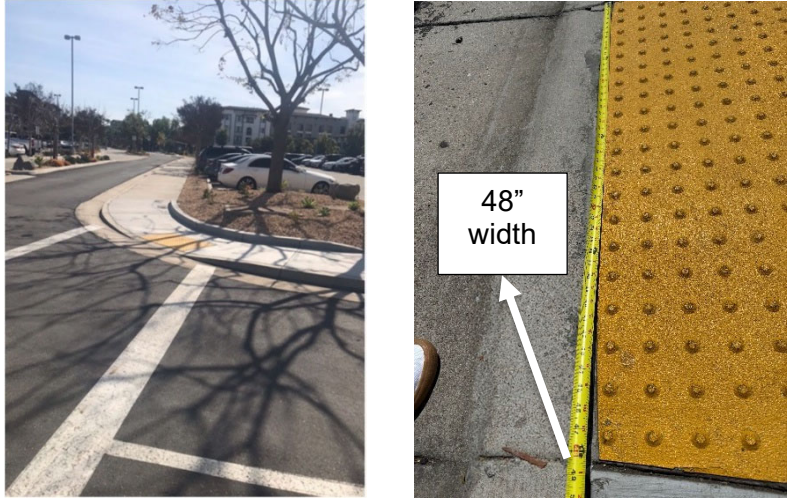
40.Curb ramp 7A	Detectable Warning Surface (DWS) is missing. Turning space at bottom of ramp is not 48 in wide at the back of curb.	Provide DWS in the landing and modify sidewalk to provide 48 inches minimum.		<p>Complete</p> <p>Curb ramp has been reconstructed with DWS to meet the ADA standards.</p>

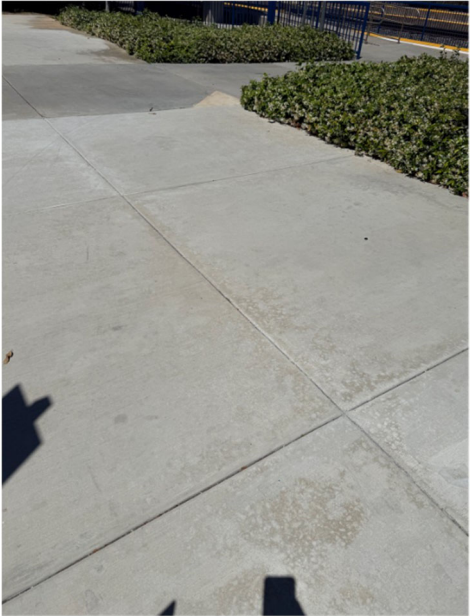
41.General Accessible Paths	There are uneven joints and cracks observed in concrete along the accessible route, and sealant/filler	Examine and repair accessible routes where there are uneven joints and cracks observed in concrete along the	Create a maintenance plan for ongoing routine inspections and repairs of all components of the accessible route.	<p>Complete</p> <p>Accessible paths have been reconstructed to meet ADA standards.</p>

Facility/Area	Access Issue	Solution	Comments	Resolution Status
La Sierra Station			See Attachment 6C for curb ramp locations, images of barriers, recommendations, and ADA requirements.	
	in deep joints is missing.	<p>accessible route, and where sealant/filler in deep joints is missing.</p> <p>Every joint deeper than ¼” and wider than ½” shall be filled with concrete and crack fillers as required.</p> <p>Every level change along the accessible route greater than ¼” and less than ½” height needs to be beveled (1:2 slope) or repaired using grinding tools and/or levelling compounds.</p> <p>Every level change greater than ½” needs to have a ramped surface (1:12) slope .</p>

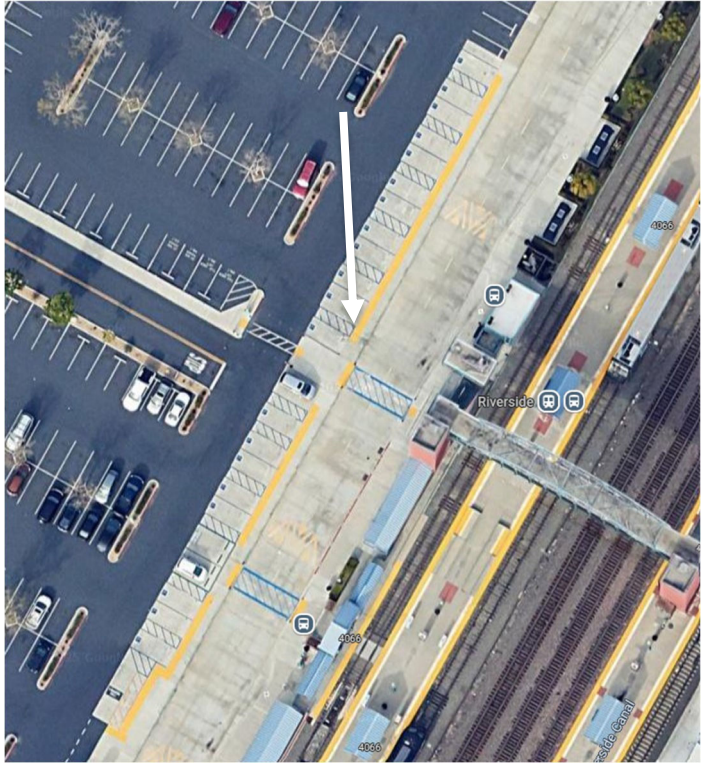
Facility/Area	Access Issue	Solution	Comments	Resolution Status
Riverside Downtown Station			See Attachment 6D for curb ramp locations, images of barriers, recommendations, and ADA requirements.	
49.Curb ramp 2c	Trip hazard due to chipped concrete and open gaps between DWS and concrete	Repair trip hazards and fill open gaps between DWS and concrete with filler and sealant		<div>Complete</div> <div>The previous curb ramp has been replaced with a flat, grade-level pavement surface that meets ADA standards.</div> <div>

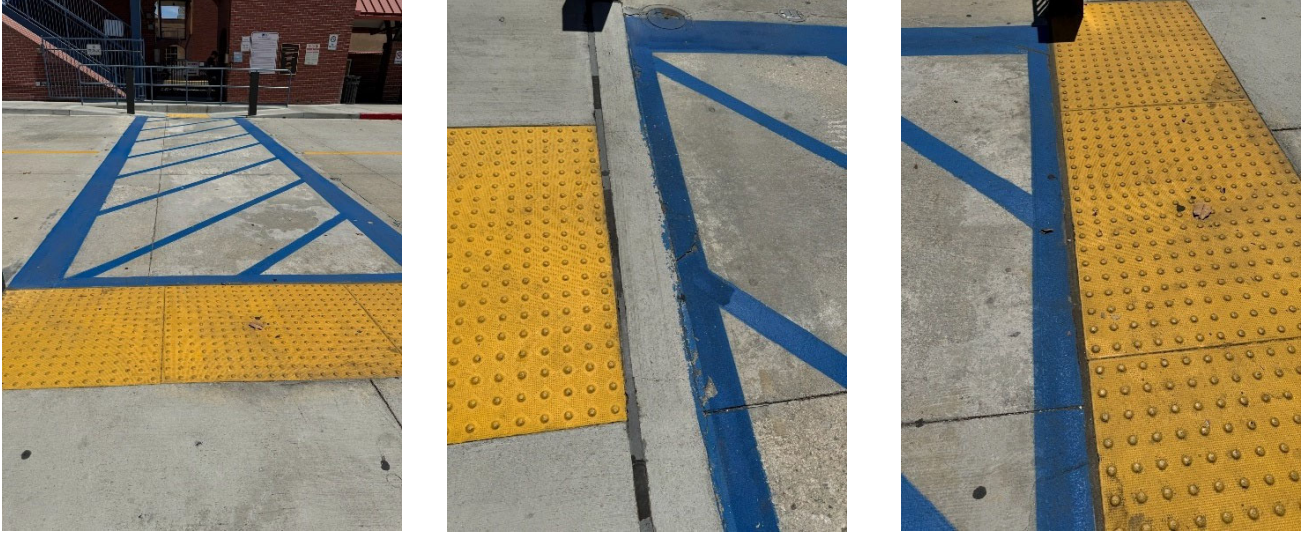
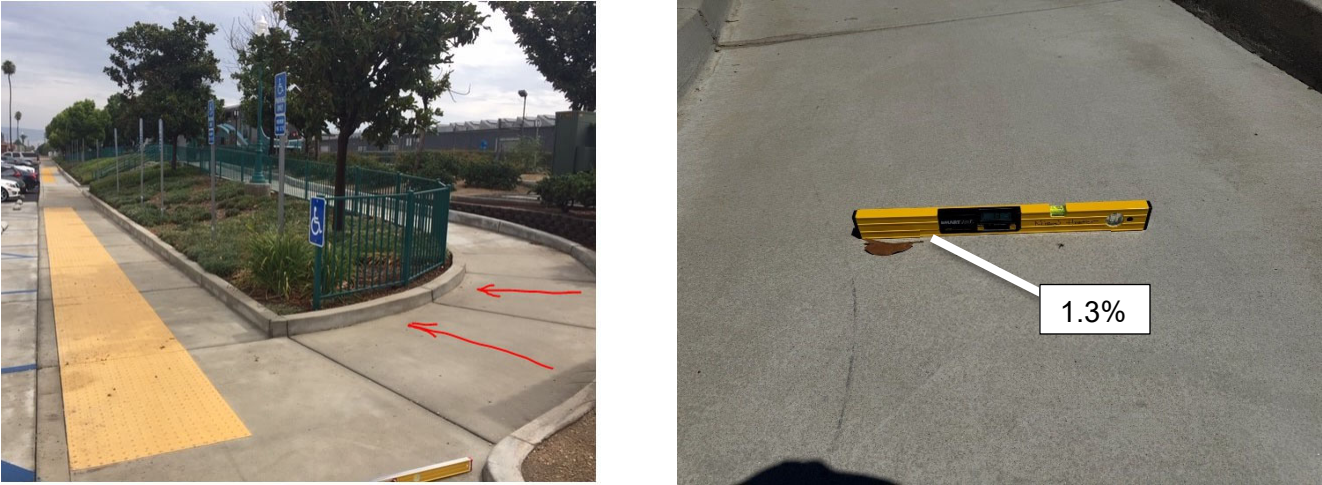
51.General Accessible Paths	There are uneven joints and cracks observed in concrete along the accessible route, and sealant/filler in deep joints is missing.	Examine and repair accessible routes where there are uneven joints and cracks observed in concrete along the accessible route, and where sealant/filler in deep joints is missing.	Create a maintenance plan for ongoing routine inspections and repairs of all components of the accessible route.	<p>i. Complete – Accessible routes uneven joints and cracks</p> <p>Accessible paths have been repaired to meet ADA standards.</p>

Facility/Area	Access Issue	Solution	Comments	Resolution Status
Riverside Downtown Station			See Attachment 6D for curb ramp locations, images of barriers, recommendations, and ADA requirements.	
		<p>Every joint deeper than ¼” and wider than ½” shall be filled with concrete and crack fillers as required.</p> <p>Every level change along the accessible route greater than ¼” and less than ½” height needs to be beveled (1:2 slope) or repaired using grinding tools and/or levelling compounds.</p> <p>Every level change greater than ½” needs to have a ramped surface (1:12) slope .</p>		<div>

</div> <p>ii. In Progress – Space around utility cover</p> <p>iii/iv. Complete – ADA accessible route cross slope of ramp. ADA access is accessible, cross slope confirmed to be ADA compliant.</p> <div>

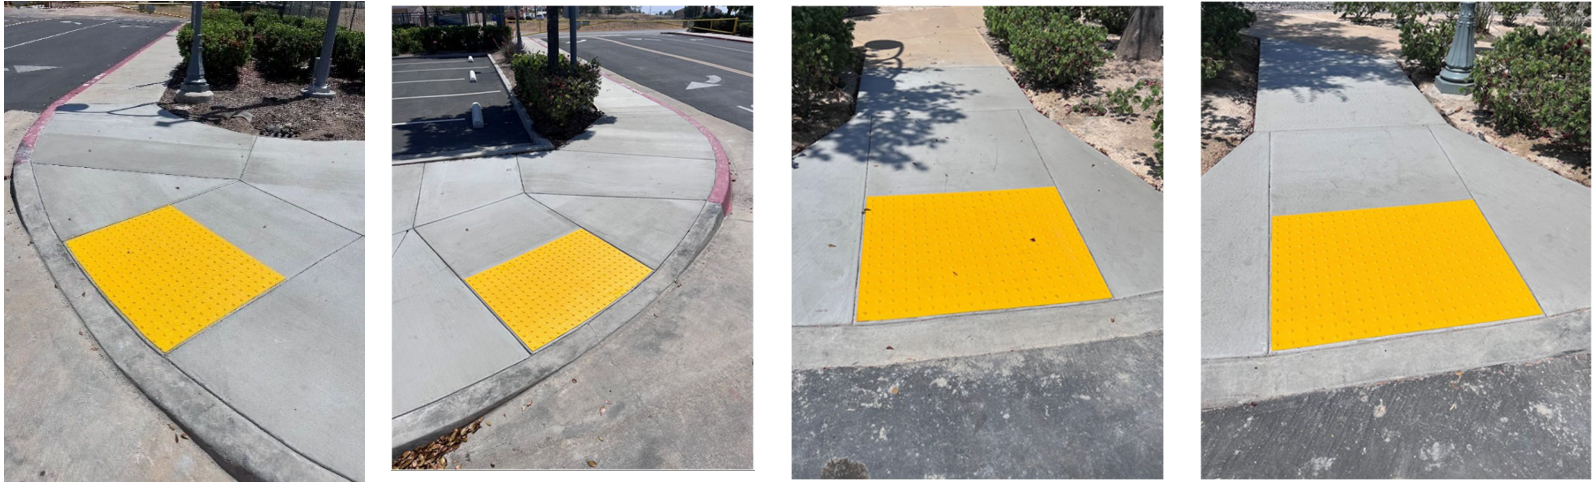
69. Curb ramps 6a, 6b, 7a, 7b	Level changes exceed ¼" without bevel, DWS is missing.	Grind concrete to eliminate level changes and apply DWS.	Same as above	Complete  The curb ramps have been reconstructed to meet ADA standards.

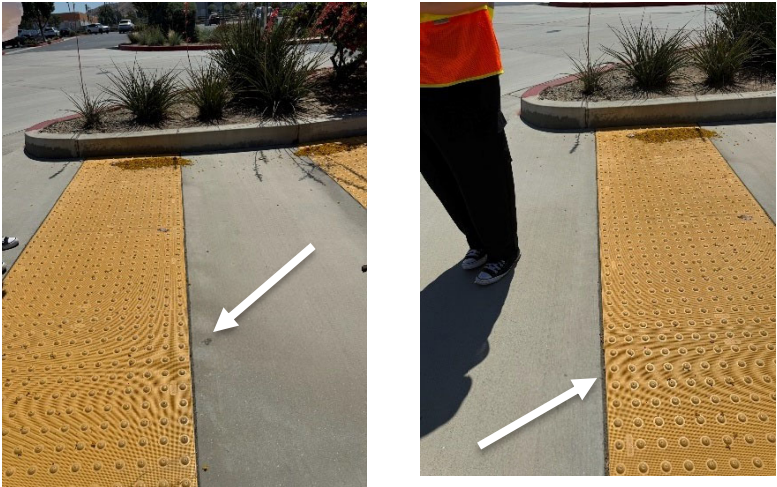
Facility/Area	Access Issue	Solution	Comments	Resolution Status
Hunter Park Station			See Attachment 6G for curb ramp locations, images of barriers, recommendations, and ADA requirements.	
87. Pedestrian Crossing 2a-2b	Pedestrian crossing at 2a, 2b has cracks, level changes more than ¼” high, and gaps in excess of ½” wide and ¼” deep	<p>Every joint deeper than ¼” and wider than ½” shall be filled with concrete and crack fillers as required.</p> <p>Every level change along the accessible route greater than ¼” and less than ½” height needs to be beveled (1:2 slope) or repaired using grinding tools and/or levelling compounds.</p> <p>Every level change greater than ½” needs to have a ramped surface (1:12) slope</p>		<p>2A. Complete Pedestrian crossing 2A has been repaired to ADA standards.</p> <div>

</div> <p>2B. In Progress</p>

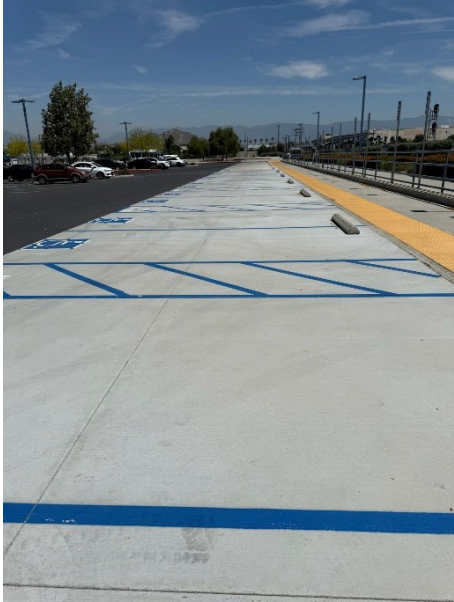
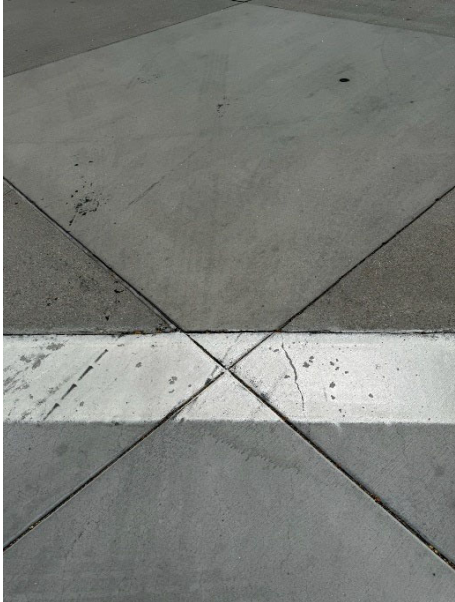
88.General Accessible Paths	There are uneven joints and cracks observed in concrete along the accessible route, and sealant/filler in deep joints is missing.	Same as above.	Update the maintenance plan for ongoing routine inspections and repairs of all components of the accessible route.	<div>Complete</div> <div>Accessible paths have been paved and repaired to meet ADA standards.</div> <div>

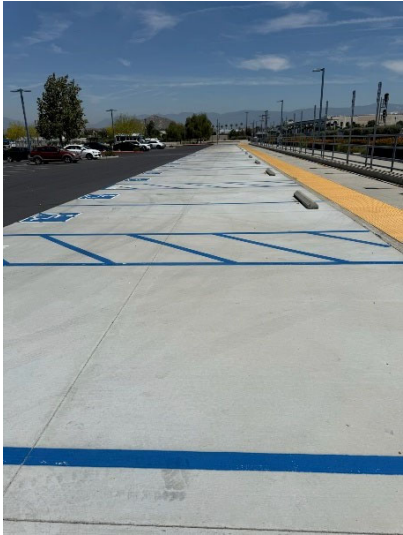
89.Parking aisles	Access aisles at parking stalls have cracks and level changes more than ¼” high and gaps in excess of ½” wide and ¼” deep.	<div>Every joint deeper than ¼” and wider than ½” shall be filled with elastomeric fillers and sealed</div> <div>Every level change along the accessible route greater than ¼” and less than ½” height needs to be beveled (1:2 slope) or repaired using grinding tools, filler and sealer.</div> <div>Every level change greater than ½” needs to have a ramped surface (1:12) slope.</div>		<div>Complete</div> <div>Access aisles and parking stalls have been repaved and recemented.</div> <div>
