Riverside County Transportation Commission
ADA Transition Plan -
Fourth Year Update
June 2026

RCTC ADA Transition Plan - Fourth Year Update June 2026

Riverside County Transportation Commission
ADA Self- Evaluation and Transition Plan
Updated: June 2026

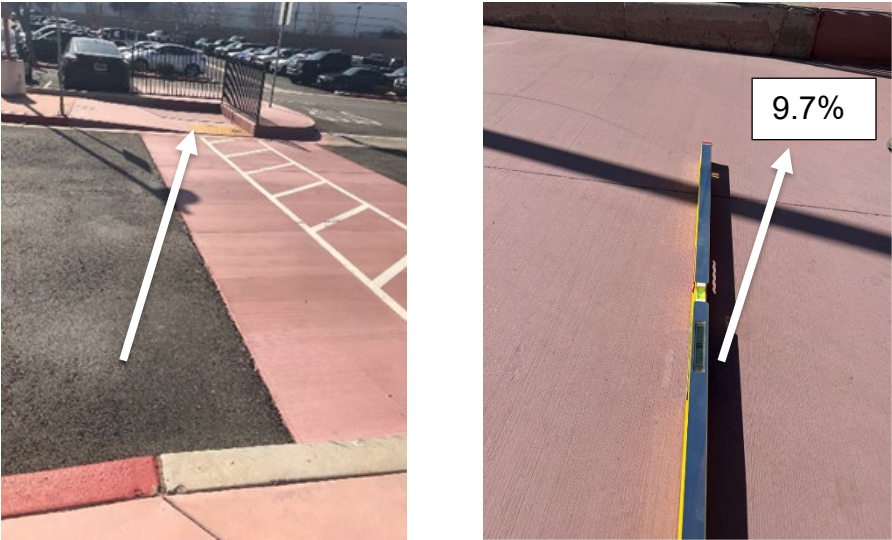
2. Curb ramp 1b	Flared side exceeds 1:10 slope (11.6%)	Repair flared sides of curb ramps to comply with 1:10 slope requirement or replace entire curb ramp. This will include placement of DWS.	<p>When repairs begin, use proper and precise instruments (4-foot smart level and 2-foot smart level) to fit within the curb ramp width, and the adjacent gutter to measure ramp slopes, cross slopes, and counter slopes.</p> <p>Use smart level instruments, calibrated in accordance with manufacturer's instructions before taking measurements.</p>	<p>Complete</p> <p>The curb ramp was reconstructed to be ADA standard.</p>

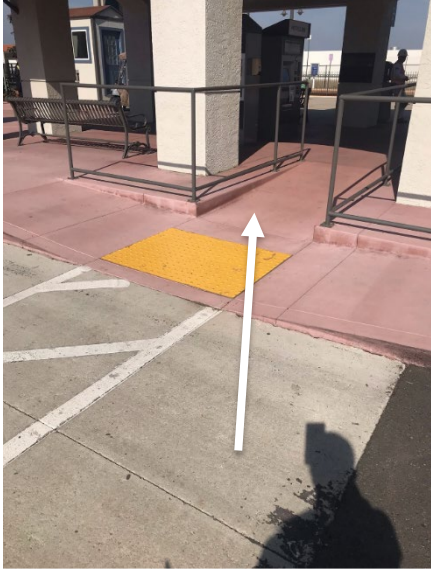
3. Curb ramp 2a	Sloped portion of ramp takes up the entire sidewalk in front of the main entrance.	Provide signage for the accessible route along the sidewalk leading to level walking route under the canopy	The landing for the curb ramp is under the station canopy is compliant. So, no structural changes are needed to this curb ramp or landing.	<p>Complete</p> <p>This slope portion of the ramp was reconstructed to meet ADA standards. Signage is no longer required.</p>

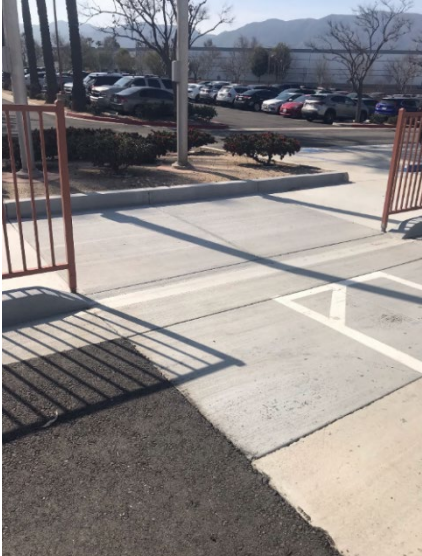
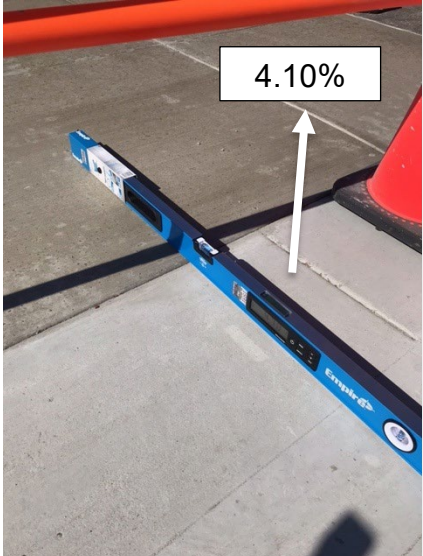
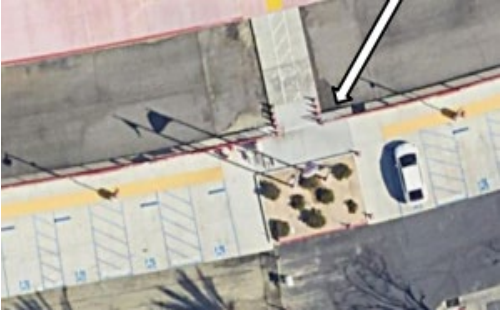
4. Curb ramp 2b	Gutter slope exceeds 1:20 (9.1%). Flared side exceeds 1:10 slope (12.2%). uneven level changes and trip hazard.	Remove and replace flared sides of the curb ramp, portions of the gutter to make slopes compliant Replace entire curb ramp. Repair uneven level changes and trip hazards. This will include placement of DWS.	See comment for item 2.	<p>Complete</p> <p>This slope portion of the ramp was reconstructed to meet ADA standards.</p>

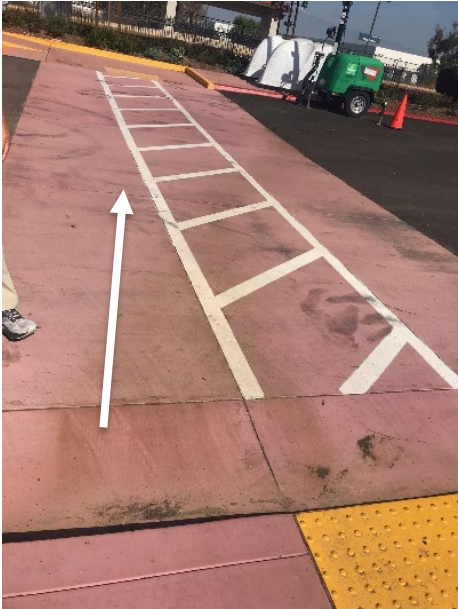
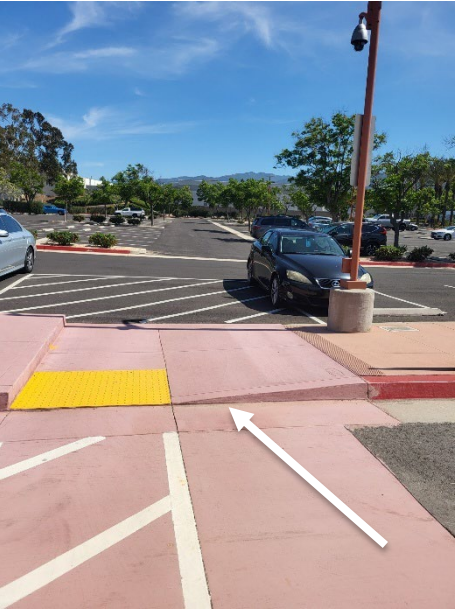
5. Curb ramp 3b	Gutter slope exceeds 1:20 (9.1%). There are uneven level changes and trip hazards.	Remove and replace portions of the gutter to make slopes compliant. Replace entire curb ramp. Repair uneven level changes and trip hazards. This will include placement of DWS.	See comment for item 2.	<p>Complete</p> <p>The area has been reconstructed to meet ADA standards.</p> <div style="display: flex; justify-content: space-around;">

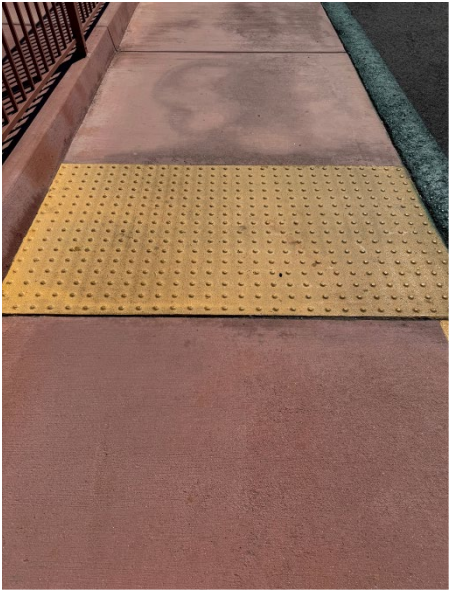
7. Pedestrian road crossing 3a-3b	Multiple cracks and gaps in excess of 1/2" wide and 1/4" deep.	Repair cracks, gaps, uneven level changes and trip hazards within the marked pedestrian crossing. Every joint deeper than 1/4" and wider than 1/2" shall be filled with concrete and crack fillers as required.		<p>Complete</p> <p>The walkway has been reconstructed to meet ADA standards.</p>

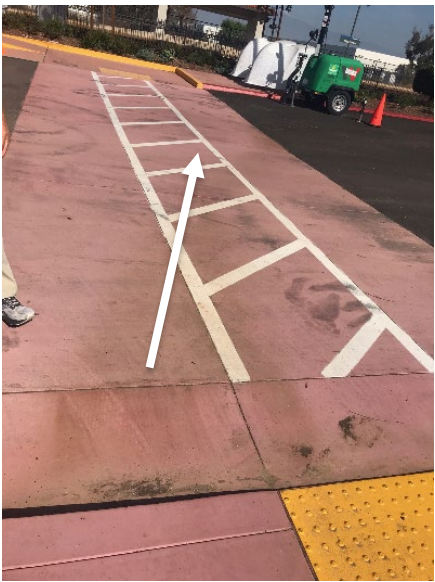
8. General Accessible Paths	There are uneven joints and cracks observed in the concrete on the platforms and along accessible route. Sealant/filler in some deep joints is missing.	<p>Repair cracks, gaps, uneven level changes and trip hazards within the accessible route.</p> <p>Every joint deeper than ¼” and wider than ½” shall be filled with concrete and crack fillers as required.</p> <p>Every level change along the accessible route greater than ¼” and less than ½” height needs to be beveled (1:2 slope) or repaired using grinding tools and/or levelling compounds.</p> <p>Every level change greater than ½” needs to have a ramped surface (1:12) slope.</p>	Create a maintenance plan for ongoing routine inspections and repairs of all components of the accessible route.	<p>Complete</p> <p>Repairs were conducted on the general access path to meet ADA standards.</p>

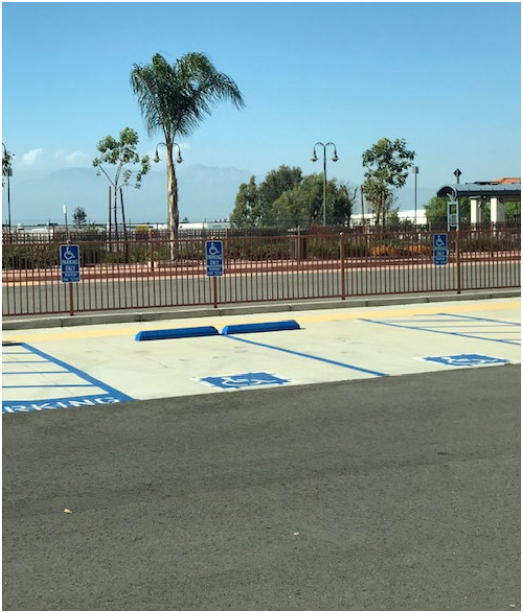
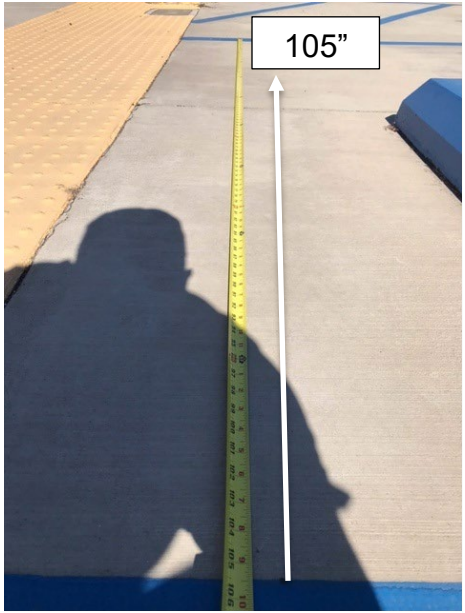
17. Parking	Width of a van accessible parking aisle is non compliant with 2010 ADA standards for van accessible spaces.	Restripe to provide 96 inches wide aisle making the van accessible space also 96 inches.		<p>Complete</p> <p>Van accessible parking aisle has been restriped to meet ADA standards.</p> <div style="display: flex; justify-content: space-around; align-items: center;">

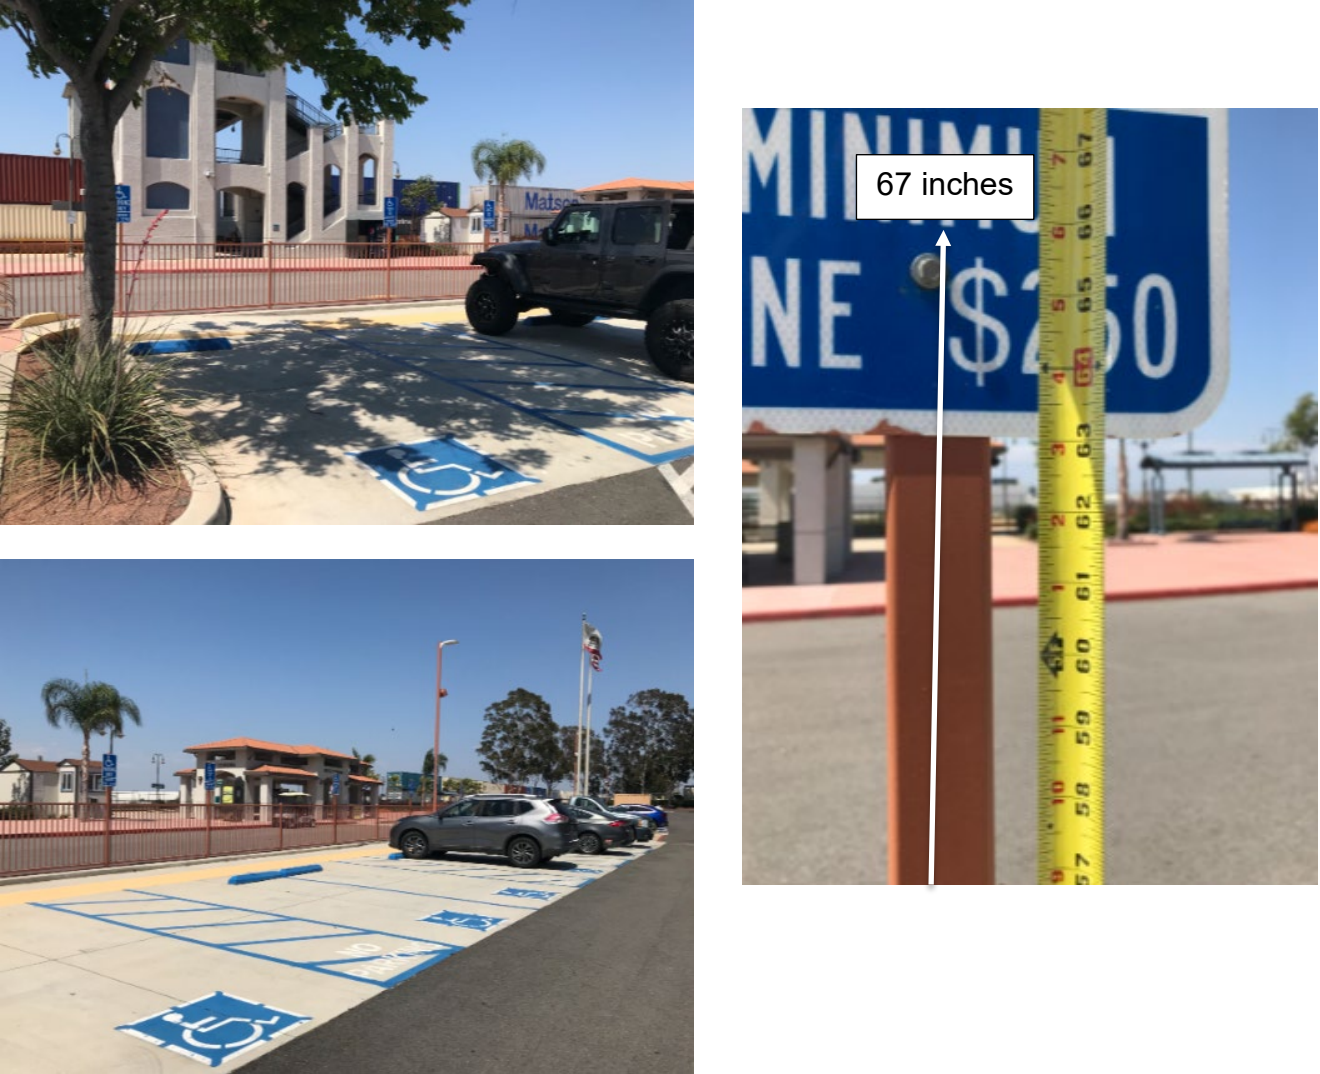
Facility/Area	Access Issue	Solution	Comments	Resolution Status
West Corona Station			See Attachment 6A for curb ramp locations, images of barriers, recommendations, and ADA requirements.	
18. Parking	Bottom of accessible parking sign is lower than the required 60 inches.	Provide post mounted signs to comply with 2010 ADA requirements.		<p>Complete</p> <p>All ADA parking signs relocated moved above 60 inches per ADA requirements.</p>

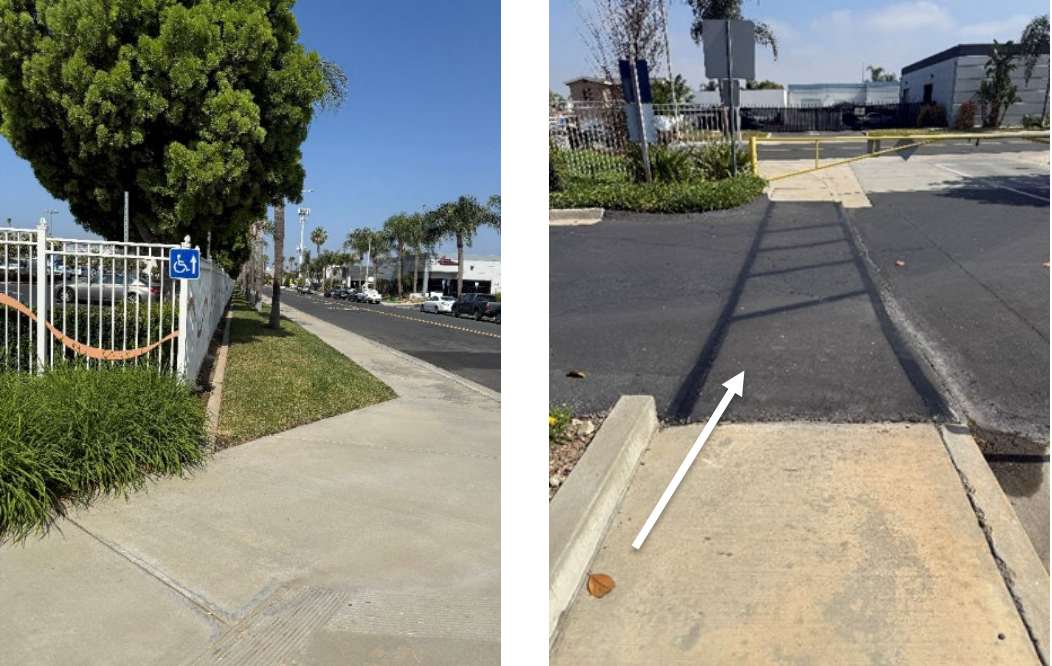
22. Curb ramp 4a	Cross slope of the ramp exceeds 2 %	Repair cross slope or replace entire curb ramp. This will include placement of DWS.	When repairs begin, use proper and precise instruments (4-foot smart level and 2-foot smart level) to fit within the curb ramp width, and the adjacent gutters to measure ramp slopes, cross slopes, and counter slopes. Use smart level instruments, calibrated in	Complete

Facility/Area	Access Issue	Solution	Comments	Resolution Status
North Main Corona Station			See Attachment 6B for curb ramp locations, images of barriers, recommendations, and ADA requirements.	
			accordance with manufacturer's instructions before taking measurements.	<p>Cross slopes were re-examined and were found to meet ADA standards. Measurements were at 1.9%, which is less than the 2% maximum standard.</p>

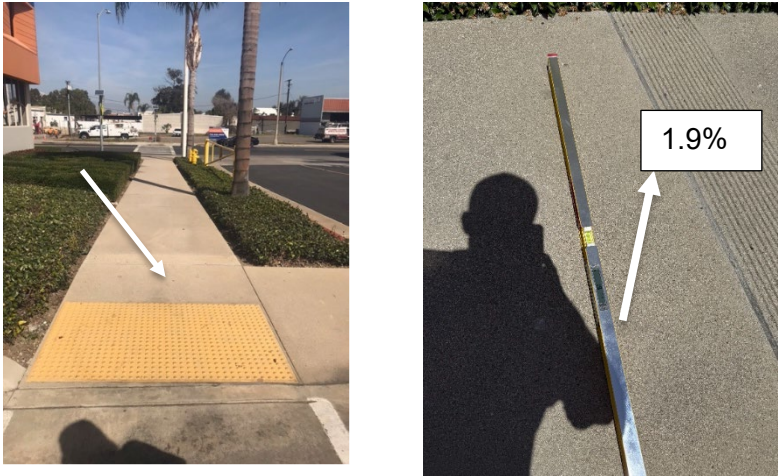
23.Curb ramp 4b	Cross slope of the ramp exceeds 2 %	Repair cross slope or replace entire curb ramp. This will include placement of DWS.	Same as above	<p>Complete</p> <p>Cross slopes were re-examined and were found to meet ADA standards. Measurements were at 1.3%, which is less than the 2% maximum standard.</p>

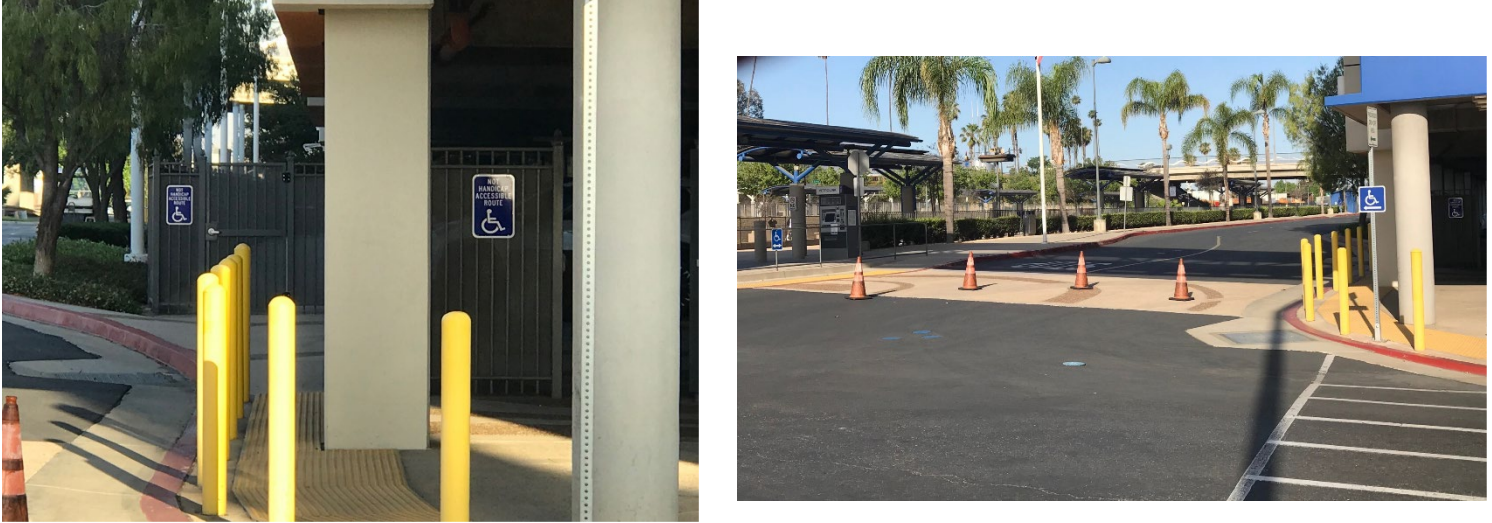
26. Sidewalk from garage to elevators	Width of accessible route on the ground level (sidewalk) from the garage exit gate going towards the elevators/pedestrian crossing narrows down to 28 inches along the structural columns and bollards. This sidewalk	Provide signage at the exit gate identifying the alternate accessible route.		Complete ADA and non-ADA directional signs were installed to clearly guide pedestrians to the accessible path of travel.

Facility/Area	Access Issue	Solution	Comments	Resolution Status
North Main Corona Station			See Attachment 6B for curb ramp locations, images of barriers, recommendations, and ADA requirements.	
	does not meet accessibility requirements for minimum width of 48 inches.

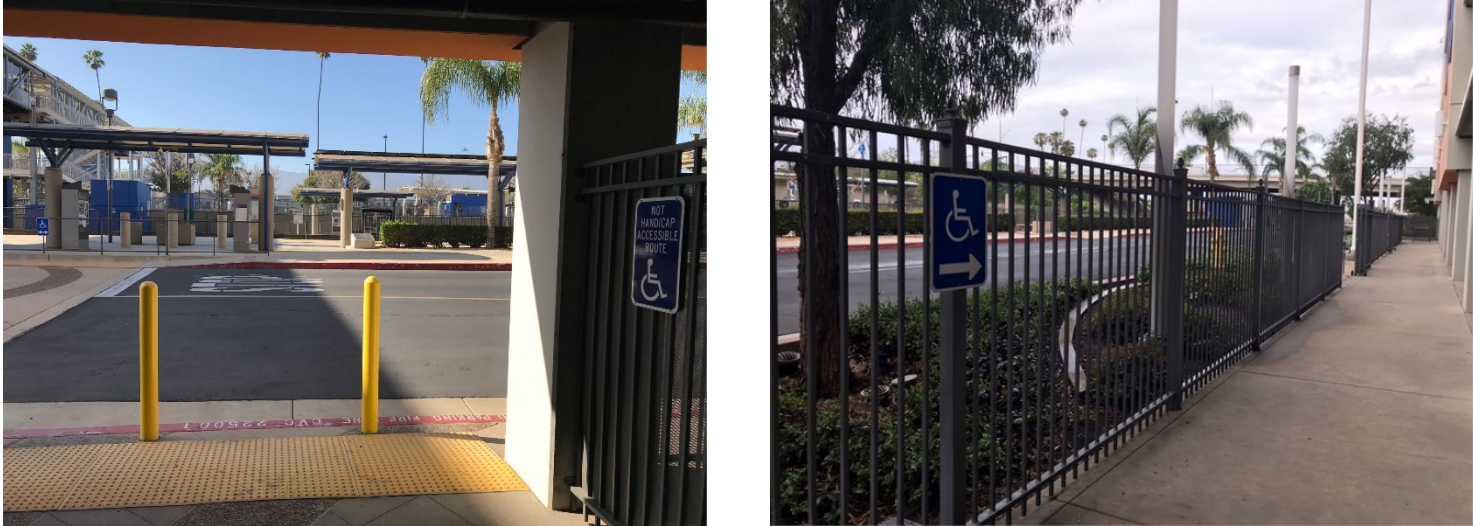
27. Sidewalk/Path from garage to the station	Curved ramps leading to the garage at 2b are not accessible due to the cross slope exceeding ADA requirements of minimum 2%	Provide signage pointing to the accessible route. Remove signage identifying the curved ramps as accessible routes.	Circular or curved ramps continually change direction. Curvilinear ramps with small radii also can create compound cross slopes and cannot, by their nature, meet the requirements for accessible routes.	<p>Complete</p> <p>The right-side entrance was opened for accessible use, verified to have compliant cross-slopes, and ADA directional signage was installed to guide users to this entrance.</p>

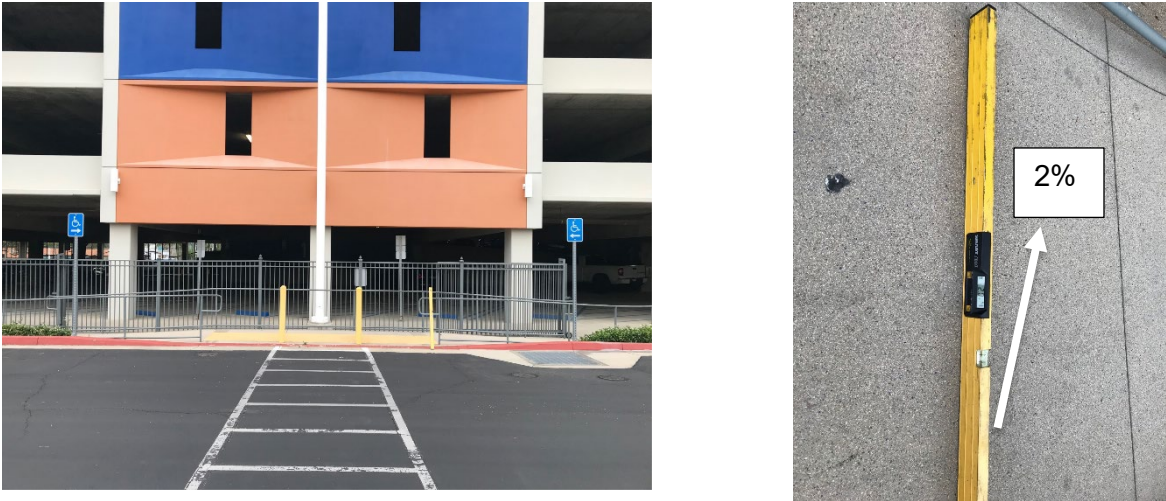
28. General Accessible Paths	Cross slope exceeds 2% on the sidewalks adjacent to the garage entry/exit	Repair cross slopes on the accessible route.	Update and create a maintenance plan for ongoing routine inspections and repairs of all components of the accessible route.	<p>Complete</p> <p>Cross slopes have been reconstructed to meet ADA standards.</p> <div style="display: flex; justify-content: space-around; align-items: center;">

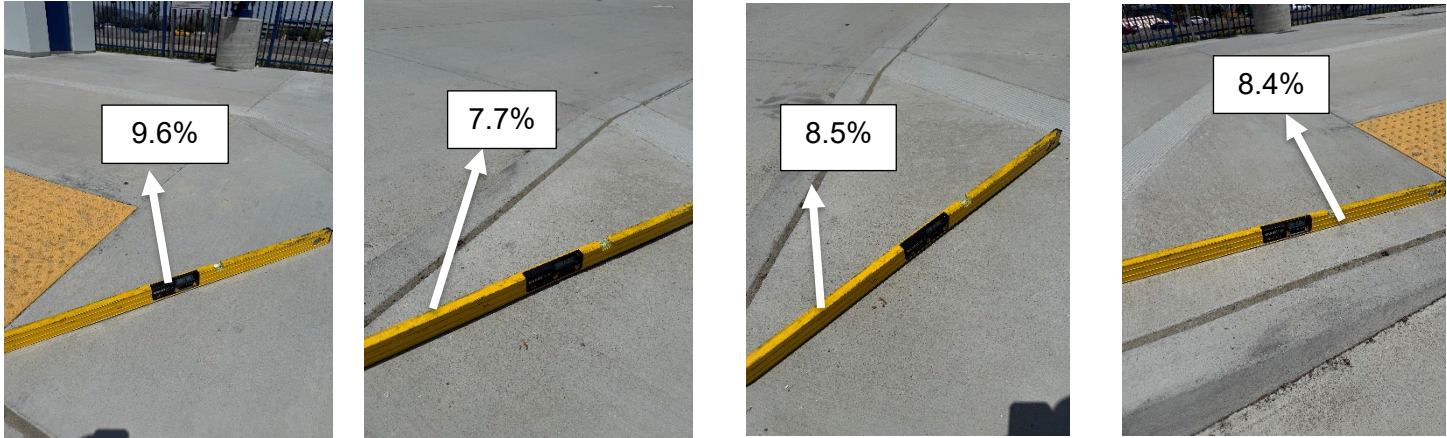
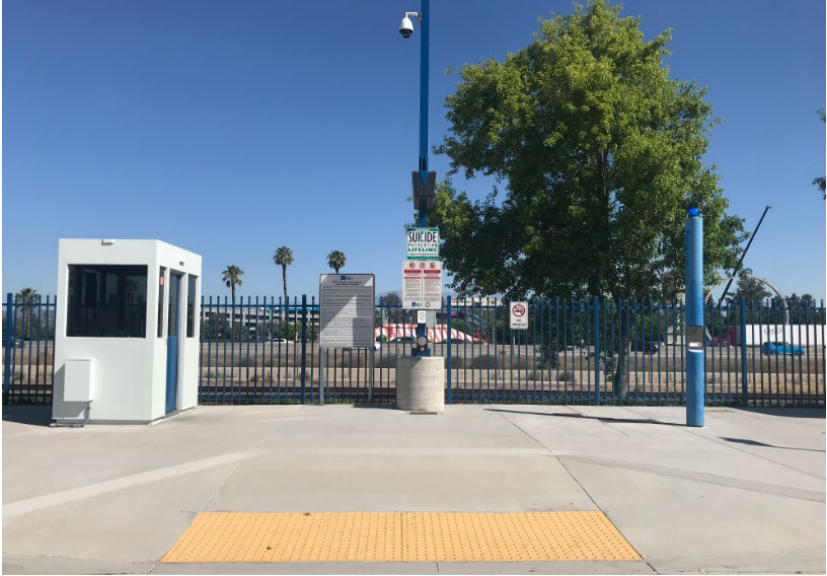
38.Curb ramp 4b	Trip hazards due to level changes exceeding ¼ inch.	Remove the trip hazard and provide flush transitions adjacent to curb	Same as above	Complete

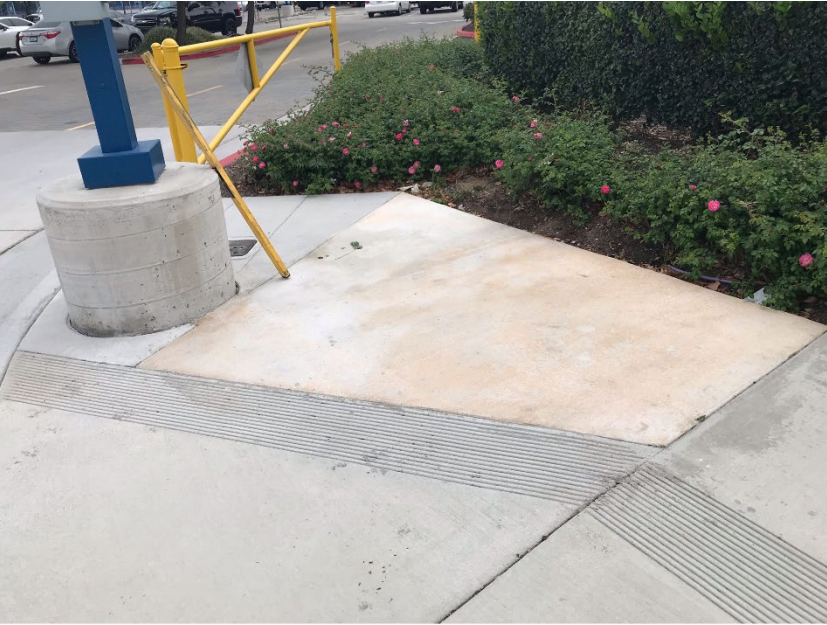
39.Curb ramp 6a	<p>Gutter slope appears to be more than 5%.</p> <p>Extent of DWS along the curved segment does not match Case CM of CA standard plan A88B.</p>	<p>Repair gutter slope.</p> <p>Reapply DWS in dominant direction of travel in entirety as shown for Case CM of CA Standard plan A 88B.</p>	Same as above	<p>Complete</p> <p>Curb ramp and gutter reconstructed to meet the ADA standards.</p>

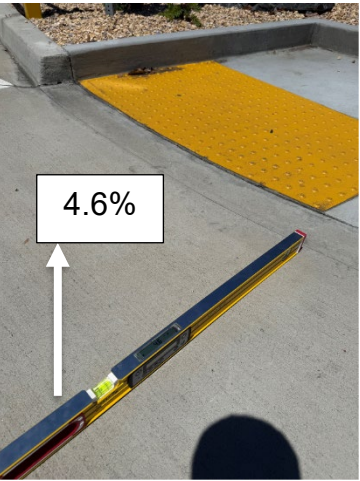
40.Curb ramp 7A	Detectable Warning Surface (DWS) is missing. Turning space at bottom of ramp is not 48 in wide at the back of curb.	Provide DWS in the landing and modify sidewalk to provide 48 inches minimum.		<p>Complete</p> <p>Curb ramp has been reconstructed with DWS to meet the ADA standards.</p> <div style="display: flex; justify-content: space-around; align-items: center;">

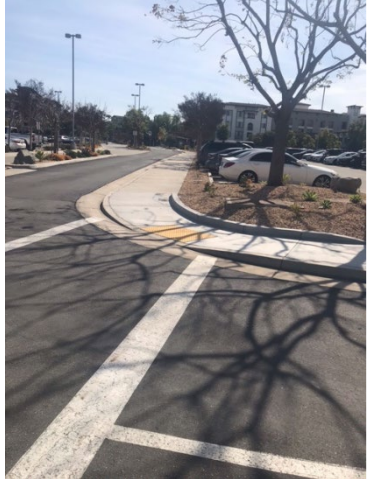
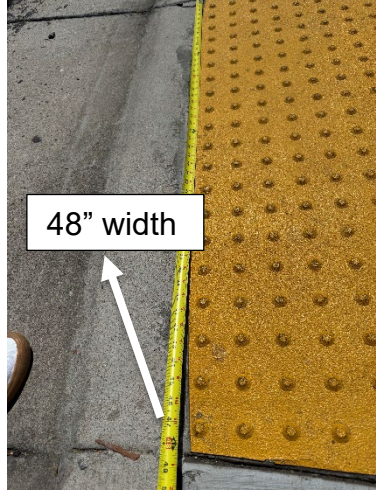
41.General Accessible Paths	There are uneven joints and cracks observed in concrete along the accessible route, and sealant/filler in deep joints is missing.	<p>Examine and repair accessible routes where there are uneven joints and cracks observed in concrete along the accessible route, and where sealant/filler in deep joints is missing.</p> <p>Every joint deeper than 1/4" and wider than 1/2" shall be filled with concrete and crack fillers as required.</p> <p>Every level change along the accessible route greater than 1/4" and less than 1/2" height needs to be</p>	Create a maintenance plan for ongoing routine inspections and repairs of all components of the accessible route.	<p>Complete</p> <p>Accessible paths have been reconstructed to meet ADA standards.</p> <div style="text-align: center;">

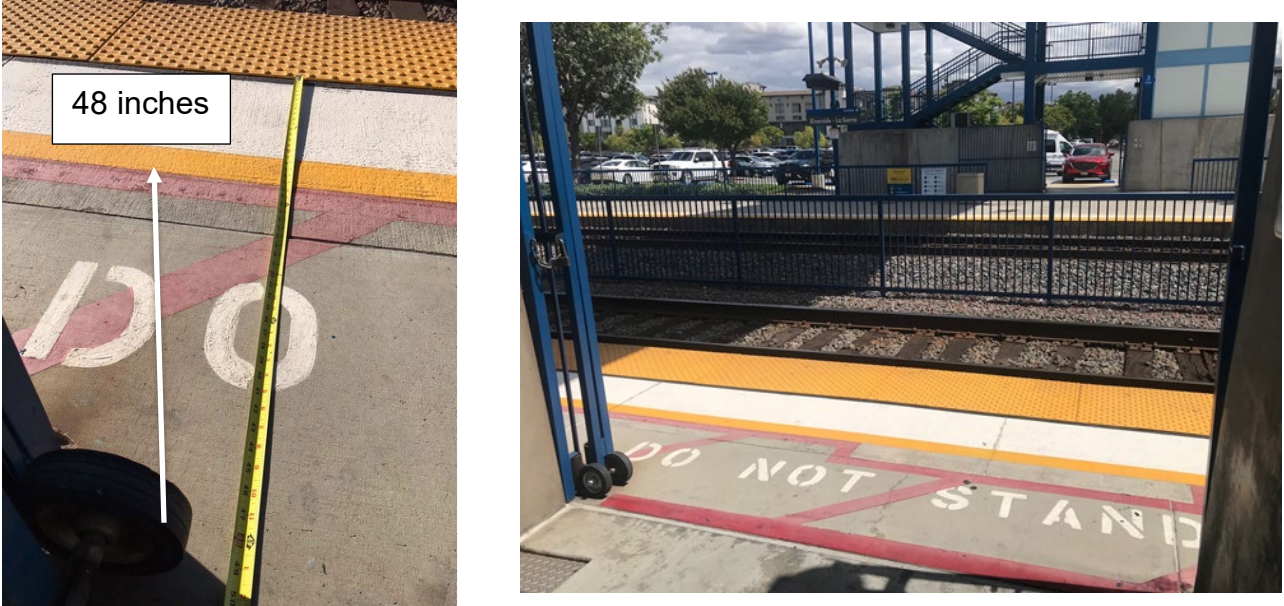
44. Platform	Escutcheon plate for the rail post in the center of the tactile warning strip is damaged and causes a trip hazard. This	Remove trip hazards		Complete Platform escutcheon plate has been repaired to meet the ADA standards

Facility/Area	Access Issue	Solution	Comments	Resolution Status
La Sierra Station			See Attachment 6C for curb ramp locations, images of barriers, recommendations, and ADA requirements.	
	occurs at South platform, mini high platform at the west end

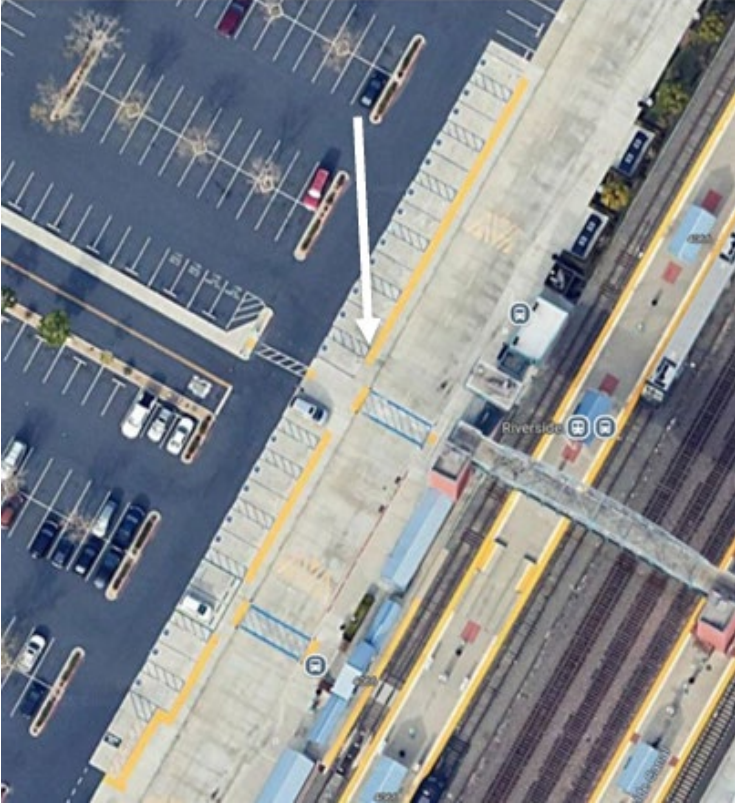
50.Curb ramp 5a	Portion of ramp at the loading zone has a slope exceeding 8.33%. The remaining portion of the ramp is accessible.	Repair slope of the inaccessible portion of ramp. This will include placement of DWS.	<p>When repairs begin, use proper and precise instruments (4-foot smart level and 2-foot smart level) to fit within the curb ramp width, and the adjacent gutters to measure ramp slopes, cross slopes, and counter slopes.</p> <p>Use smart level instruments, calibrated in</p>	<p>Complete</p> <p>Curb ramp has been repaired and now complies with ADA standards. The slope of the ramp is 7.0%.</p>

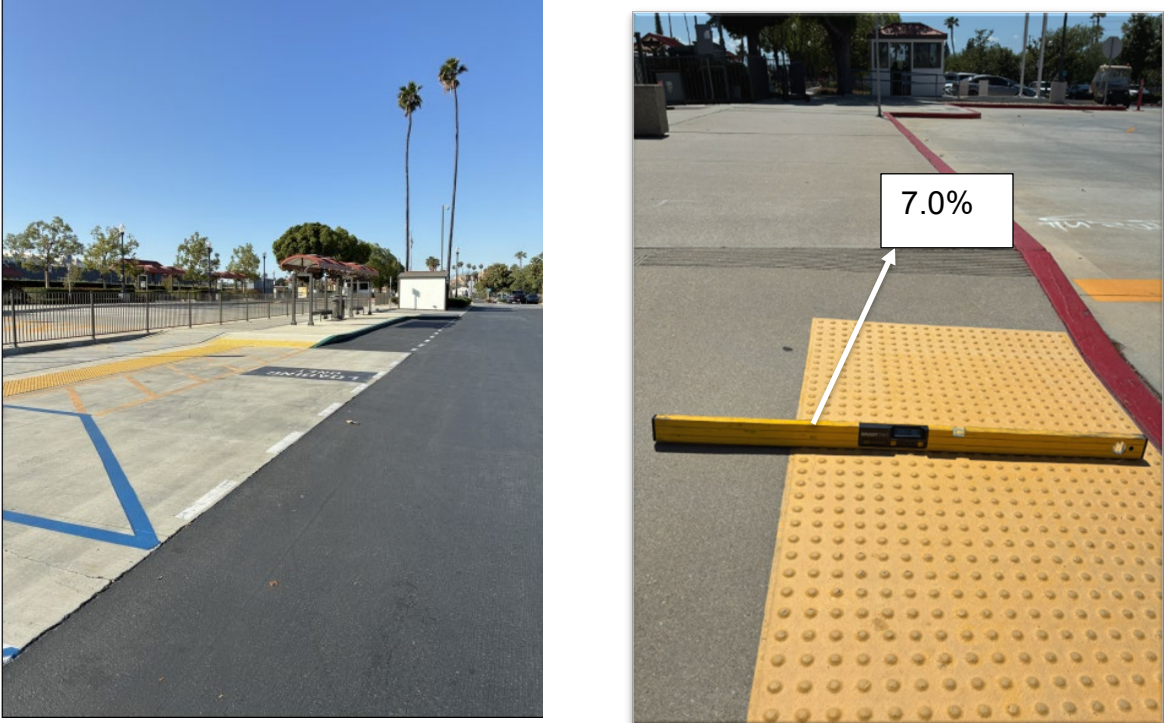
51.General Accessible Paths	There are uneven joints and cracks observed in concrete along the accessible route, and sealant/filler in deep joints is missing.	<p>Examine and repair accessible routes where there are uneven joints and cracks observed in concrete along the accessible route, and where sealant/filler in deep joints is missing.</p> <p>Every joint deeper than 1/4" and wider than 1/2" shall be filled with concrete and crack fillers as required.</p> <p>Every level change along the accessible route greater than 1/4"</p>	Create a maintenance plan for ongoing routine inspections and repairs of all components of the accessible route.	<p>i. Complete – Accessible routes uneven joints and cracks</p> <p>Accessible paths have been repaired to meet ADA standards.</p>

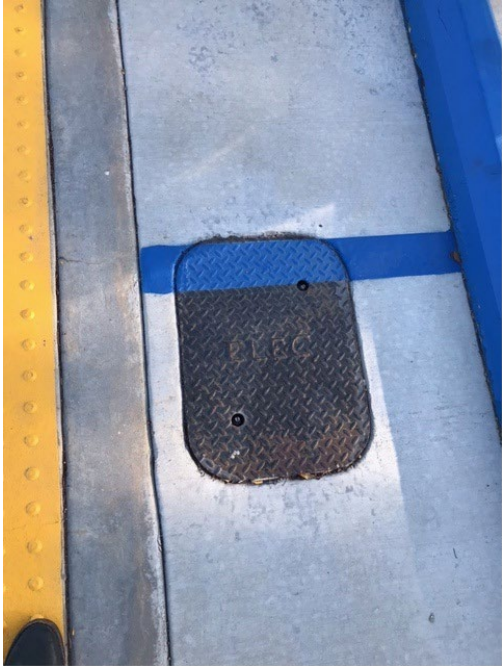
72. Platform	Utility covers are not ADA compliant due to missing filler pieces in lifting holes.	Add filler pieces in all holes exceeding 1/2" diameter.		<p>Complete</p> <p>Utility covers filler pieces have been added to all the holes to meet ADA standards.</p>
