## **Evaluation of Physical Barriers - South Perris Station**

Address: South Perris Blvd, Perris, CA 92570

**RCTC ADA Self-Evaluation and Transition Plan - Attachment 6I** 01 July, 2022 These elements were assessed to identify any physical barriers:

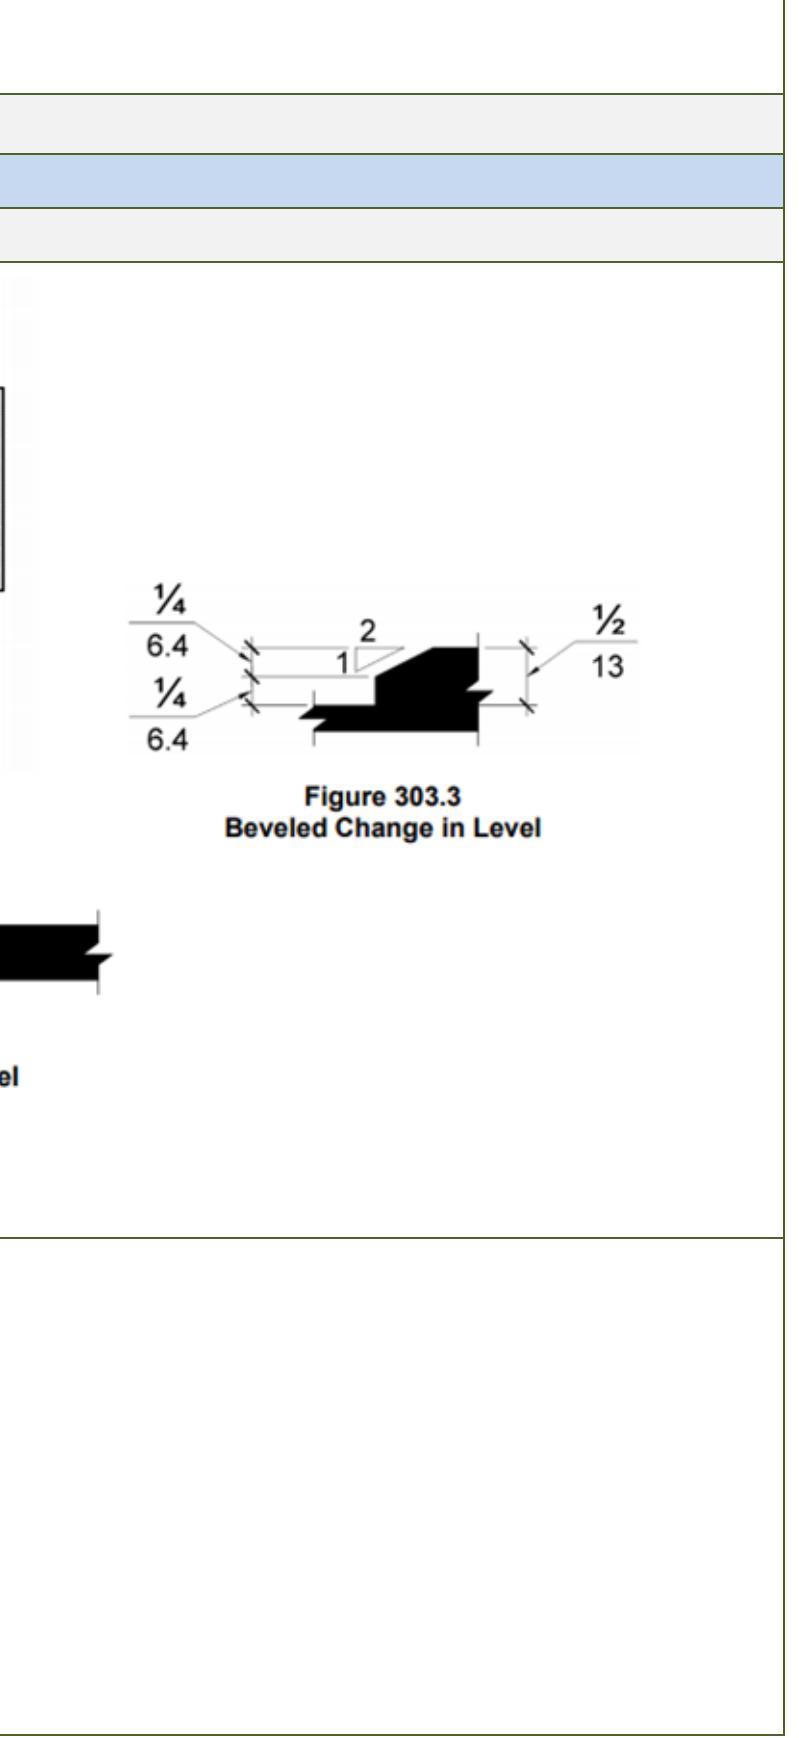
a) Pedestrian Push Button- Not Applicable	No action by RCTC	
3. Accessible Routes		
a) Walking surface		
Aisles at the ADA parking spots have major cracks, level changes, and gaps. The asphalt has separated from the concrete causing gaps wider than an inch. The parking spaces are not accessible due to these issues.	Examine all parking aisles, accessible routes and repair all cracks. Every joint deeper than 1⁄4" and wider than 1⁄2" shall be filled. Every level change along the accessible route greater than 1⁄4" and less than 1⁄2" height needs to be beveled (1:2) slope or repaired. Every level change greater than 1⁄2" needs to have a ramped surface (1:12) slope.	dominant direction of travel long dimension perpendicular to dominant direction of travel 1/2 max 13 Figure 302.3 Elongated Openings in Floor or Ground Surfaces 1/4 max 6.4 Figure 303.2 Vertical Change in Level
Cracked concrete at drop off zone.	Same as above

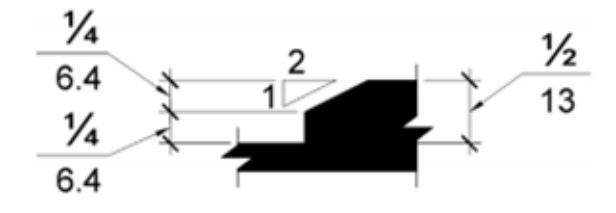
a. Walking Surfaces		
I. General: Joints and gaps in concrete to be repaired or maintained for compliance with 302.3, 303.2, and 303.3.	Examine all pedestrian routes and repair all cracks. Every joint in concrete deeper than ¼" and wider than ½" shall be filled. Every level change along the accessible route greater than ¼" and less than ½" height needs to be beveled (1:2) slope or repaired. Every level change greater than ½" needs to have a ramped surface (1:12) slope.	dominant direction of travel long dimension perpendicular to dominant direction of travel $\frac{1}{2}$ max $\frac{1}{13}$ Figure 302.3 Elongated Openings in Floor or Ground Surfaces $\frac{1}{4}$ max 6.4 Figure 303.2 Figure 303.2 Vertical Change in Level
