# Historic Resources Report for the Riverside-Downtown Station Improvements Project

4066 Vine Street, Riverside, California 92507

**July 2021**

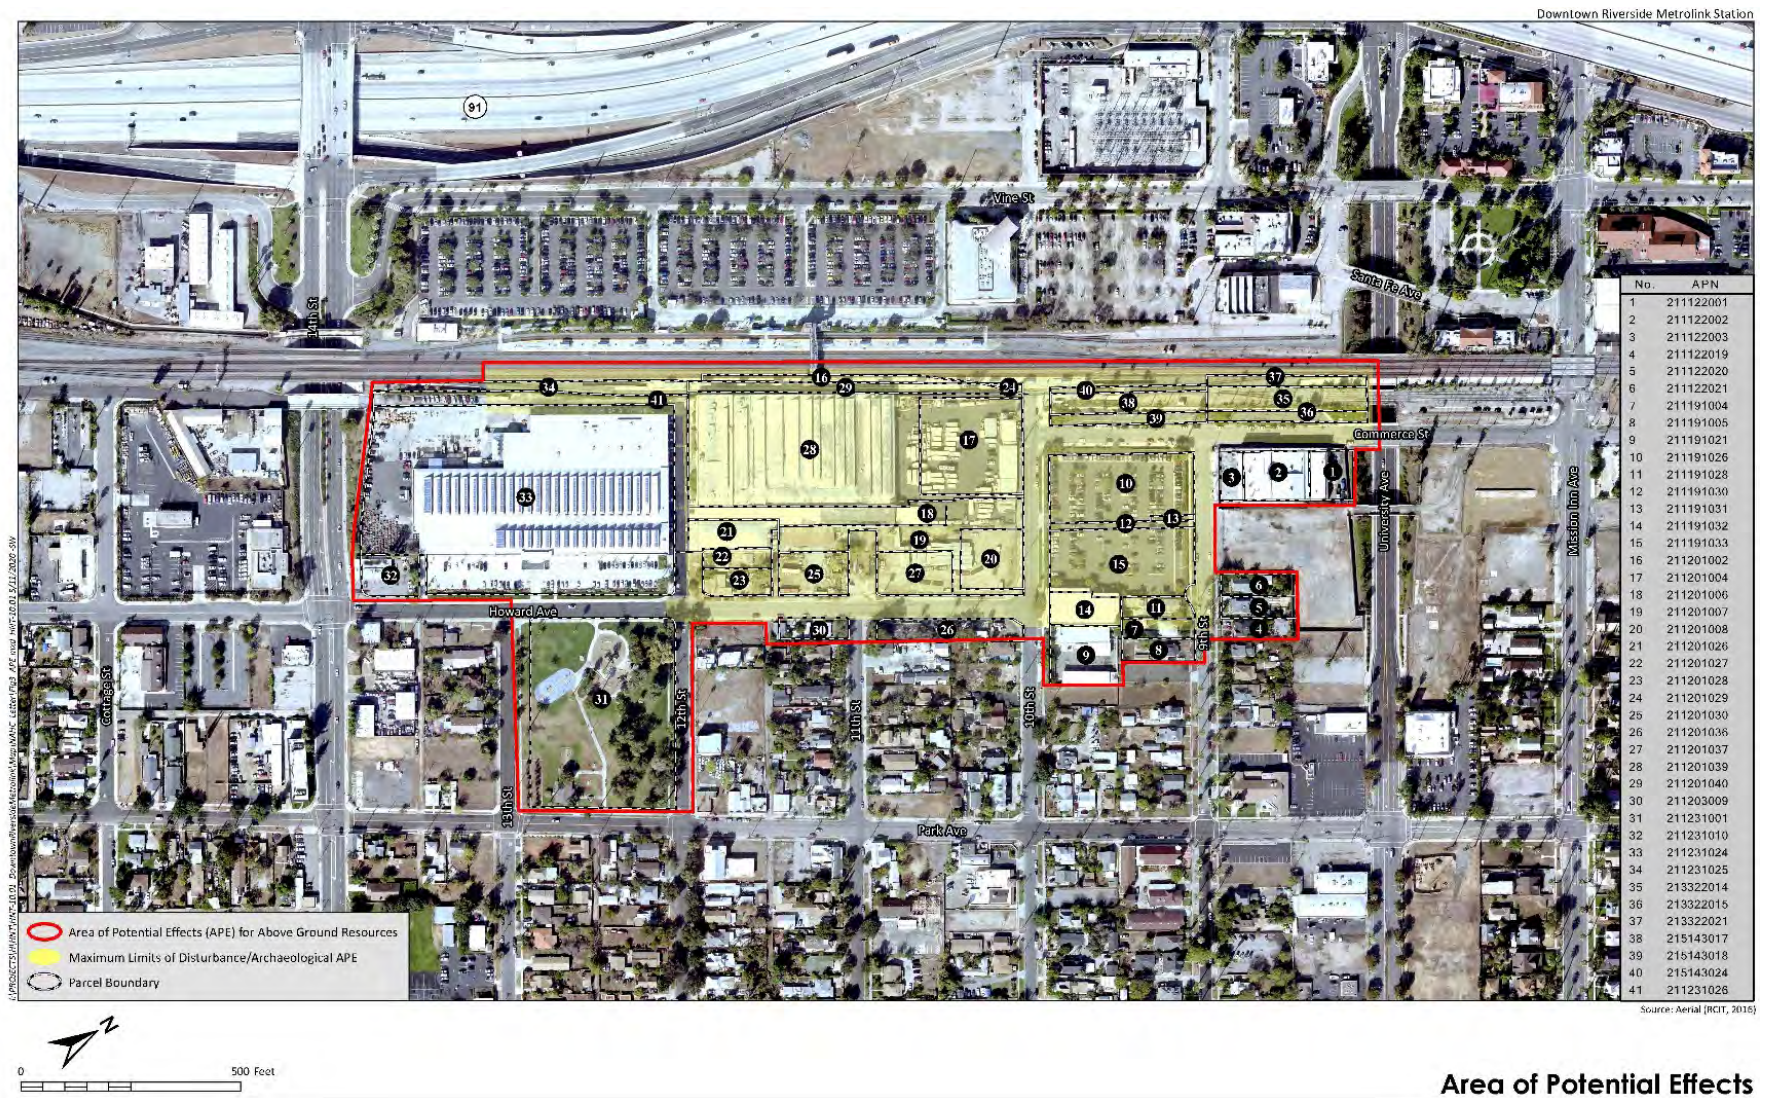
Figure 3-1. Area of Potential Effect

The APE for this undertaking is defined as the area of land encompassed by the BNSF railroad corridor to the west, Ninth Street (generally) to the north, Howard Avenue to the east, and 14<sup>th</sup> Street to the south. The LOD is within this area (yellow shaded area in Figure 3-1), and the maximum depth of disturbance across the LOD is 10 feet. The vertical limit of the APE is 35 feet high to accommodate any visual effects caused by the extension of the pedestrian overpass.

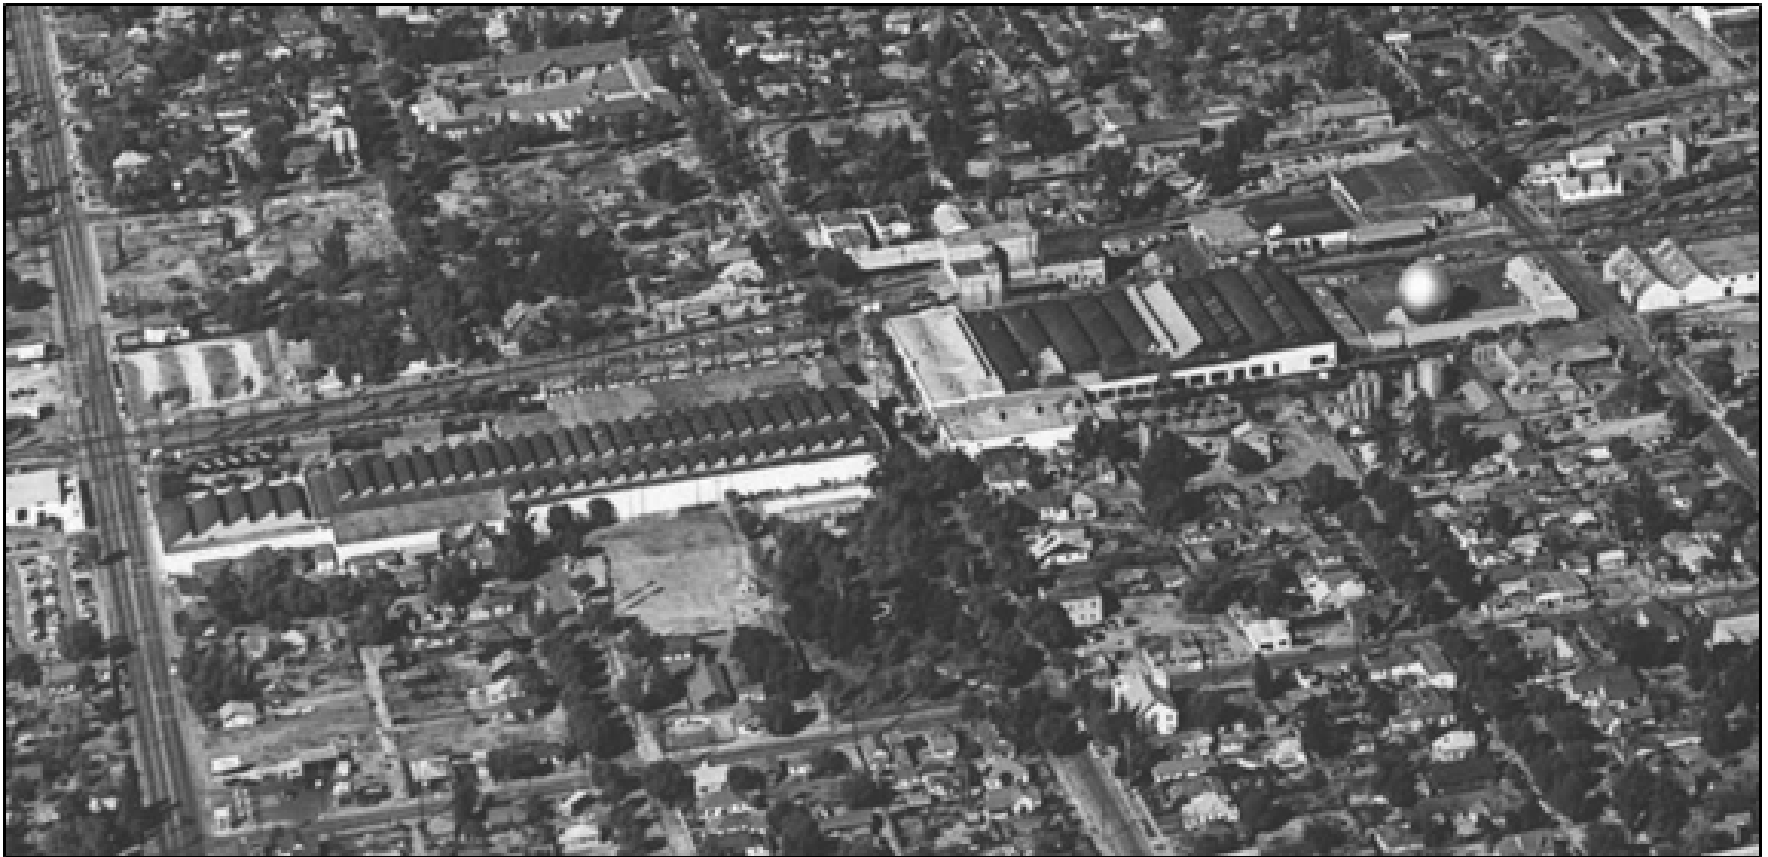
**Figure 4-2. FMC Complex, Looking West, November 1955**

*Spence Photo Archives, University of California, Los Angeles. Courtesy: Chattel Architecture, Planning, and Preservation, Inc. Illustrates the urban fabric surrounding the APE from 1955.*

The FMC Complex (1938 to 1942) is between 14<sup>th</sup> Street and 10<sup>th</sup> Street (south to north) and parallels the railroad corridor in the heart of Eastside. Flanking the complex are modest worker's residences and a neighborhood park (Lincoln Park) that served as a community center of sorts for the Latino and African American communities residing in Eastside. After the war, Eastside continued to be home to largely Latino and African American families (Rincon and Associates, 2018: 84). Figure 4-2 illustrates this post-World War II setting of FMC in the community.

Figure 4-2 provides an overview of the complex as it appeared in 1955, during the peak of FMC operations and the period of its maximum buildup.

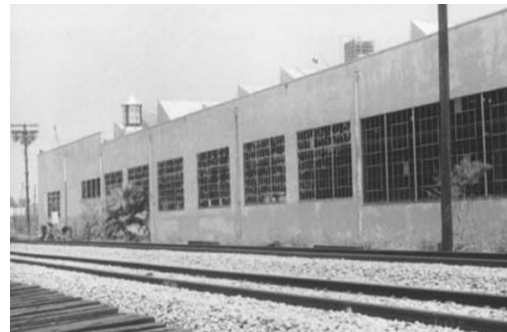
**Figure 4-5. Plant 1 Building A, Historic View**

The primary building (designed by architect Herbert Hamm of Pasadena) in the complex and the first to be constructed was Plant 1, completed in 1938 and located on the northern half of the property. Plant 1 (Building A) (Figure 4-5) was the first manufacturing facility in the complex and comprises a large, two-story, rectangular-plan industrial building constructed of concrete and covered with stucco.

**West Elevation Alterations.** Although the windows in the west elevation appear to be original (Figure 4-5), they are set into a wall that was reconstructed in 1997 (Figure 4-6), moving the entire western elevation eastward 13 feet to accommodate construction of the adjacent RDS (Figure 4-7). This reconstructed elevation is clad in contemporary stucco, and the placement of most of its window bays is very similar to their placement in the original west elevation.

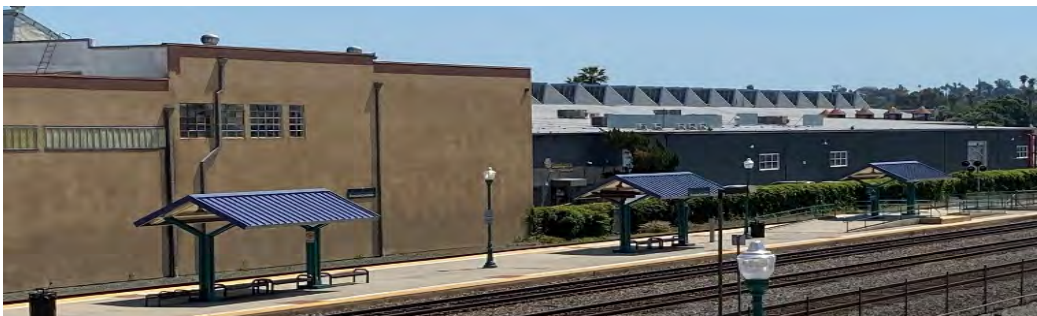
**Figure 4-6. FMC Plant 1 Building A West Elevation Looking Southeast with Plant 2 in the background (Existing)**

**West Elevation Alterations:** Although the windows in the west elevation appear to be original (Figure 4-5), they are set into a wall that was reconstructed in 1997 (Figure 4-6), moving the entire western elevation eastward 13 feet to accommodate construction of the adjacent RDS (Figure 4-7). This reconstructed elevation is clad in contemporary stucco, and the placement of most of its window bays is very similar to their placement in the original west elevation.

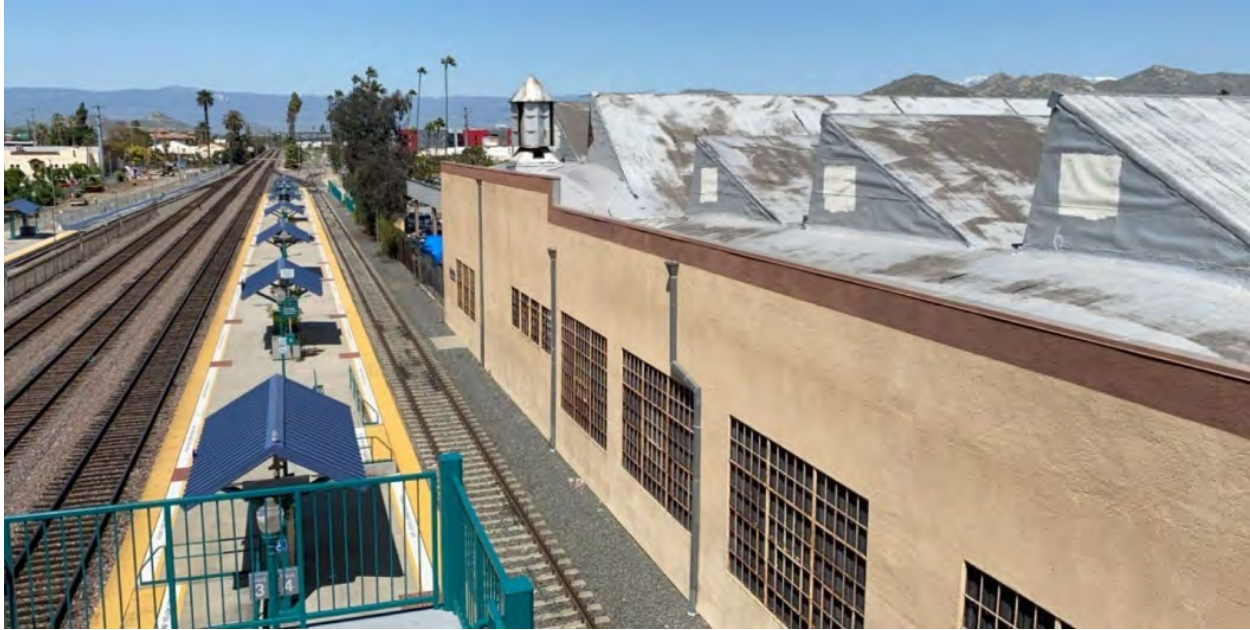
**Figure 4-7. FMC Plant 1 Building A West Elevation, Looking Northeast (Existing)**

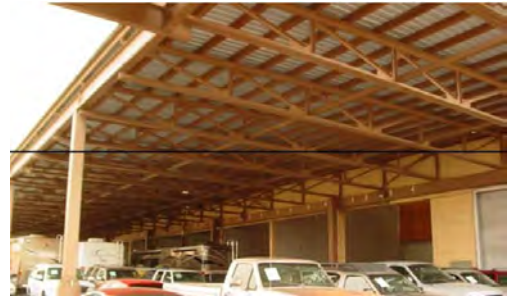
The north elevation contains a row of large truck bays that are a recent alteration (Figure 4-8).

**Alterations to the North Elevation.** Originally, this elevation featured numerous multi-light windows similar to the windows on the west elevation. Truck bays now occupy the bays where windows were once located. The truck canopies were demolished sometime after 2007.

**Figure 4-8. North Elevation ca. 2007**

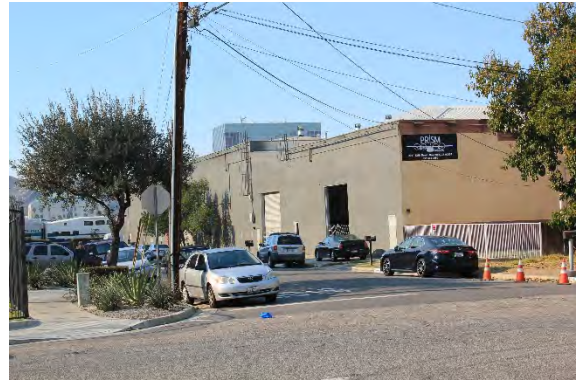
**Alterations to Additions C and D.** The south elevation of Plant 1 has been altered to encompass Additions C and D from the exterior and reads as one continuous building in its current configuration. Originally, this addition had three large sawtooth light bays that have since been removed. This addition is now connected to Plant 1 via a two-story corrugated metal gabled-roof breezeway that appears to date from 1973 and is designated as Addition D (Figure 4-9).

**Figure 4-9. Plant 1 View  
Looking Northwest**

**East Elevation: Additions C and D.** The east elevation of Plant 1 has been altered and encompassed by Additions C and D from the exterior and reads as one continuous building in its current configuration. Originally, this addition had three large sawtooth light bays that have since been removed. This addition is now connected to Plant 1 via a two-story corrugated metal gabled-roof breezeway that appears to date from 1973 and is designated as Addition D (Figure 4-9).

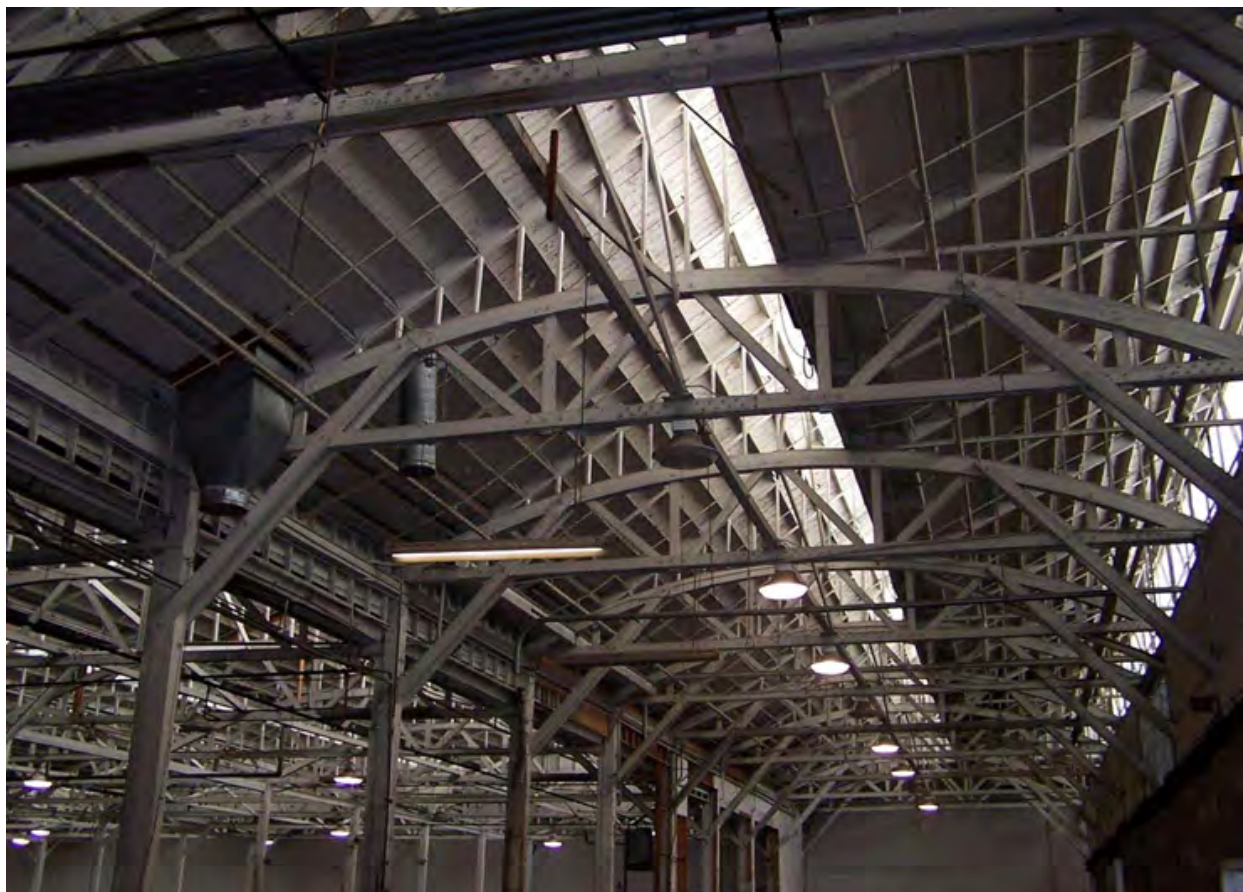
Photographic documentation of the interior (Figure 4-10) illustrates the scale of the building and the exposed heavy timber and dimension lumber framing elements, including the bowstring trusses, wood-framed skylights, and expansive open floor plan. At present, the company occupying Plant 1 is unable to allow access to determine whether interior alterations have occurred. The following description is based on a site review undertaken in 2019 (Bechtel, 2019):

The building is predominantly of timber construction with steel girders added to support elevated floors (non-original). Heavy timber columns are spaced at 20 feet on center east–west and 40 feet on center north–south, except for the westernmost bay. All timber members are rough-sawn lumber. The skylights and roof support system comprise timber trusses of dimension lumber; purlins; girders; roof and floor planking of dimension lumber; and steel girders and timber columns (Figure 4-10). Knee braces connect the columns and trusses. Column bases are pinned to the concrete flooring. The interior of the building was renovated by current occupant.

**Figure 4-10. FMC Plant 1 Building A, Bowstring Truss and Sawtooth Roof Looking West/Southwest**

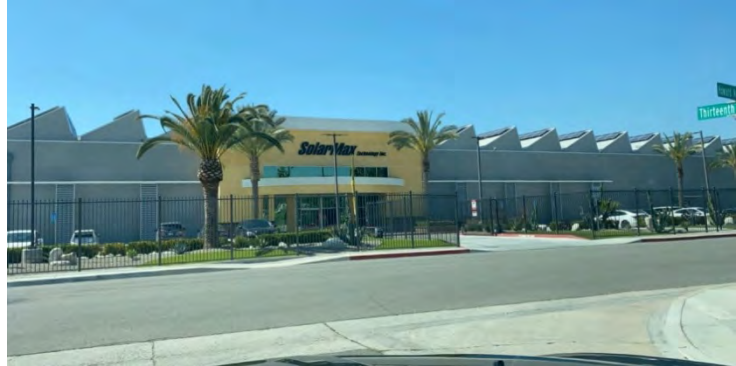
The long, blank façade of the east elevation is a primary character-defining feature. In addition, the sawtooth roof is a primary character-defining feature (Figure 4-12).

**Figure 4-12. East Elevation, Current View**

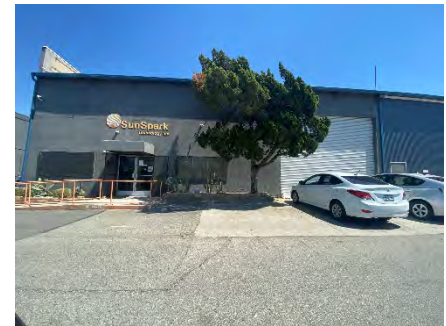
The west elevation is primarily clad in painted corrugated metal. The exception is a stucco-clad section at the north end, where a building entrance is located. There is a flat canopy above the double-door entrance. Windows are diminutive on this expansive building. There are three small sets of tripartite, 4-over-4, double-hung windows in wood frames. A truck entrance is present at its northern portion and two additional truck entrances are in the middle of this elevation. The overhead garage doors appear to be metal (Figure 4-13).

**Figure 4-13. Plant 2 West Elevation**

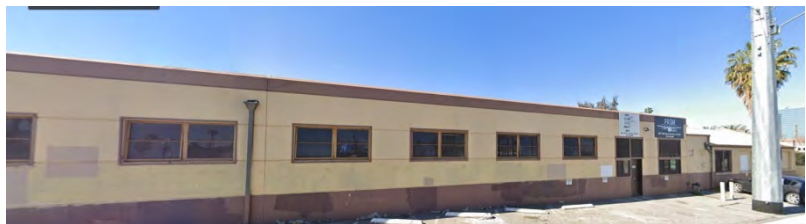
Facing 10<sup>th</sup> Street at the northeastern portion of the FMC Complex is a one-story, rectangular-plan, concrete-masonry building that appears to date from the 1940s. The north elevation (Figure 4-14) features seven window bays, each

**Figure 4-14. Building K North Elevation**

having a pair of divided-light horizontal-pivot windows in wood frames. A painted parapet and apron, as well as horizontal scoring of the concrete, are the only decorative elements to north elevation. A pedestrian entrance is present at the west end of the north elevation. It is accompanied by a single-light sidelight. The door and sidelight are topped by two of the pivot-type window bays present across this elevation.

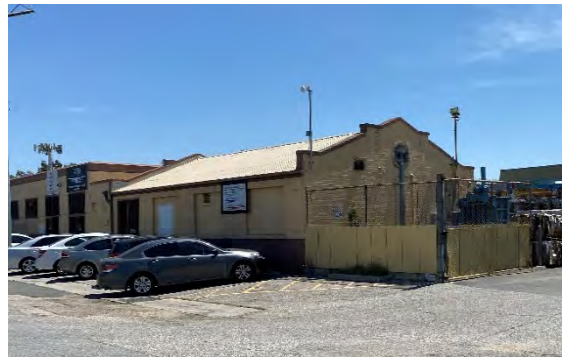
Located at the northwest corner of the FMC Complex is a rectangular-plan, side-gabled, single-story building having (minimalist) Mission Revival details. Originally built for the So Cal Gas Company in the 1910s, the building is a load-bearing brick masonry building with a two-tone paint scheme. Most of the structural bays on the north and south elevations feature recessed wall niches. The medium-pitched roof is clad in standing seam metal. This building is attached to Building K to the east. At the northwest corner of the property is a chain link fence and swinging gate allowing vehicle access. Buildings K and M are largely intact and were acquired by the FMC in the 1950s (Figure 4-15).

**Figure 4-15. Building M, Former So Cal Gas Company**

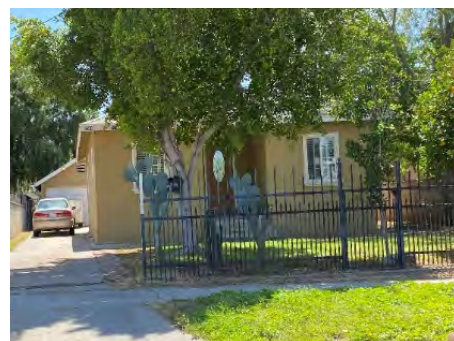
This one-story Folk Victorian cottage is sheathed with contemporary stucco and capped by a hipped roof with boxed eaves (Figure 4-16). The primary elevation is divided into three bays with a central entry flanked by two vinyl-clad, divided-light, horizontal sliding windows. A porch with a shed roof supported by four stuccoed columns on a low, stucco-covered enclosing wall spans the width of the bays.

**Figure 4-16. 2982 9<sup>th</sup> Street**

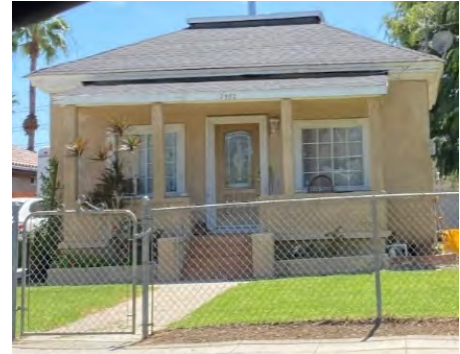
This modest Postwar cottage has a square plan and is capped by a low-pitched, hipped roof (Figure 4-17). The primary elevation is divided into three bays with a central recessed entry flanked by vinyl-clad horizontal sliding windows. The exterior of this one-story, single-family wood frame-constructed dwelling is covered with stucco.

**Figure 4-17. 2994 9<sup>th</sup> Street**

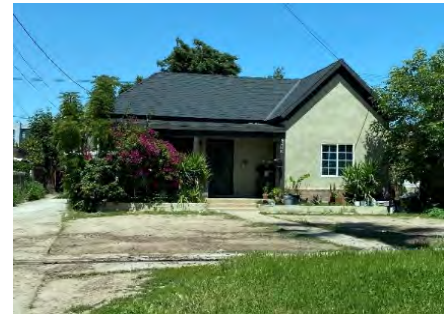
This one-story, wood-frame-constructed vernacular cottage has been modified over the years (Figure 4-18). It is sheathed with stucco and capped by a hipped roof with a front-facing cross gable clad in asphalt composition shingles. The gable end had a double-hung sash window with narrow surrounds when recorded in 2001 by others. The window is a new, vinyl-clad, divided-light, horizontal sliding (or operable) unit. The porch consists of a shed roof supported by metal posts. The main entrance is roughly centered under the shed-roofed porch.

**Figure 4-18. 2995 9<sup>th</sup> Street**

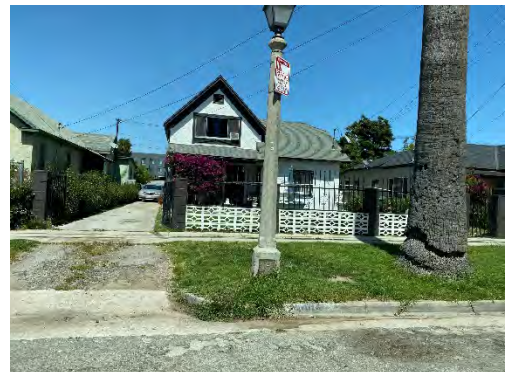
**Figure 4-19. 3005 9<sup>th</sup> Street**

This a one and a half story, wood frame-constructed Tudor cottage features a clipped, side-gabled roof intersecting the taller, one and a half story front-gabled volume (Figure 4-19). The roof features overhanging eaves and an under-eave fascia board but has no rafter ends. A shed roof covers the portico and is supported by simple, round columns. The exterior is stucco covered and the roof is a newer asphalt composition shingle roof. The windows are vinyl replacement units in simple wood surrounds and include single-light picture windows and horizontal sliding units on the main street-facing façade.

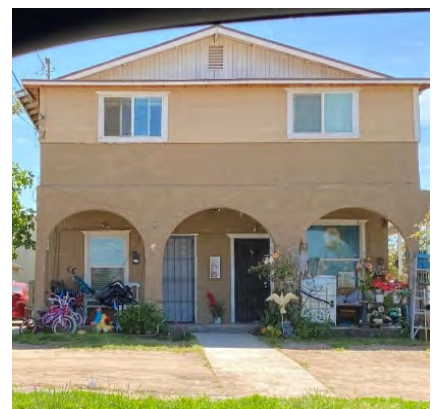
This two-story, multi-family, vernacular dwelling has been extensively altered. It may have been a foursquare duplex at one time (Figure 4-20). The first story of the primary elevation consists of a stucco-clad, arcaded portico sheltering two doors and two windows. The second story extends over the arcaded portico and has two vinyl-clad, horizontal-sliding windows. This wood frame-constructed residence is clad in stucco and horizontal wood siding above the arcade and in the gable end.

**Figure 4-20. 3006 9<sup>th</sup> Street**

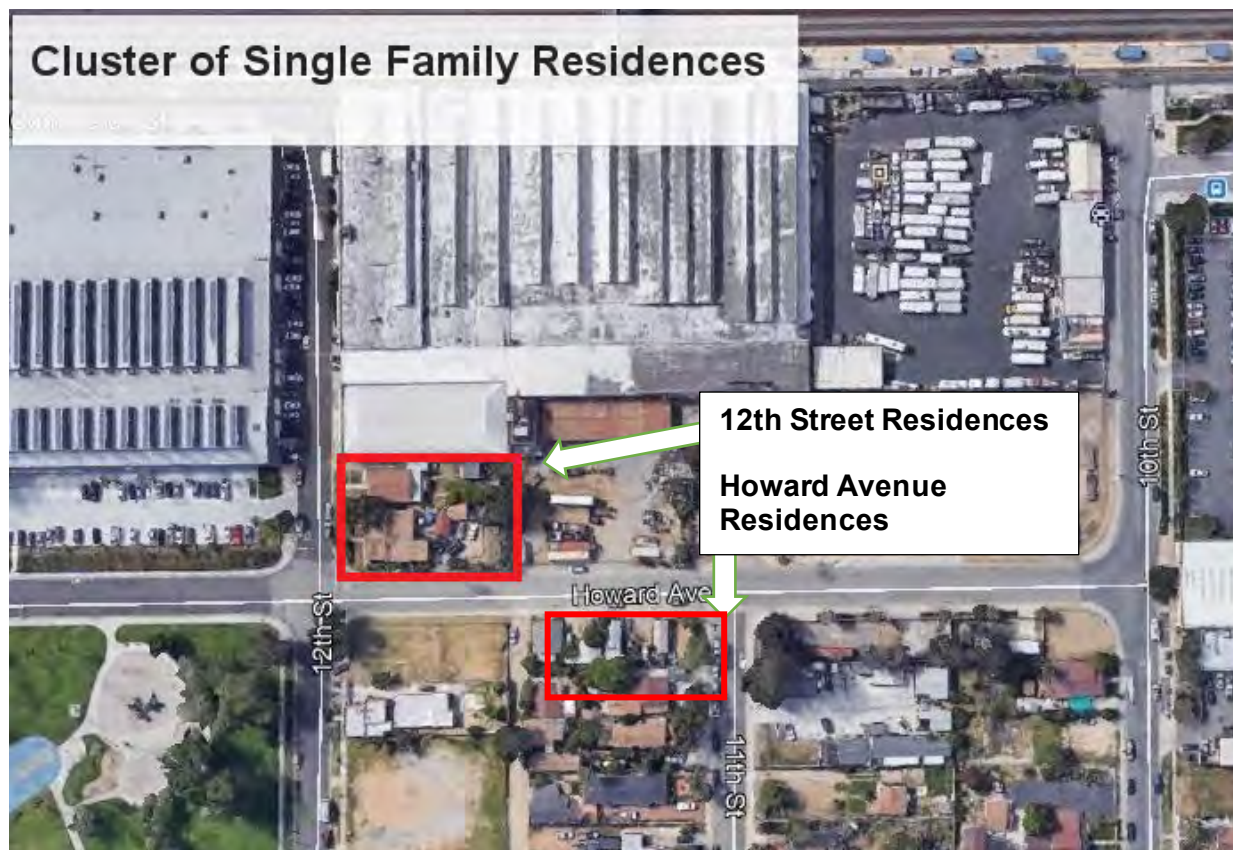
The neighborhood to the southeast of the FMC Complex is residential in nature, and many of the single-family residences here predate the complex. The two dwellings located on 12<sup>th</sup> Street (22 and 23 in the APE) and adjacent to Plant 1 are present on Sanborn Maps as early as 1895. Although highly modified from their original configurations, they are still used as residences (Figure 4-22).

**Figure 4-22. 12<sup>th</sup> Street and Howard Avenue Single Family Residences**

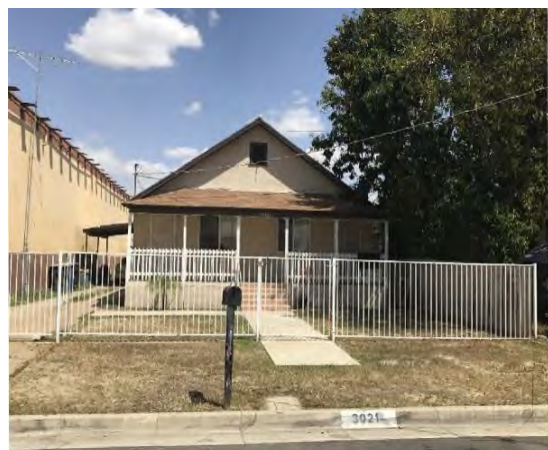
This single-family dwelling is rectangular in plan and one story in height (Figure 4-23). The exterior is covered with stucco. The house is capped with a medium-pitched, front-gabled roof clad in asphalt composition shingles. A porch, which spans the width of the street-facing façade, features a hipped roof supported by simple wood columns. There are rafter tails above the porch's lintel. The entrance is at the left (west) corner of the porch and is flanked by two vinyl-clad, horizontal-sliding windows. A picketed balustrade railing encloses the porch. A louvred vent just under the ridgeline of the end gable is framed with a simple wood frame and sill. This property was surveyed in 2001 as P-33-027705 and categorized as a 5S3 resource (individually eligible as a local historic landmark).

**Figure 4-23. 3021 12<sup>th</sup> Street**

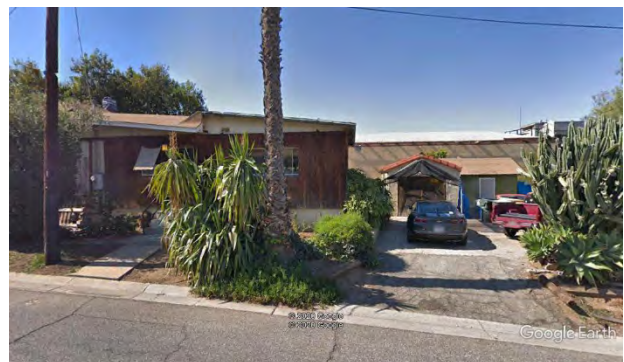
Most of the alterations date to the historic period; however, they are not considered compatible with the original design. Sanborn Fire Insurance Maps from 1908 and ca. 1951 show the main dwelling is still extant; however, it has undergone substantial alteration since 1908: The pent-roofed, front-gabled porch has been infilled and 1960-era additions have been constructed on the rear of the house. The porch has been enclosed to a narrow stoop and recessed entrance, and the distinctive closed-pedimented, front-gabled main section of the main façade is overshadowed by two intersecting hipped gable dormers (one of which may have been original) that infilled the area between the bay window dormer and the pent-gabled porch. The ca. 1960-era additions to the rear of the house (Figure 4-25) are utilitarian, shed-roofed buildings clad in wood siding. Additionally, the detached garage, which appears on the ca. 1951 Sanborn map, is now a cottage.

**Figure 4-25. Rear Elevation 3009 12<sup>th</sup> Street**

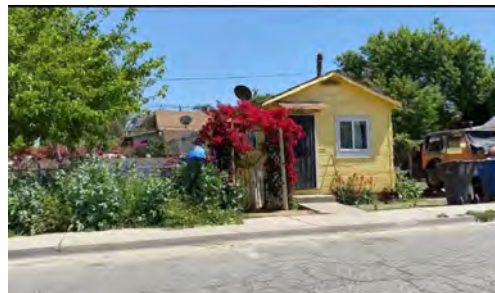
The 4110 Howard Avenue residence is rectangular in plan, one story in height, and of wood-frame construction (Figure 4-26). This unadorned example of a shotgun house is clad in wide, wood drop siding and is capped by a low-pitched, front-gabled roof featuring slightly overhanging eaves, a narrow wood fascia/barge board at the front elevation, and exposed wood rafter tails along the side elevations. The roof is clad in asphalt composition shingles. The small front elevation is largely occupied by the front door and a vinyl-clad, horizontal sliding window. The offset entry door is located toward the northern side of the front elevation and has a metal security door, which is topped by a simple shed-roofed overhang. Within the gable end of the street-facing elevation is a small attic vent framed in wood.

**Figure 4-26. 4110 Howard Avenue**

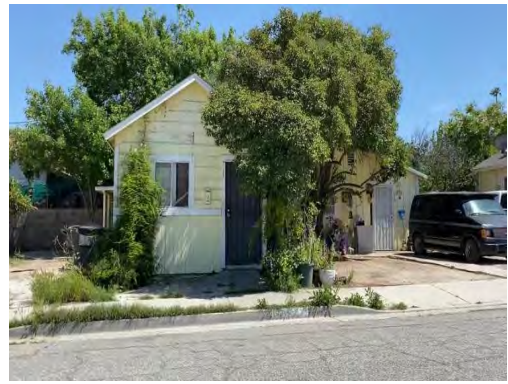
**Figure 4-27. 4120 Howard Avenue**

This single-family residence is a rectangular plan, wood frame-constructed, single-story building that exhibits the character and scale of a shotgun house (Figure 4-27). The building is clad primarily in wide, wood drop siding across its front and side elevations with a vertically-scored, T1-11 apron on the front elevation. The medium-pitched, front-gabled roof is clad in asphalt composition shingles. The gable end features a wide, wood-plank, under-eave board. The front elevation has an offset entry that is at the southern edge of the façade. A wood address plaque is placed above the entry, and a metal security screen protects the entry door. Flanking the doorway is a vinyl-clad, horizontal-sliding window in a wood-framed opening.

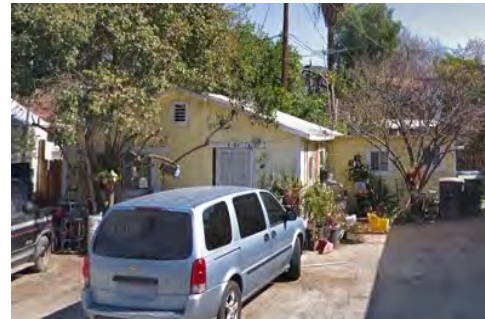
**Figure 4-28. 4130 Howard Avenue**

This small single-family residence has an L-shaped plan. It is one story in height and wood frame-constructed (Figure 4-28). It is a front gable-and-wing arrangement with few distinguishing characteristics. The exterior is clad in vertical board and batten wood siding and features an off-center entry protected by a metal security door. The entry is partially framed in wood surrounds and features an extended lintel with a wood plaque address marker on it. A thin, wood fascia is present upon this gable. The wing component of this residence is clad in wood siding. A vinyl-clad, horizontal-sliding window with simple wood framing is present on this wing.

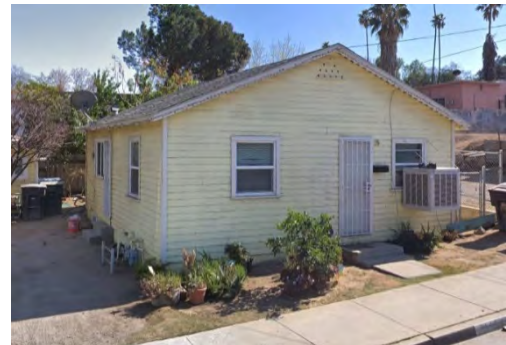
**Figure 4-29. 4140 Howard Avenue**

The 4140 Howard Avenue residence is a one-story, wood frame-constructed, rectangular-plan, single-family residence (Figure 4-29). The building is clad in wood clapboard siding and has a front-gabled roof topped with asphalt composition shingles. The residence (the southernmost of four on the parcel) is slightly set back on its property and features a small front yard with various shrub and succulent specimens. A small concrete walkway is present in front of the door.

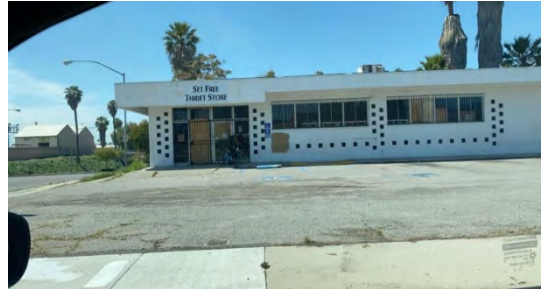
**Figure 4-31. 3021 14<sup>th</sup> Street**

3021 14<sup>th</sup> Street is 32 in the APE (Figure 4-31). Rectangular in plan and one story in height, this low-slung, concrete masonry unit-constructed strip commercial building features ribbon windows placed high on the street-facing facades and a corner entrance under a deeply overhanging canopy. The storefront (non-original) comprises double doors flanked by full-length sidelights and has multi-light transoms above. A loading bay is located toward the rear of the building. The ribbon windows are single-light units in metal (presumably aluminum) frames and appear to be original.

Within this context, this strip commercial building does not appear to meet the registration requirements outlined above because it is not a distinctive example of the style, exhibiting only the low-slung volume, extended canopy, and ribbon windows. The storefront has been replaced, and the exterior has been modified with applied, decorative squares. It is not considered eligible for local listing or for state or federal listing under any of the criteria, primarily Criterion 3/C, because it lacks distinction within Riverside's Modernism context.

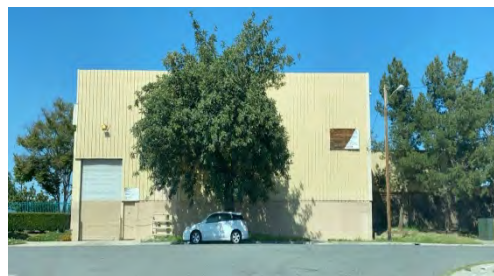
**Figure 4-33. 3075 10<sup>th</sup> Street**

The Royal Citrus Packing House was evaluated in 2003 for its historic significance and integrity and found to lack the integrity necessary to be considered eligible for the National Register of Historic Places (Refer to resource P-33-13079). In its current configuration, it is rectangular in plan, roughly two stories in height, and of load-bearing masonry construction with a vertical standing seam metal façade attached to the exterior of the 10<sup>th</sup> Street elevation.

According to the 2003 evaluation by CRM Tech, "...the building offers no more than mere clues of its 1888-1891 roots, and bears little resemblance to its pre-1939, Alfred Lewis-era forerunner or forerunners. In fact, due to the highly visible exterior alterations dating to the 1970s to 1990s, the building does not even retain enough of its historic appearance to recall the 1950s period. Furthermore, much of the building, both exterior and interior, has suffered significant structural damages resulting from recent hazardous material abatement efforts." Therefore, the aspects of integrity of material, workmanship, design, setting, feel, and association have been compromised to the point that it can no longer convey its historic significance. As a result, it is not recommended eligible for local listing, the CRHR, or the NRHP.

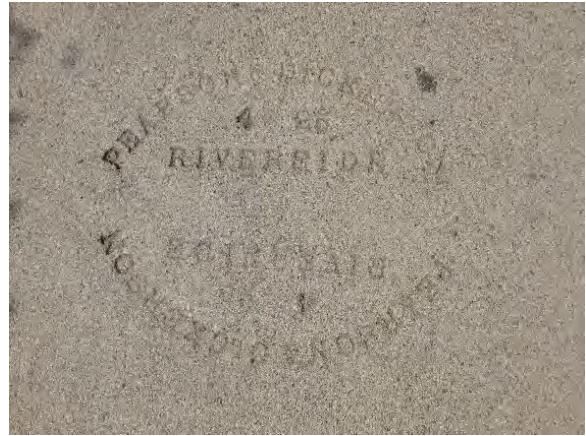
**Figure 4-34. Sidewalk Stamp**

Two of the sidewalk stamps, (one marked “Pearson & Dickenson” and dated 1925 (Figure 4-34), are on the south side of 10<sup>th</sup> Street (east of Howard Avenue). One marked “City Inspector” with no date is on the east side of Howard Avenue, just north of 10<sup>th</sup> Street. And, on the north side of 12<sup>th</sup> Street, (east of Howard Avenue) one is marked “Frank Sloan 1950,” and on the other side of the street is a curb incised with “WPA 1939.” (Works Progress Administration)

The sidewalks are intermittent in the neighborhood where the sidewalk stamps are located. The dates on the stamps correspond with the date of construction for the park. During the 1930s, park improvements occurred, and may have included the WPA-era sidewalks. A park improvement bond measure in the early 1950s may also have included sidewalk improvements. As individual objects, they are not considered significant, as they are commonly found in older neighborhoods nation-wide. They are not recommended eligible for local listing as a historic landmark, nor do they warrant listing in CRHR or NRHP under Criterion 1 or Criterion C, respectively.

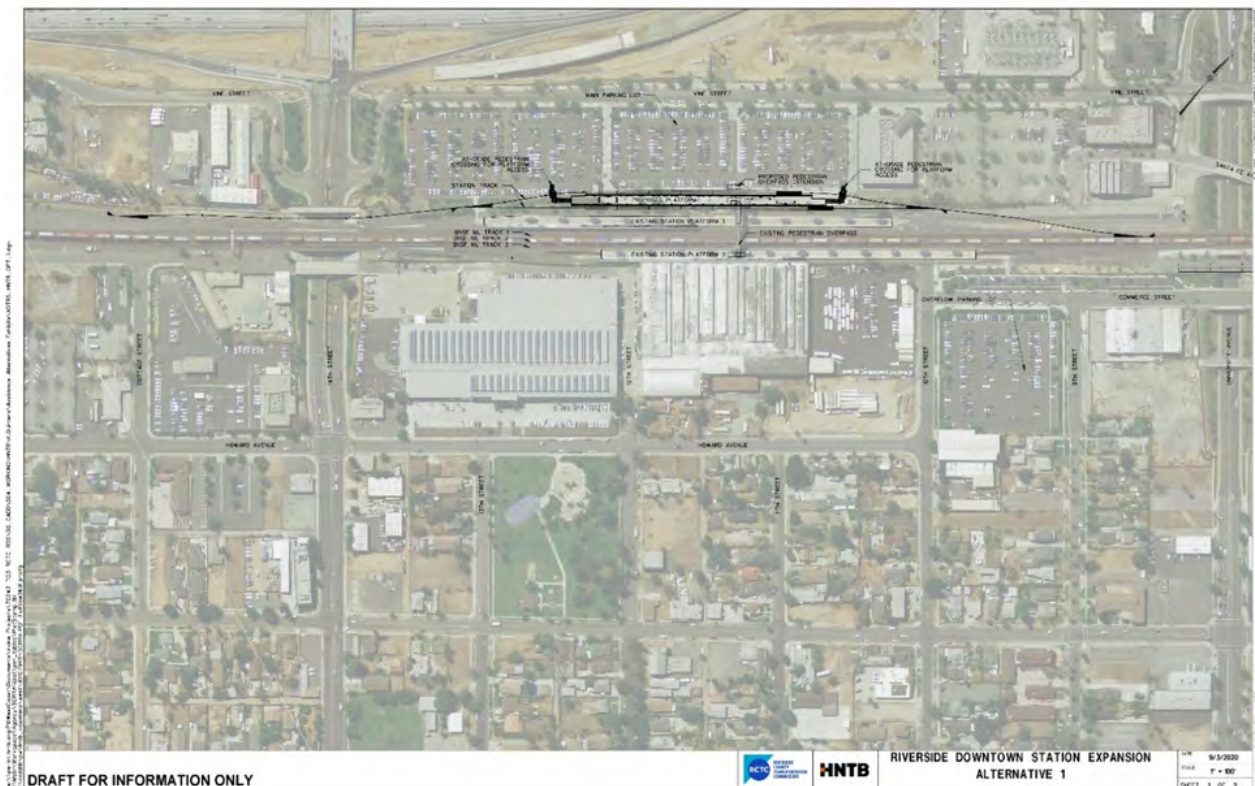
Figure 5-1. Avoidance Alternative 1

Avoidance Alternative 1 avoids the FMC Complex (Plant 1 and Plant 2) on the east side of the station by moving proposed improvements to the west side of the station (Figure 5-1). This avoidance alternative would provide a new platform and tracks on the west side of the existing station with pedestrian at-grade crossings at both ends of the new platform. The existing pedestrian overpass would be extended to the new platform with an option to extend to the main parking lot.

- Requires construction of a new railroad bridge over 14<sup>th</sup> Street.
- Requires a new turnout and Control Point on BNSF Mainline Track 1.
- Reduces existing parking capacity.
- Requires reconfiguration of bus access into the main station parking lot.

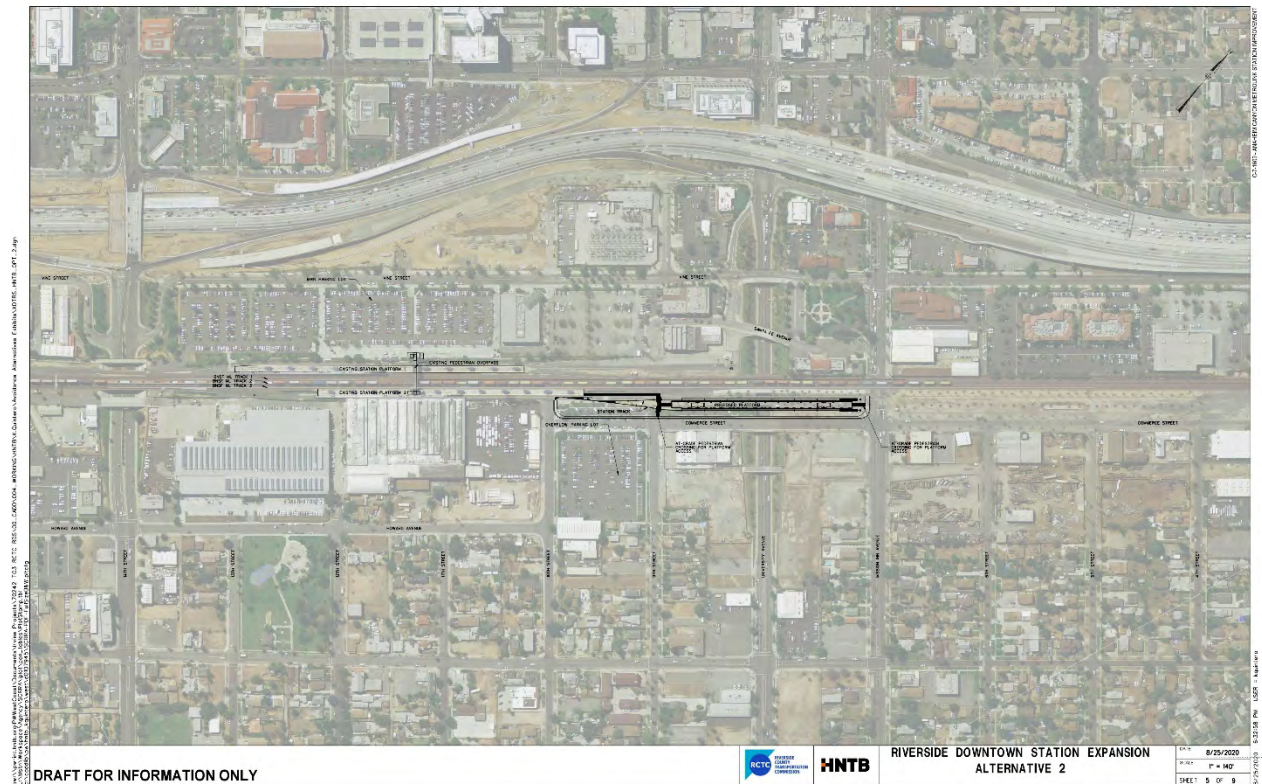
**Figure 5-3. Avoidance Alternative 2**

- Requires a new turnout and Control Point on BNSF Mainline Track 1.
- Reduces existing parking capacity and requires reconfiguration of bus access into the main station parking lot.

Although Avoidance Alternative 2 would avoid the FMC Complex (Plant 1 and Plant 2) and result in a Section 106 finding of no adverse effect to FMC Complex (Plant 1 and Plant 2), it would not address the purpose and need of the project because this avoidance alternative:

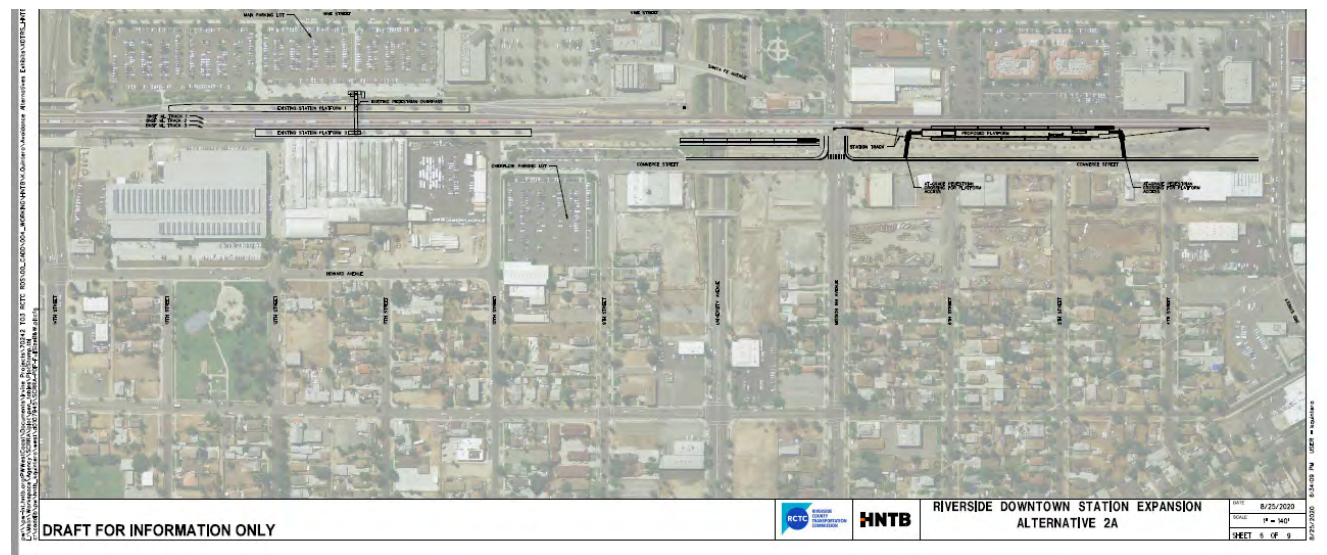
Figure 5-4. Avoidance Alternative 2A

Avoidance Alternative 2A avoids the FMC Complex (Plant 1 and Plant 2) and the two existing layover tracks on the east side of the station by shifting improvements north of Mission Inn Avenue (Figure 5-4). This avoidance alternative would provide a new platform and tracks on the east side of the existing station, and pedestrian grade crossings would be provided at both ends of the new platform.

- Requires Mission Inn Avenue to be grade separated to accommodate the 4<sup>th</sup> and 5<sup>th</sup> tracks and meet CPUC standards.
- Requires a new turnout on BNSF Mainline Track 3 and CP.
- Increases the distance of the west end of platform to the pedestrian bridge to 2,300 feet from the main parking, and the east end of the platform to the furthest parking spot in the main parking area is 4,600 feet, which would not provide convenient passenger access.
- Does not increase parking capacity.

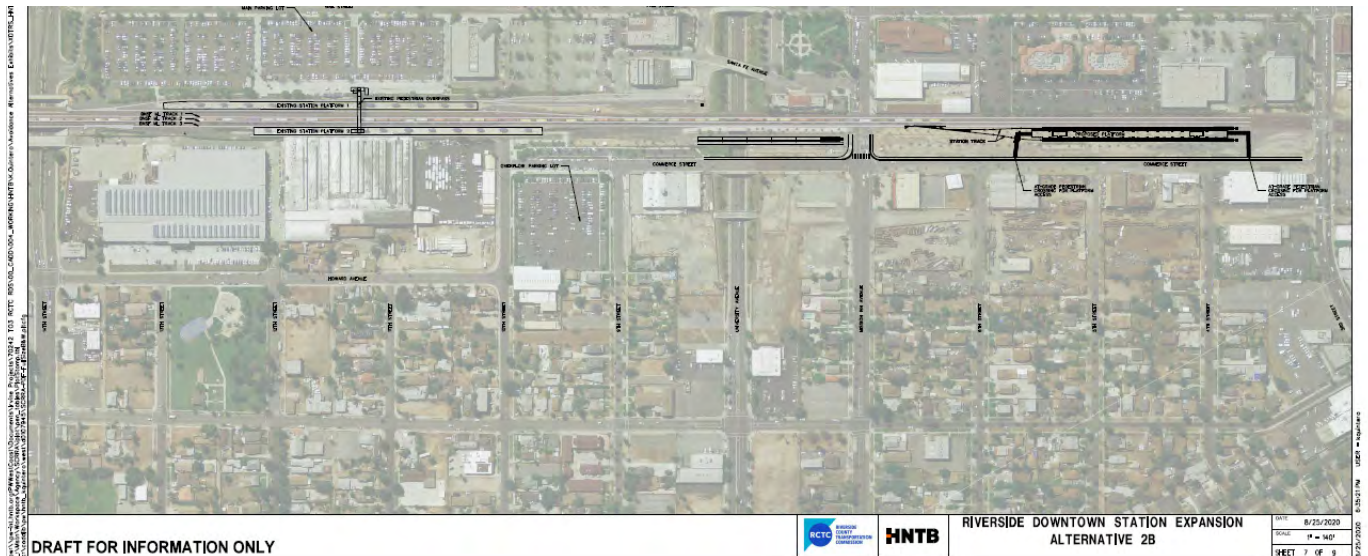
**Figure 5-5. Avoidance Alternative 2B**

Avoidance Alternative 2B avoids the FMC Complex (Plant 1 and Plant 2) on the east side of the station and avoids the existing layover tracks by shifting the track improvements farther north, past Mission Inn Avenue (Figure 5-5). This avoidance alternative would provide a new platform and tracks on the east side of the existing station and pedestrian grade crossing would be provided at the south end of the new platform.

- Includes a stub-ended configuration that is not acceptable for train operations at this location because it would require a reverse (double move) on the BNSF mainline, adversely impacting their operations. The additional movements would create delays, inefficiencies, and unacceptable operations.
- Requires a new turnout on BNSF Mainline Track 3 and new CP.
- Increases the distance to the west end of platform to the pedestrian bridge to 2,300 feet from the main parking, and the east end of the platform to the furthest parking spot in the main parking area is 4,600 feet, which would not provide convenient passenger access.
- Does not increase parking capacity.

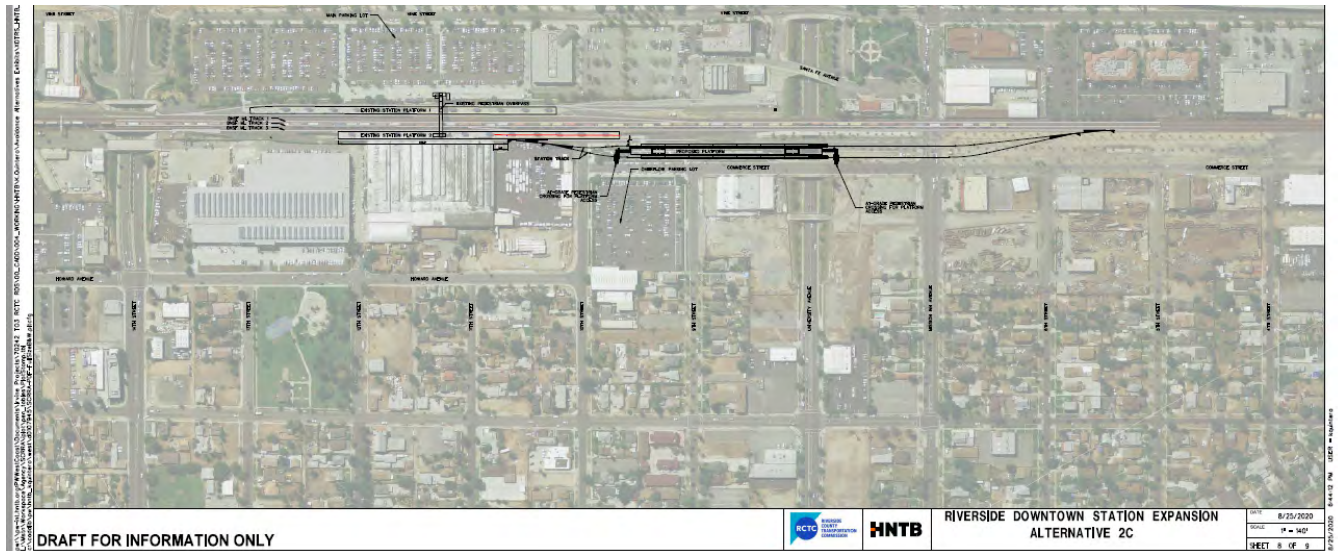
**Figure 5-6. Avoidance Alternative 2C**

- Requires a new turnout on BNSF Mainline Track 3 and CP.
- Increases the distance from west end of platform to the pedestrian bridge to 1,100 feet from the main parking, and the east end of the platform to the furthest parking spot in the main parking area is 3,400 feet, which would not provide convenient passenger access.

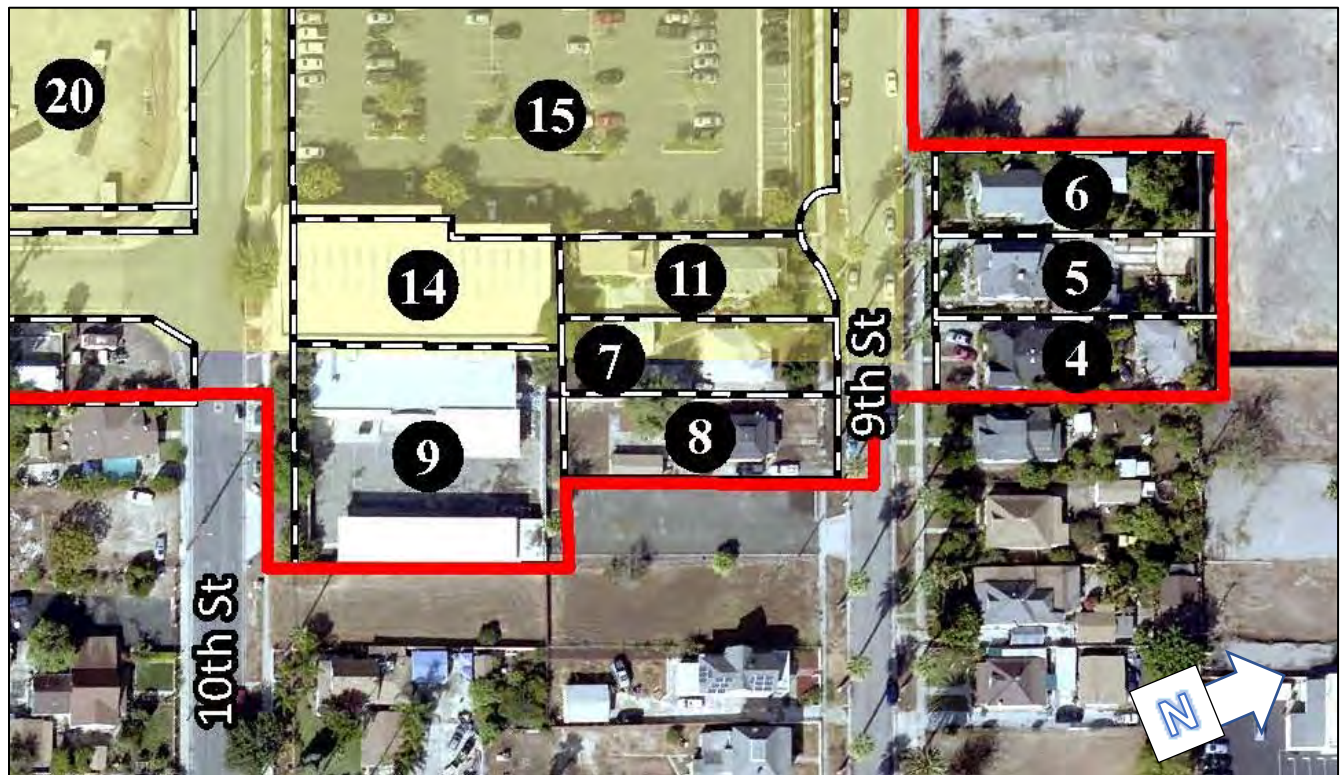
**Figure 6-1. Ninth Street Conservation Area Residences within the APE**

Within the Area of Potential Effects, there are six historic residences that are also within the Ninth Street Neighborhood Conservation Area (Figure 6-1). Of these contributing resources, two are adjacent to the proposed new intersection connecting Howard Avenue to 9<sup>th</sup> Street (3006 9<sup>th</sup> Street, No. 11 in the APE; and 3015 9<sup>th</sup> Street, No. 6 in the APE).

The Build Alternative with Design Options 3A and 3B will have indirect impacts on the Ninth Street Conservation Area, resulting in Class II/Less than Significant Impacts. The new intersection associated with extending Howard Avenue north to 9<sup>th</sup> Street will alter the setting of the district and add traffic in the vicinity of contributing historic resources. The new intersection, will be west of the contributing historic residences in the district, which would not result in property acquisition or removal of historic structures.
