# Historic Resources Report for the Riverside-Downtown Station Improvements Project

4066 Vine Street, Riverside, California 92507

**July 2021**

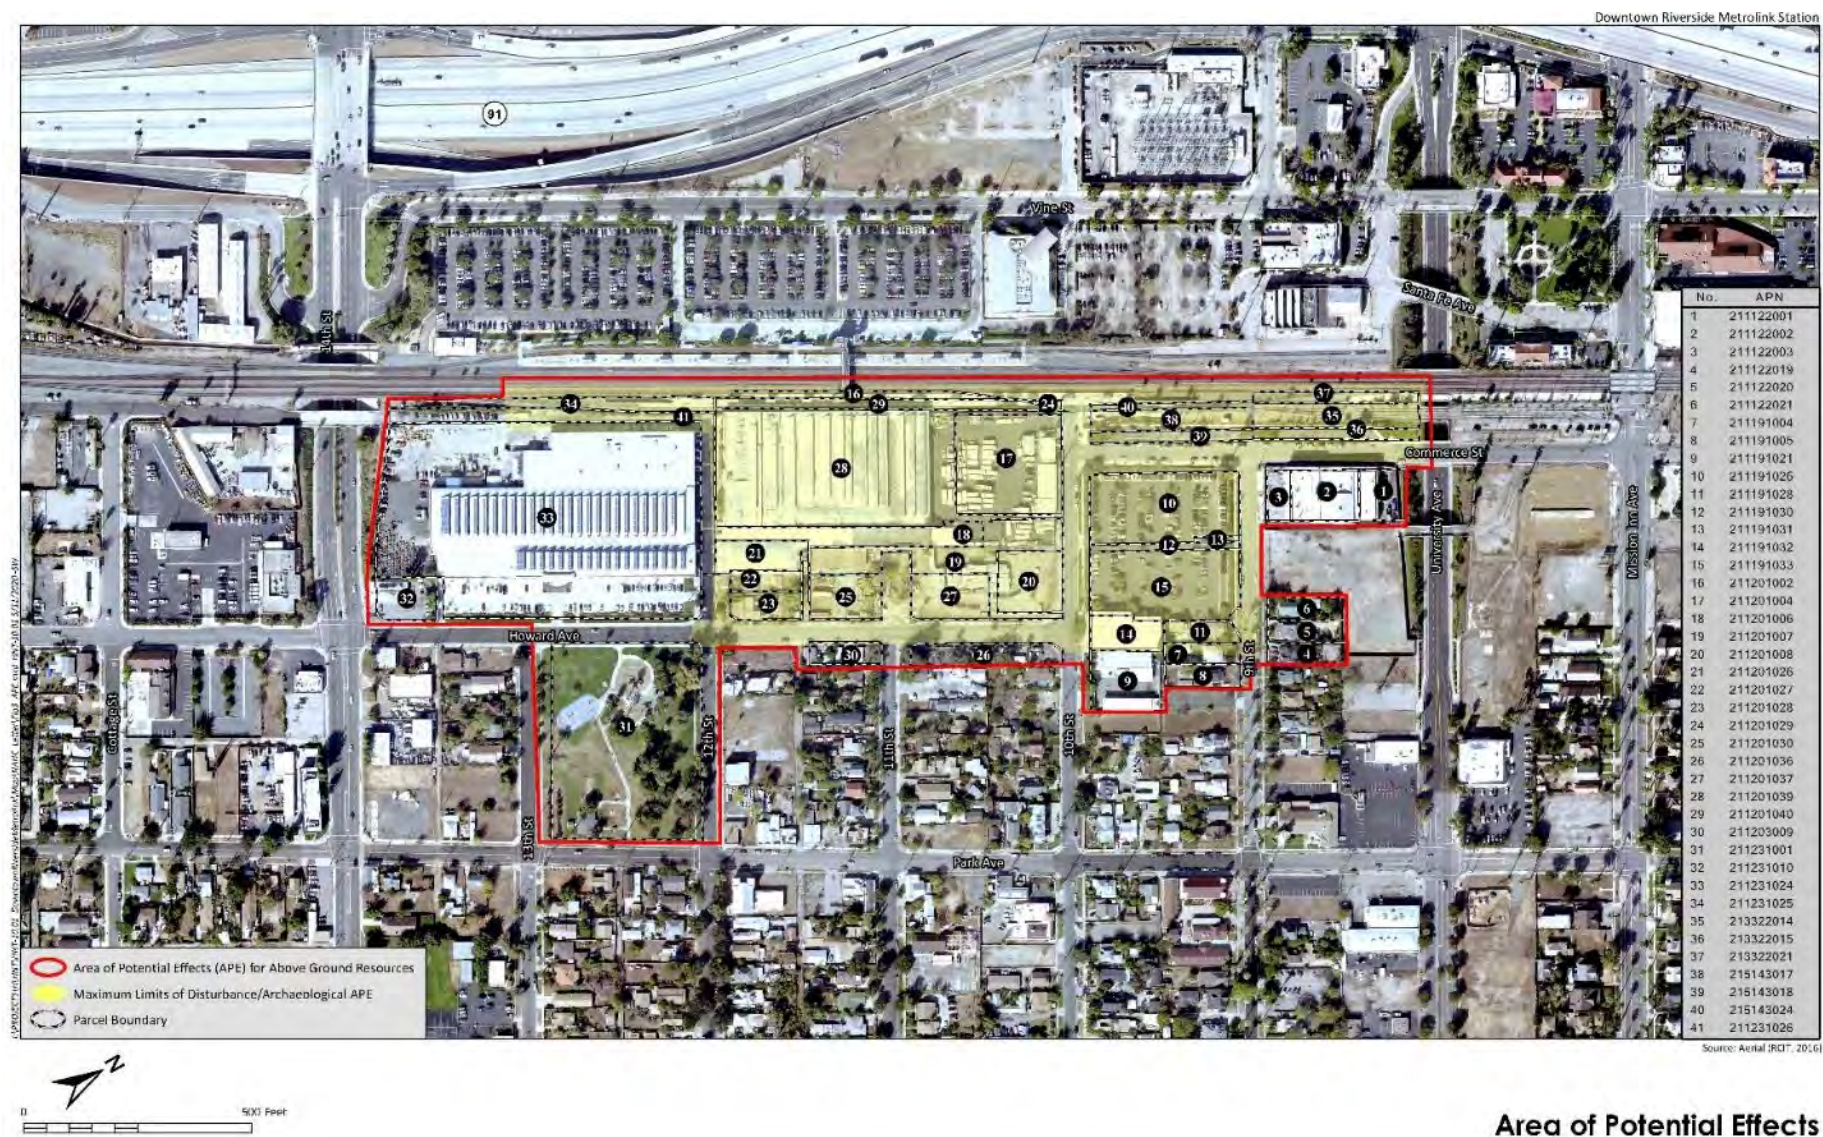
Figure 1-10. Area of Potential Effects

Pursuant to 36 CFR 800.4(a)(1), the APE is the geographic area within which an undertaking may directly or indirectly alter the character or use of historic properties (Figure 1-10). The APE for the Project encompasses two elements. The first is the Limits of Disturbance (LOD). This is the zone where there may be ground disturbance from project construction (often referred to as the Direct APE and generally considered the archaeological APE). The LOD includes both the horizontal and vertical areas associated with ground disturbing and physical construction activities. Subsurface disturbance will occur during removal of building foundations and contaminated soil removal to an estimated depth of 5 feet below the surface across the majority of the proposed maximum limits of disturbance, where existing structures and/or contaminated soils would require excavation. For parcel 28 (APN 211201039), excavation is expected to be up to a maximum depth of 10 feet for the extension of the pedestrian overpass; this depth of excavation would be limited to the area where foundations are required. The LOD is the APE for the archaeological survey. As discussed in Section 3.4.4, the project location has been used for industrial activities since the late 1800s; thus, all excavation will be performed in areas that have been subject to a great deal of past disturbance.

Surrounding the LOD is a buffer zone where there may be effects on surrounding parcels from noise, vibration or visual intrusions associated with construction and post-construction project operation. This buffer zone is often referred to as the Indirect APE, or APE for the Historic Built Environment. As shown in Figure 1-10 and summarized in Table 1-3, 41 parcels are within the APE; the APNs are listed in Table 1-3.

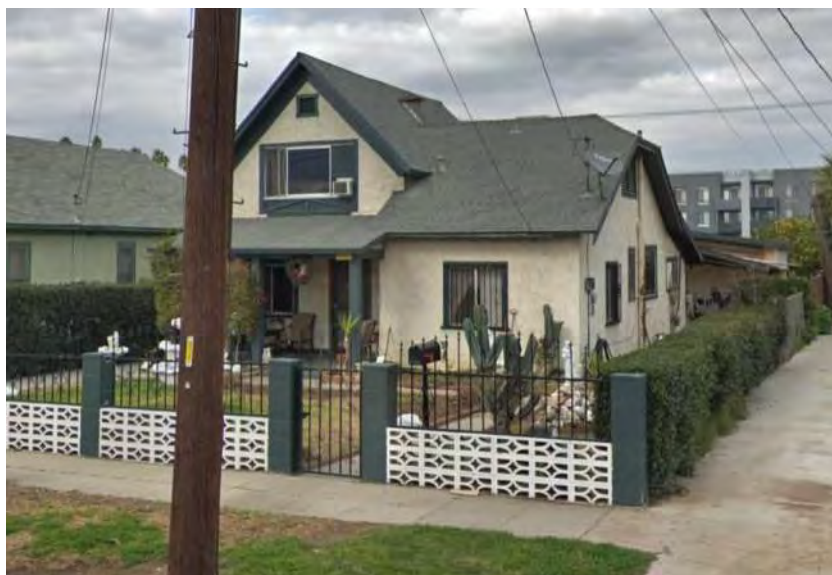
P5a. Photograph or Drawing (Photograph required for buildings, structures, and objects.)

This 1-1/2-story, wood frame-constructed Tudor cottage features a clipped, side-gabled roof intersecting the taller, 1-1/2-story front-gabled volume. The roof features overhanging eaves and an under-eave fascia board but has no rafter ends. A shed roof covers the portico and is supported by simple, round columns. The exterior is stucco covered and the roof is a newer asphalt composition shingle roof. The windows are vinyl replacement units in simple wood surrounds and include single-light picture windows and horizontal sliding units on the main street-facing façade.

Windows replaced with vinyl-clad horizontal sliding and one-over-one units.

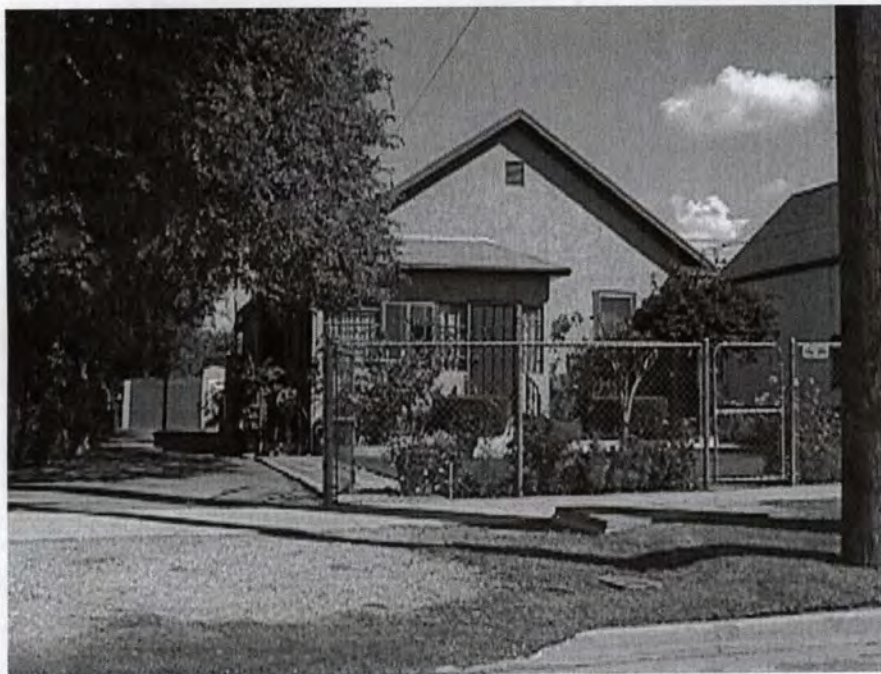
*This simple, one-story vernacular bungalow is capped by a front-facing gabled roof and covered with stucco. The fenestration pattern has been altered and now consists of a square fixed sash and replacement aluminum sliders on the primary elevation. A shed roof porch supported by metal posts covers the entry of this single-family residence.*

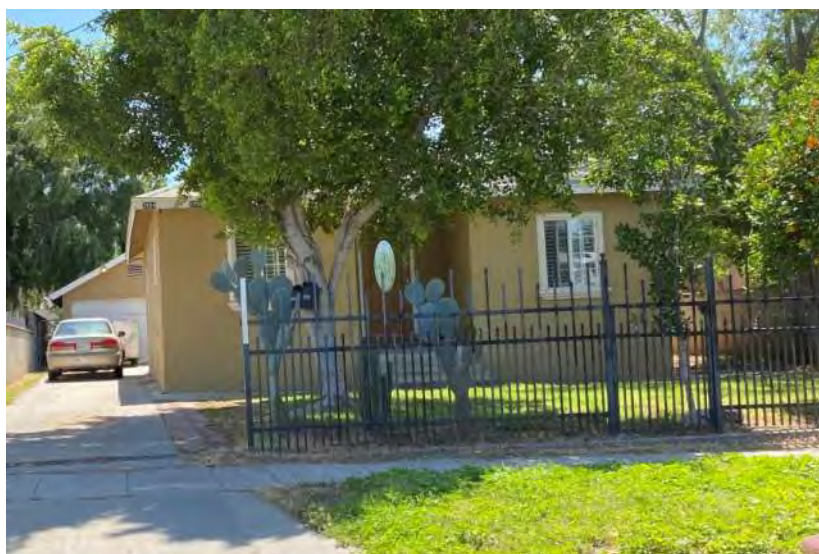
P5a. Photograph or Drawing (Photograph required for buildings, structures, and objects)

This modest Postwar cottage has a square plan and is capped by a low-pitched, hipped roof. The primary elevation is divided into three bays with a central recessed entry flanked by vinyl-clad horizontal sliding windows. The exterior of this one-story, single-family wood frame dwelling is covered with stucco.

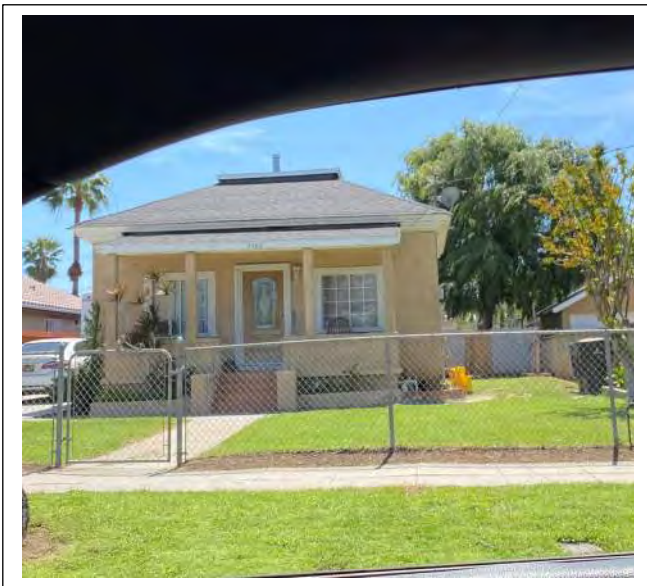
P5a. Photograph or Drawing (Photograph required for buildings, structures, and objects.)

This one-story Folk Victorian cottage is sheathed with contemporary stucco and capped by a hipped roof with boxed eaves. The primary elevation is divided into three bays with a central entry flanked by two vinyl-clad, divided-light, horizontal sliding windows. A porch with a shed roof supported by four stuccoed columns on a low, stucco-covered enclosing wall spans the width of the bays.

Windows replaced

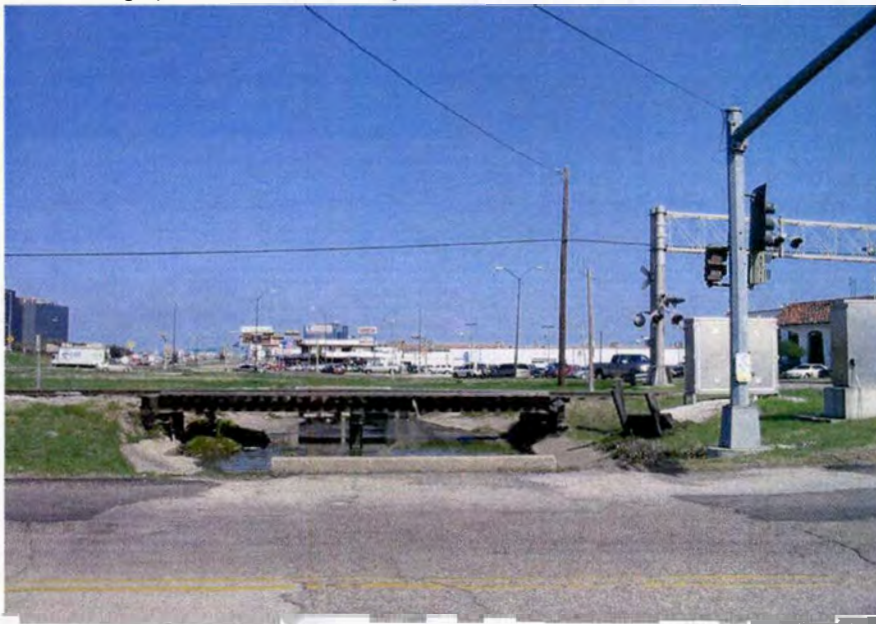
\* P3a. Description: (Describe resource and its major elements. Include design, materials, condition, alterations, size, setting, and boundaries.)  
Per previous analysis, the portions of the canal have been designated by the OHP as a 3S.

View of the canal. IMG\_0008

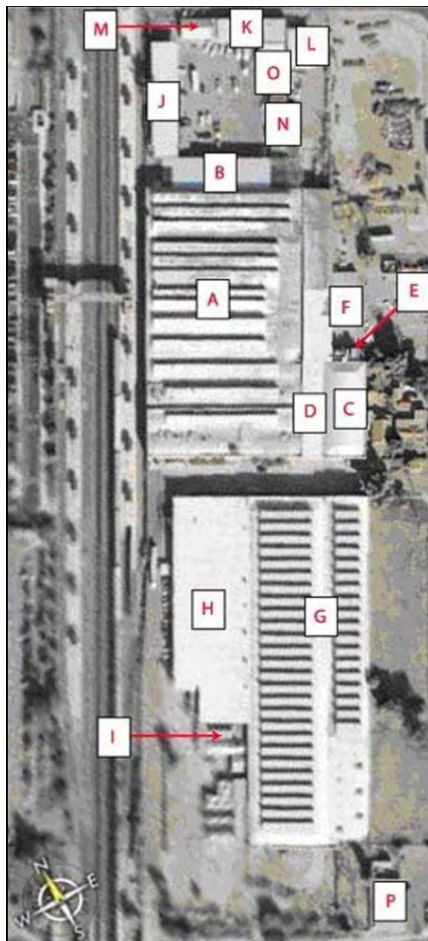
The primary building (designed by architect Herbert Hamm of Pasadena) in the complex and the first to be constructed was "Plant 1," completed in 1938 and located on the northern half of the property. Plant 1 (Building A on Figure 2) was the first manufacturing facility in the complex and comprises a large, two-story, rectangular-plan industrial building constructed of concrete and covered with stucco.

Figure 2. Aerial view of FMC complex ca 1995, with buildings and Additions labeled

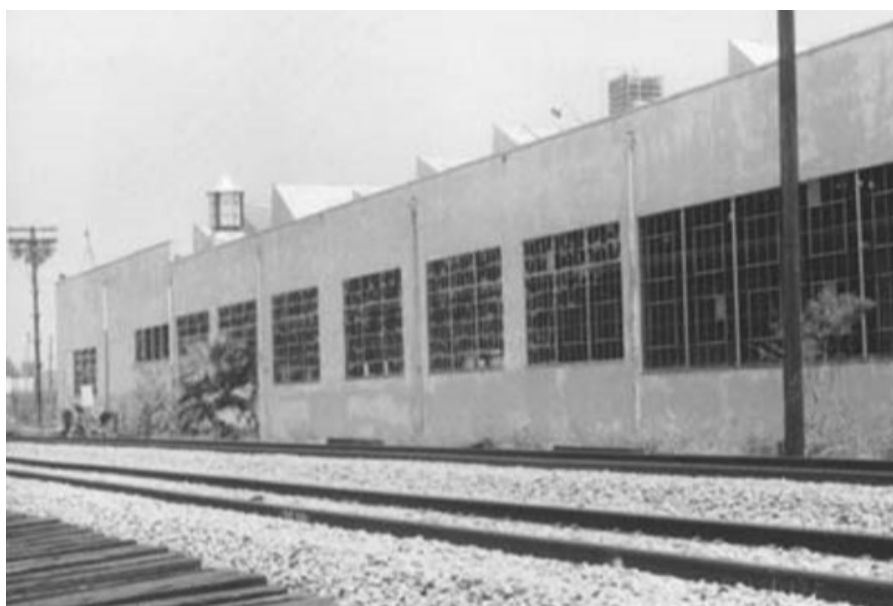
Figure 4. Plant 1, Building A: West Elevation (historic view)

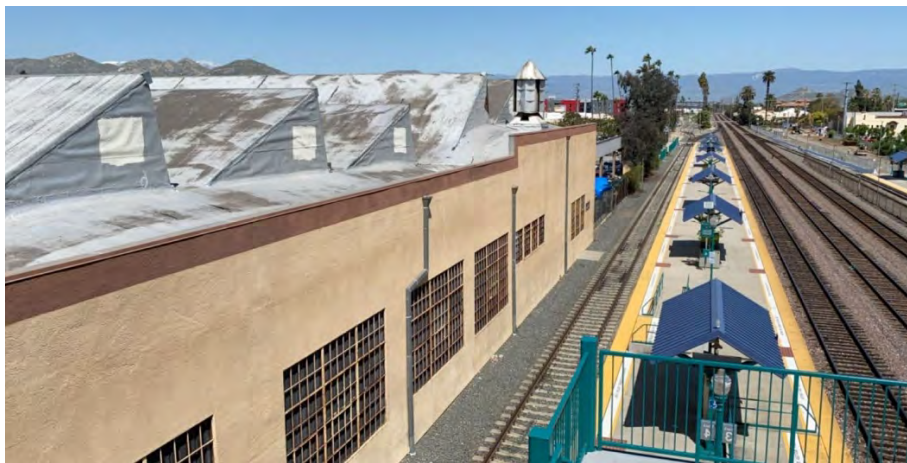
Alterations to the West Elevation: Although the windows in the west elevation appear to be original, they are set into a wall that was reconstructed in 1997, moving the entire western elevation eastward 13 feet to accommodate construction of the adjacent Metrolink Station platform (Figure 3). This reconstructed elevation is clad in contemporary stucco, and the placement of

Figure 5. Plant 1, Building A: West Elevation (looking south)

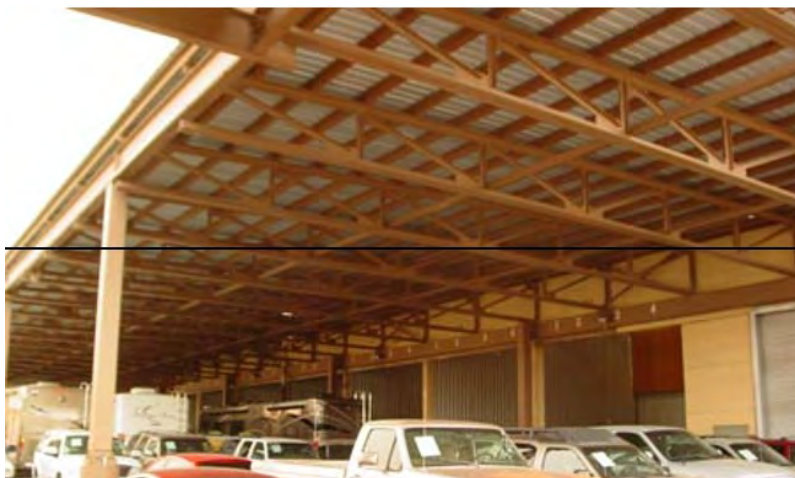
Figure 6. Plant 1, Building A: North Elevation Truck Entrances (source: Jones and Stokes, 2007)

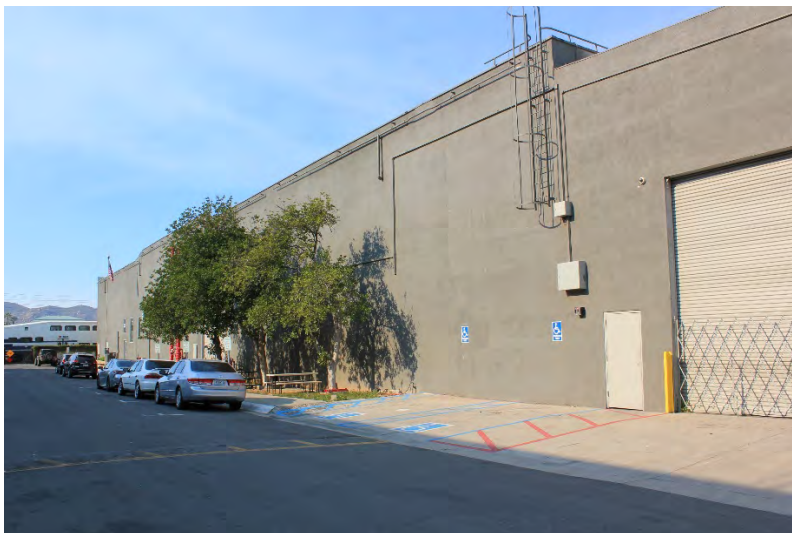
Figure 7. Plant 1, Building A: South Elevation (looking west)

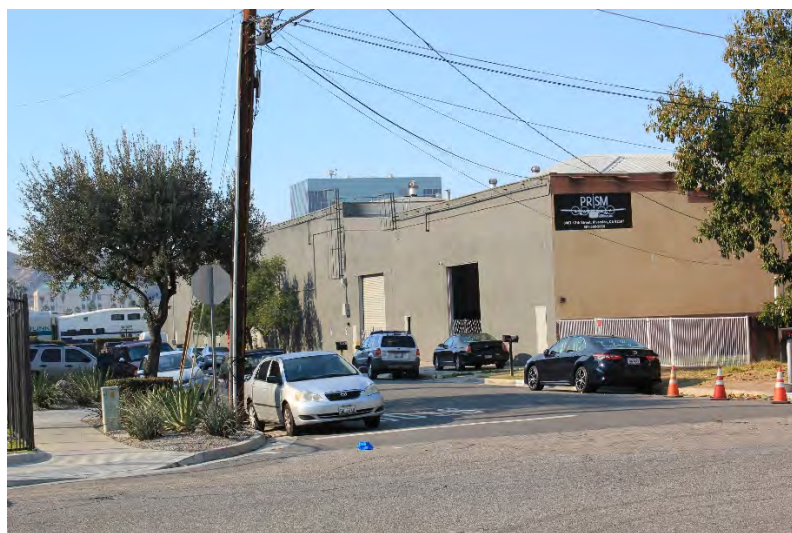
Figure 8. Plant 1, Addition C: South Elevation (looking northwest)

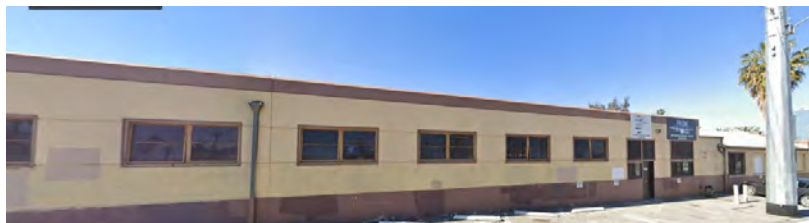
Figure 9. Plant 1, Building K: North Elevation

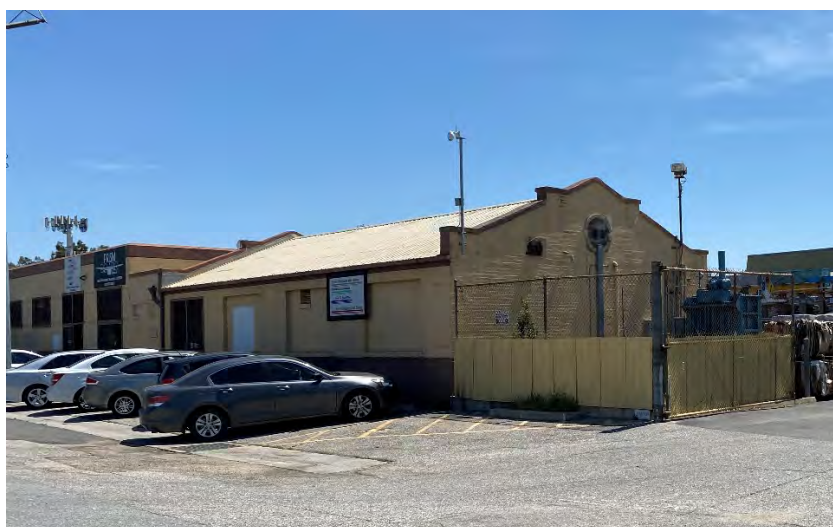
Figure 10. Plant 1, Building M: General View (looking southeast)

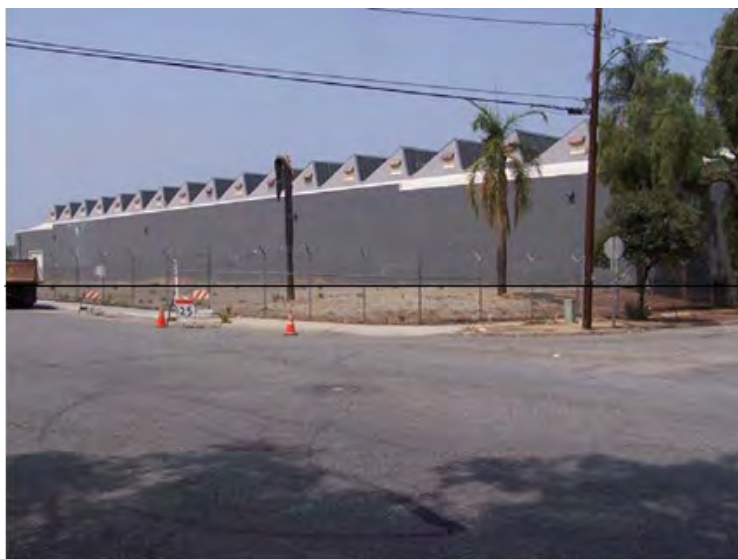
Figure 12. Plant 2: East Elevation circa 2007 (looking southwest)

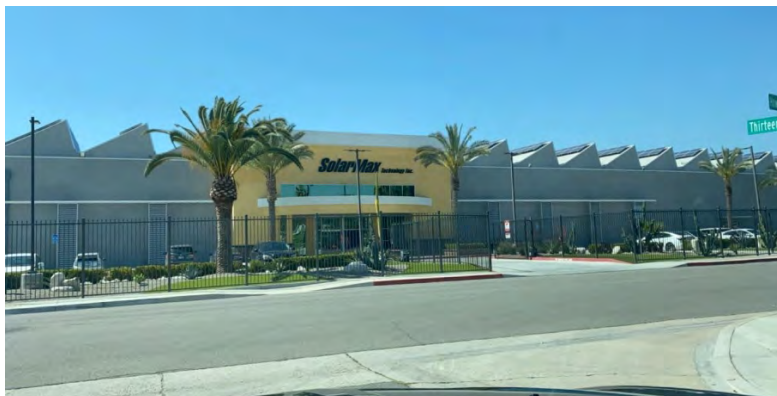
Figure 13. Plant 2: East Elevation (looking west)

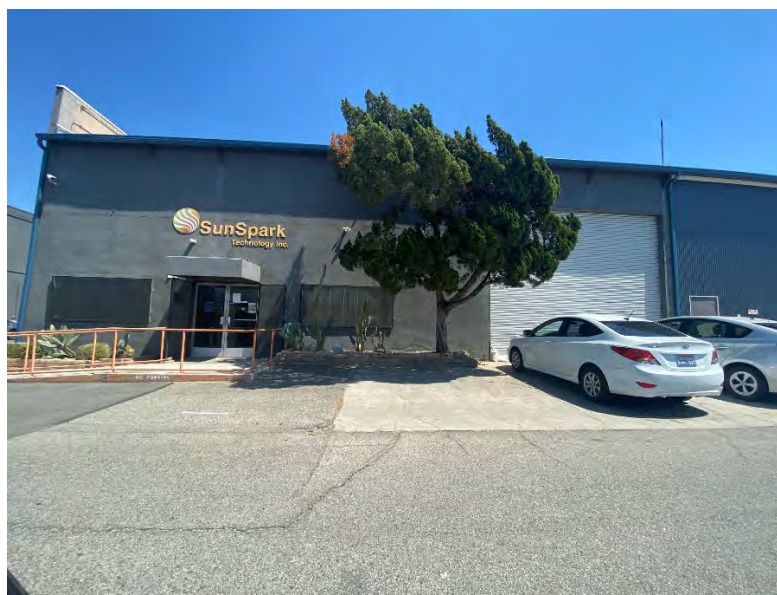
Figure 14. Plant 2: West Elevation (north portion)

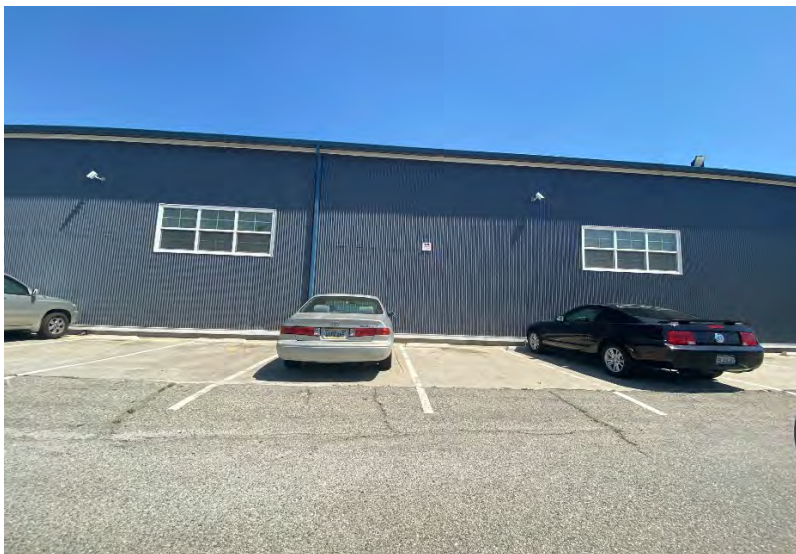
Figure 15. Plant 2: West Elevation (midsection)

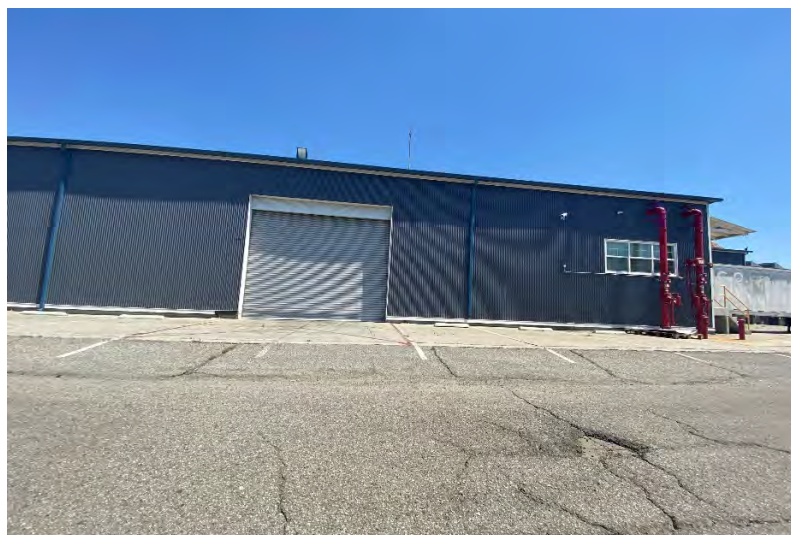
Figure 16. Plant 2: West Elevation (south portion)

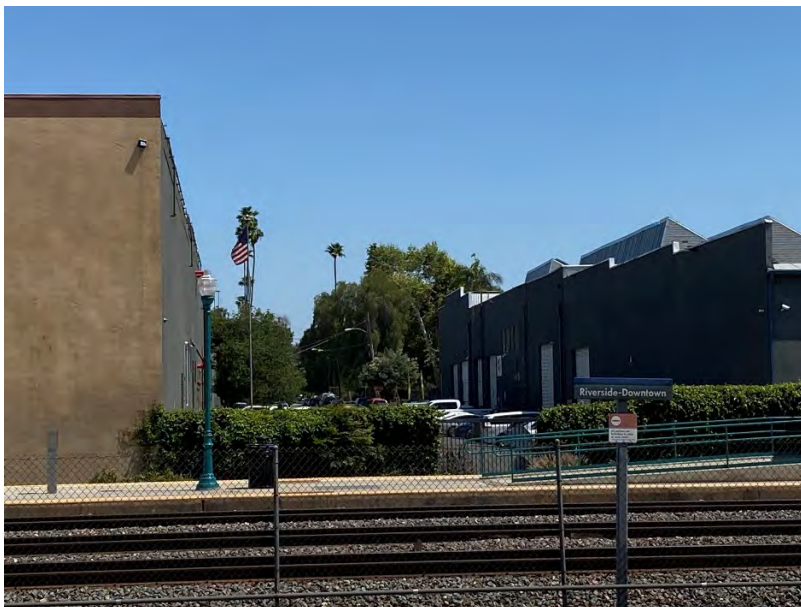
Figure 17. Plant 2: North Elevation (looking southeast)

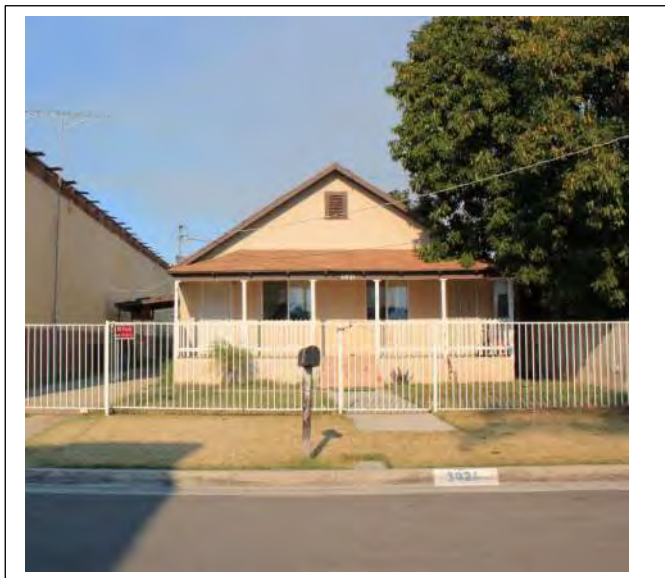
P5a. Photograph or Drawing (Photograph required for buildings, structures, and objects.)

This single-family dwelling is rectangular in plan and one story in height. The exterior is covered with stucco. The house is capped with a medium-pitched, front-gabled roof clad in asphalt composition shingles. A porch, which spans the width of the street-facing façade, features a hipped roof supported by simple wood columns. There are rafter tails above the porch's lintel. The entrance is at the left (west) corner of the porch and is flanked by two vinyl-clad, horizontal-sliding windows. A picketed balustrade railing encloses the porch. A louvred vent just under the ridgeline of the end gable is framed with a simple wood frame and sill. This property was recorded in 2001 as 33-027705 and categorized as a 5S3 resource (individually eligible as a local historic landmark).

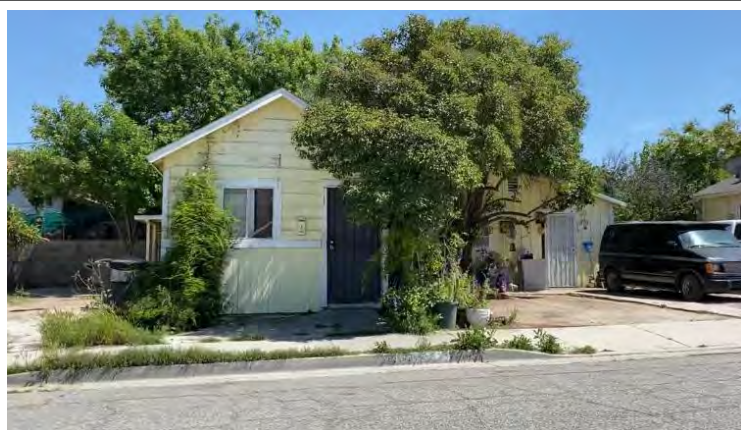
P5a. Photograph or Drawing (Photograph required for buildings, structures, and objects.)

This single-family residence is a rectangular plan, wood-frame-constructed, single story structure that exhibits the character and scale of a shotgun house. The building is clad primarily in wide wood drop siding across its front and side elevations with vertically scored, T1-11 apron on the front elevation. The medium-pitched, front-gabled roof is clad in asphalt composition shingles. The gable end features a wide wood plank under the eave board. The front elevation has an offset entry that is at the southern edge of the façade. A wood address plaque is placed above the entry, and a metal security screen protects the entry door. Flanking the doorway is a vinyl-clad, horizontal-sliding window in a wood-framed opening.

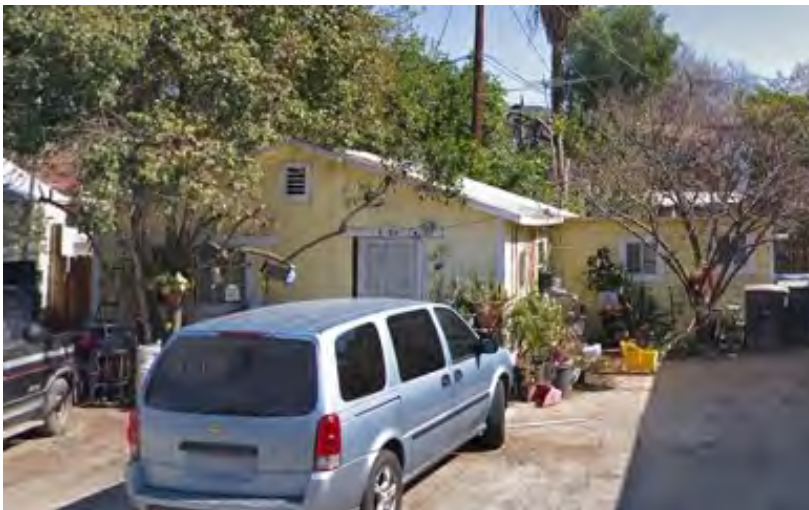
P5a. Photograph or Drawing (Photograph required for buildings, structures, and objects.)

This small single-family residence has an L-shaped plan. It is one story in height and wood-frame-constructed. It is a front gable and wing arrangement with few distinguishing characteristics. The exterior is clad in vertical board and batten wood siding and features an off-center entry protected by a metal security door. The entry is partially framed in wood surrounds and features an extended lintel with a wood plaque address marker on it. A thin, wood fascia is present upon this gable. The wing component of this residence is clad in wood siding. A vinyl-clad, horizontal-sliding window with simple wood framing is present on this wing.

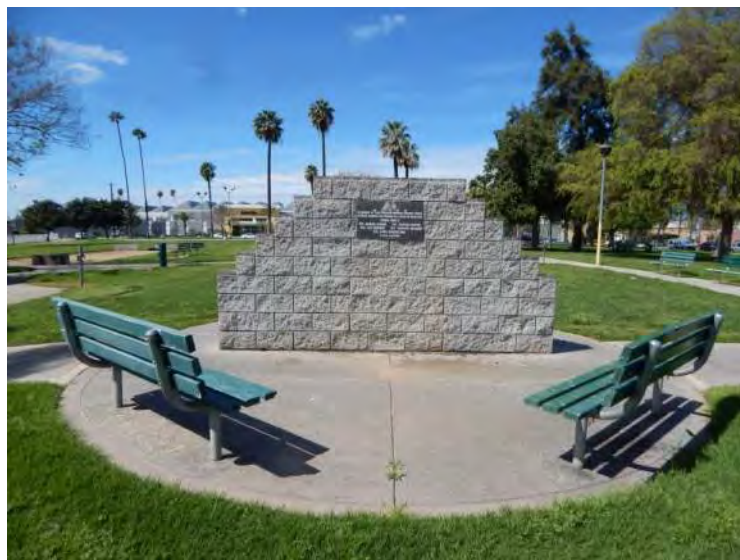
P5a. Photograph or Drawing (Photograph required for buildings, structures, and objects.)

Lincoln Park is in the Eastside neighborhood and occupies a city block bordered to the north by 12<sup>th</sup> Street, to the west by Park Avenue, 13<sup>th</sup> Street to the south and Howard Avenue to the east. The park served as a community center for the Eastside residents as early as the 1920s and has a long association with Latino and African-American sports, civil rights movement events, and community support organizations. A plaque and World War II memorial are located on the east side of the park. The plaque commemorates Hispanic-American members of the community who died during the war.

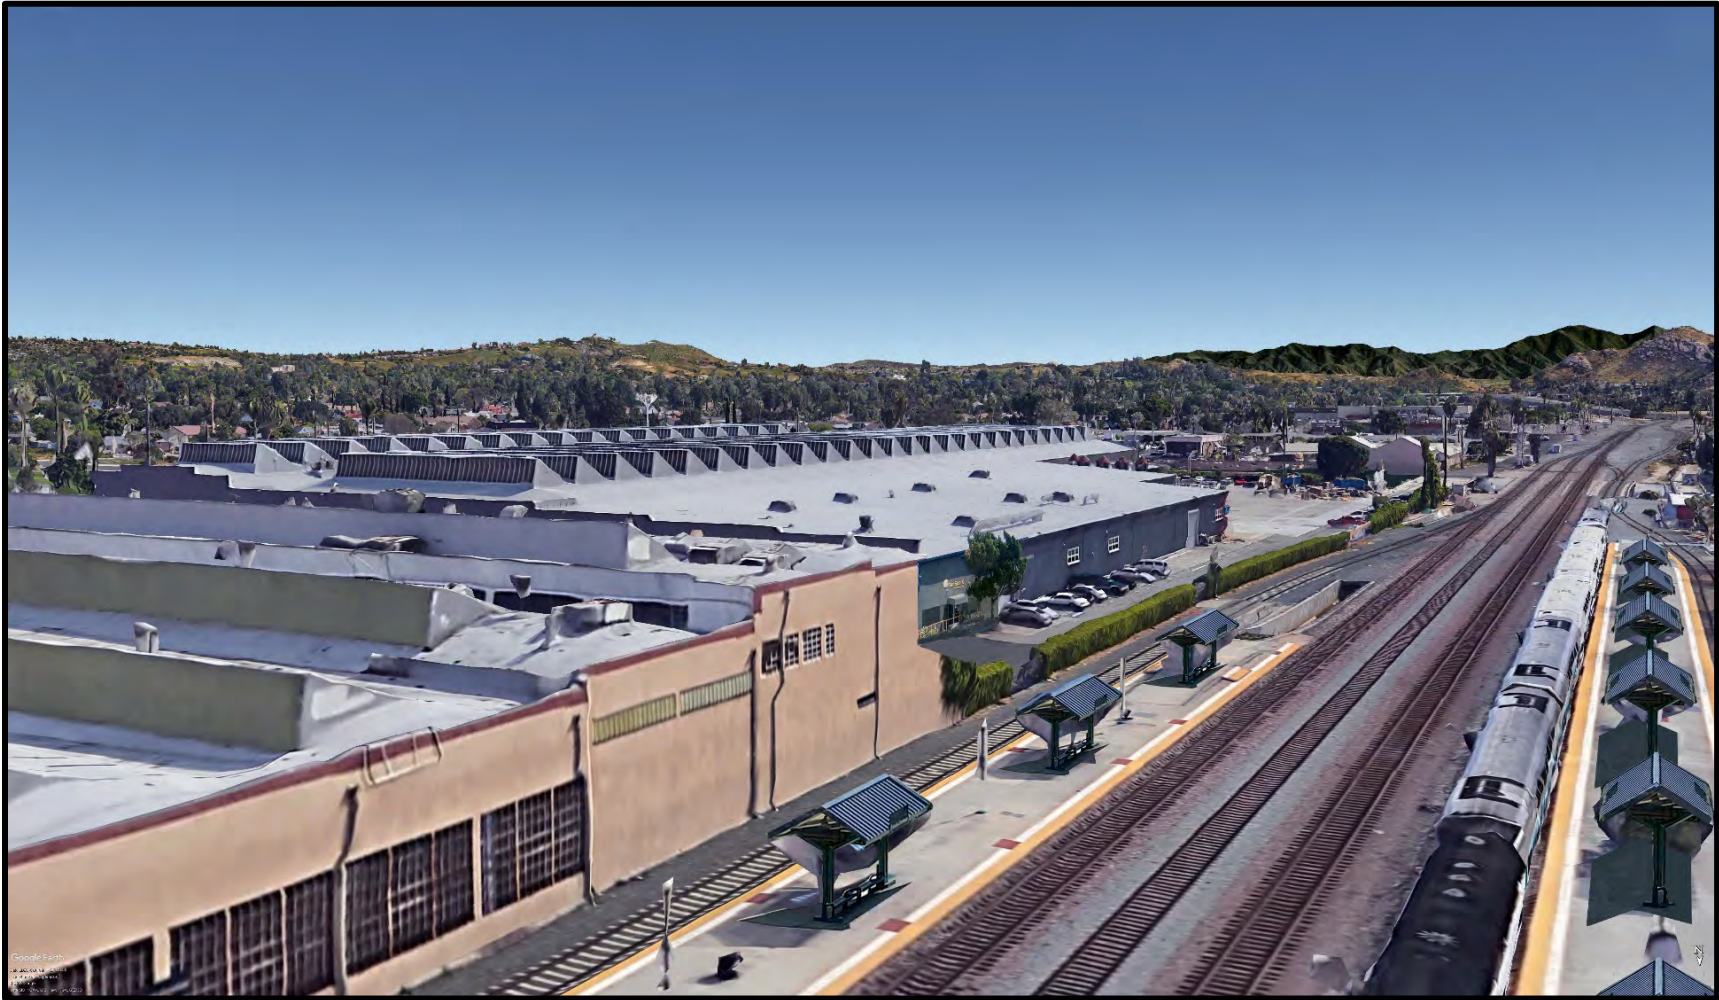
**Figure D-1. View of FMC Plants 1 and 2 and Metrolink Station, Looking Southeast (Existing)**

Figures D-1 through D-10 are visual simulations that provide a reference for the impacts caused by demolition of historic resources.

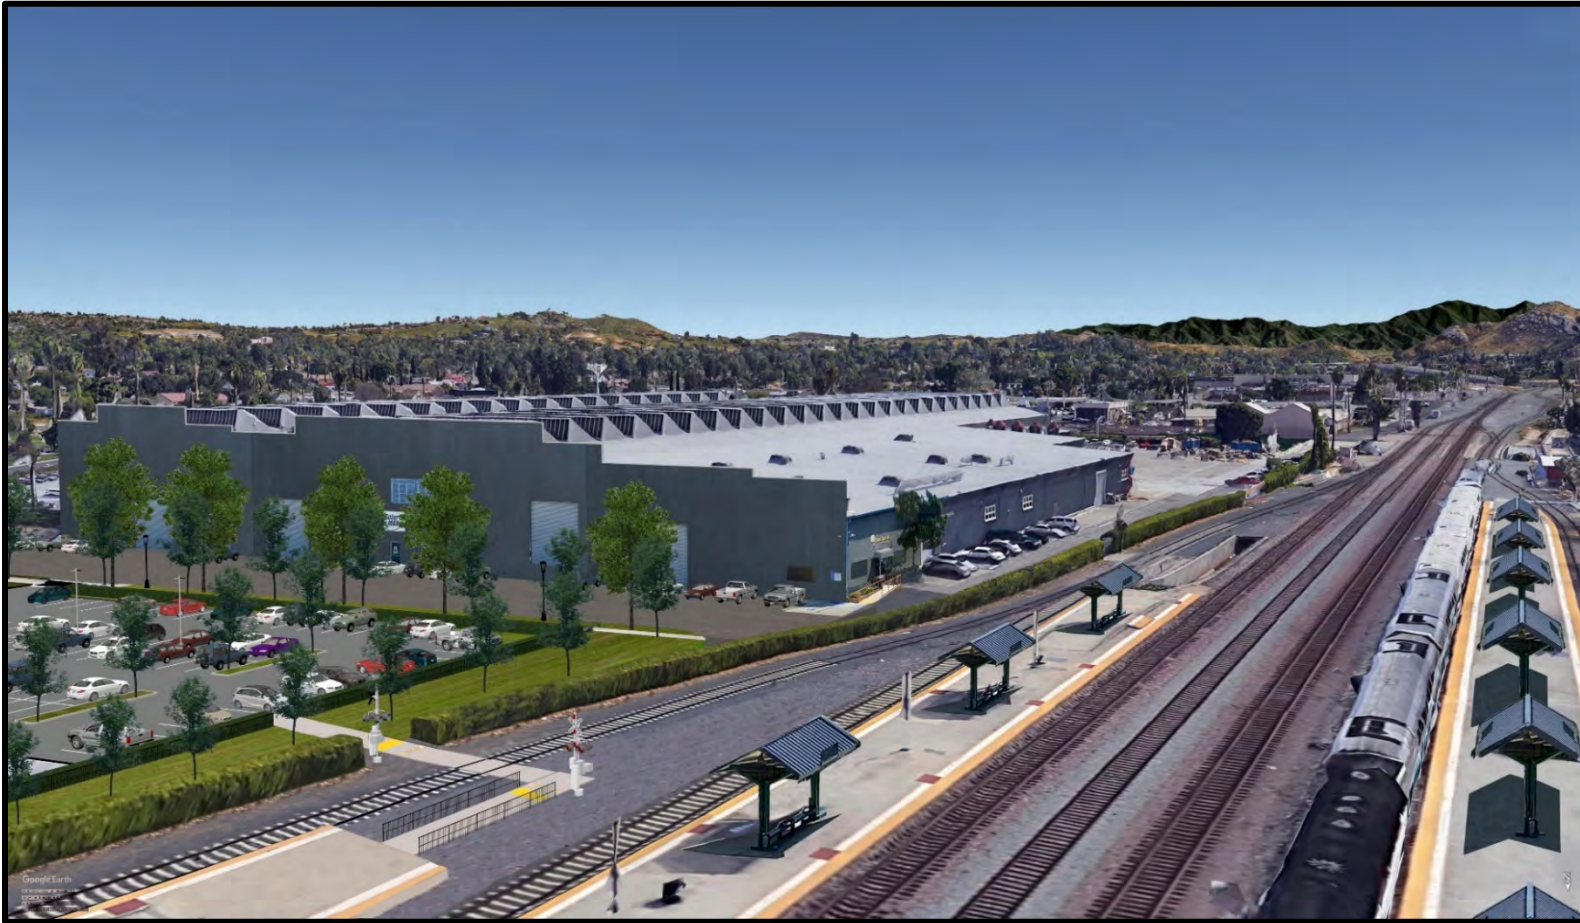
**Figure D-2. FMC Complex with Project (Proposed)**

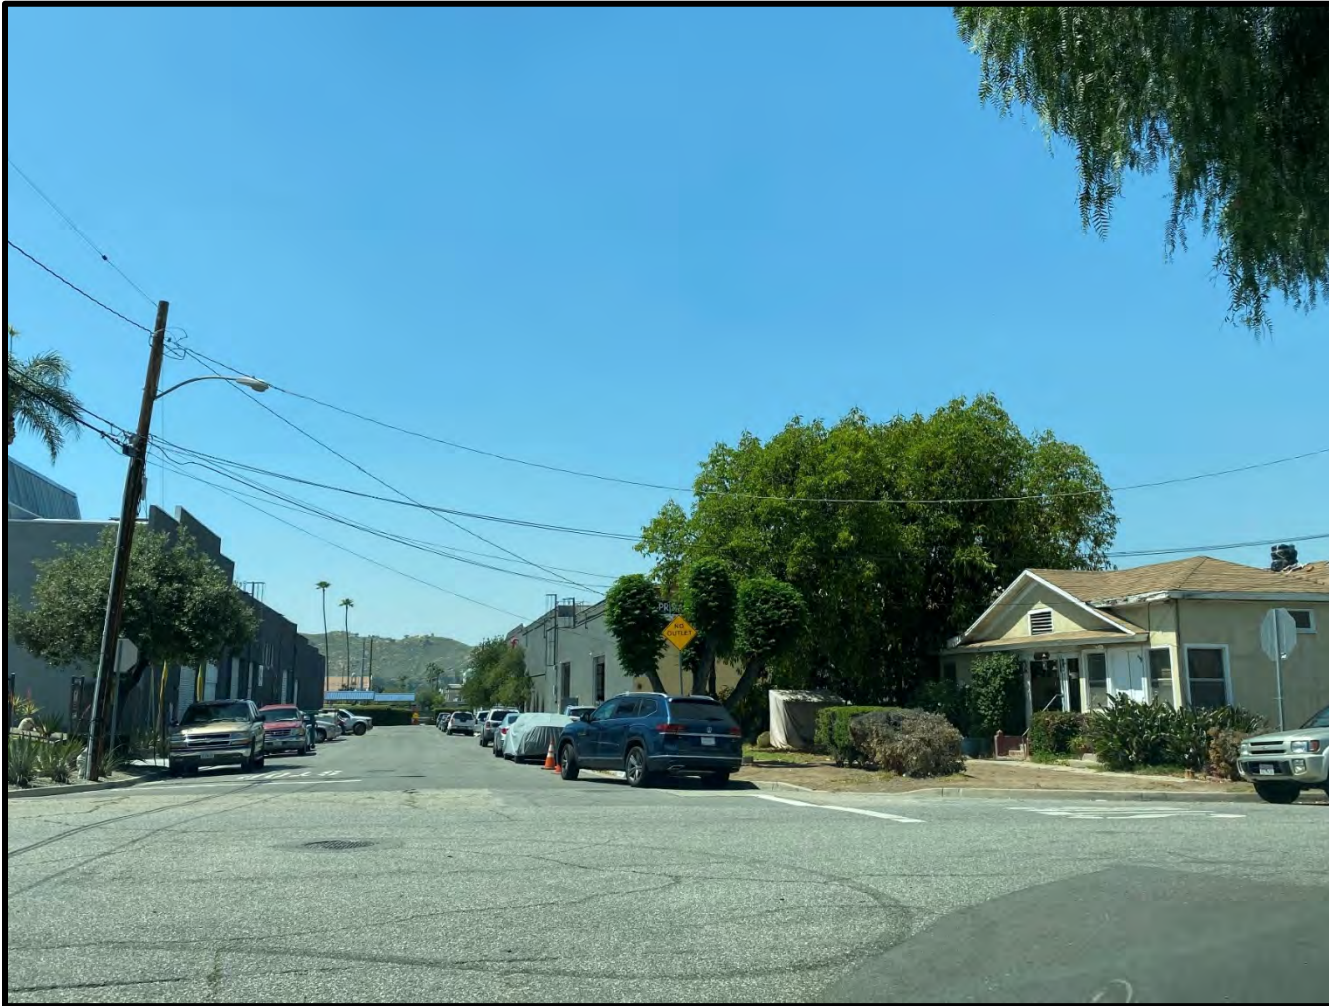
**Figure D-3. 12<sup>th</sup>/Howard Street Looking East towards Plant 1 and 2 with Residences in Foreground (Existing)**

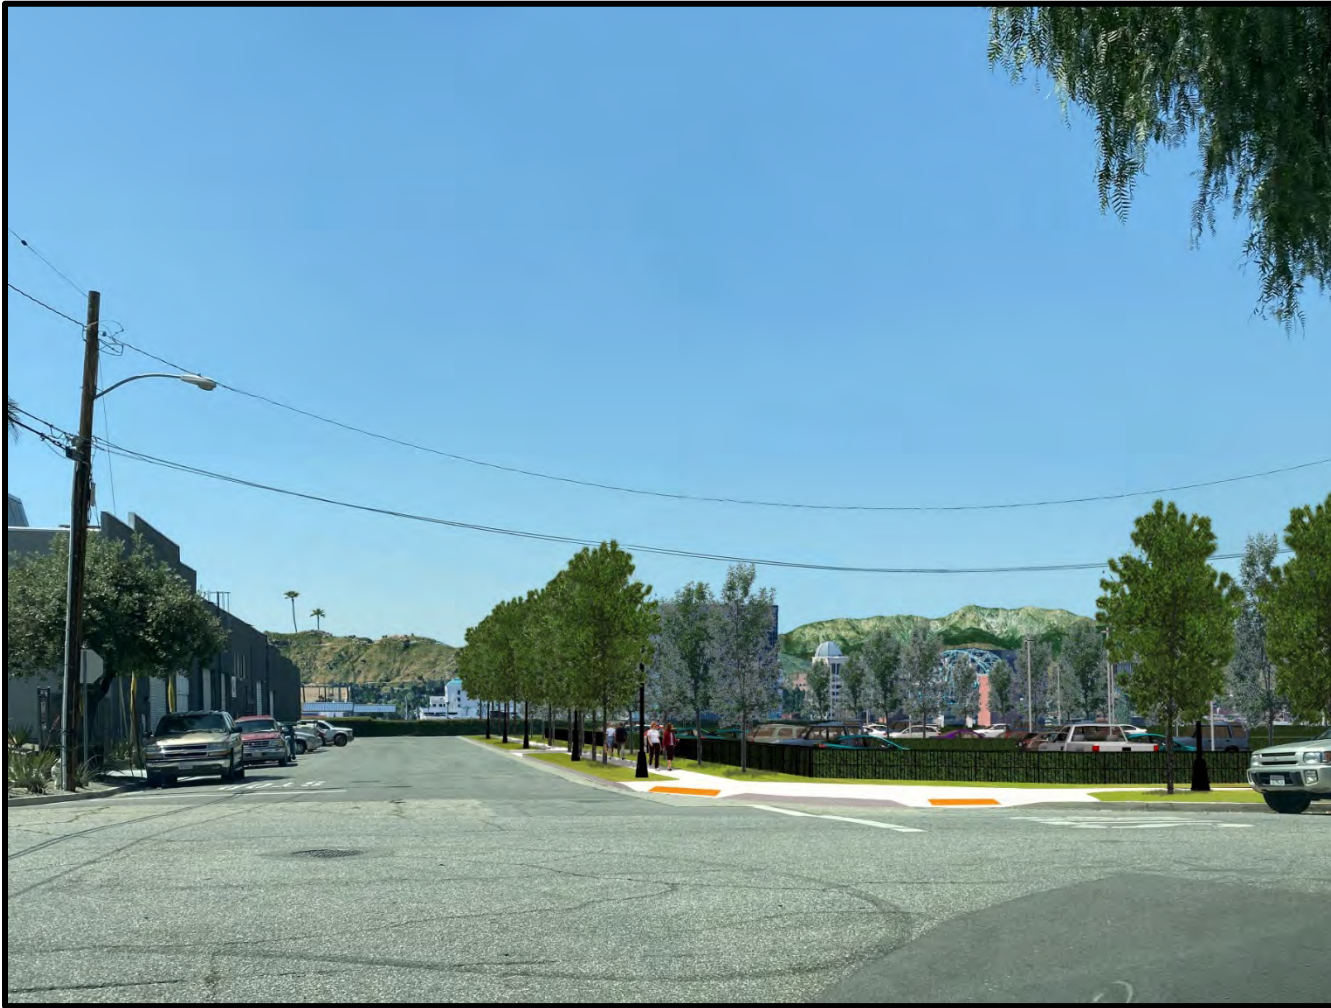
**Figure D-4. 12<sup>th</sup>/Howard Street with Project (Proposed - Option 1A)**

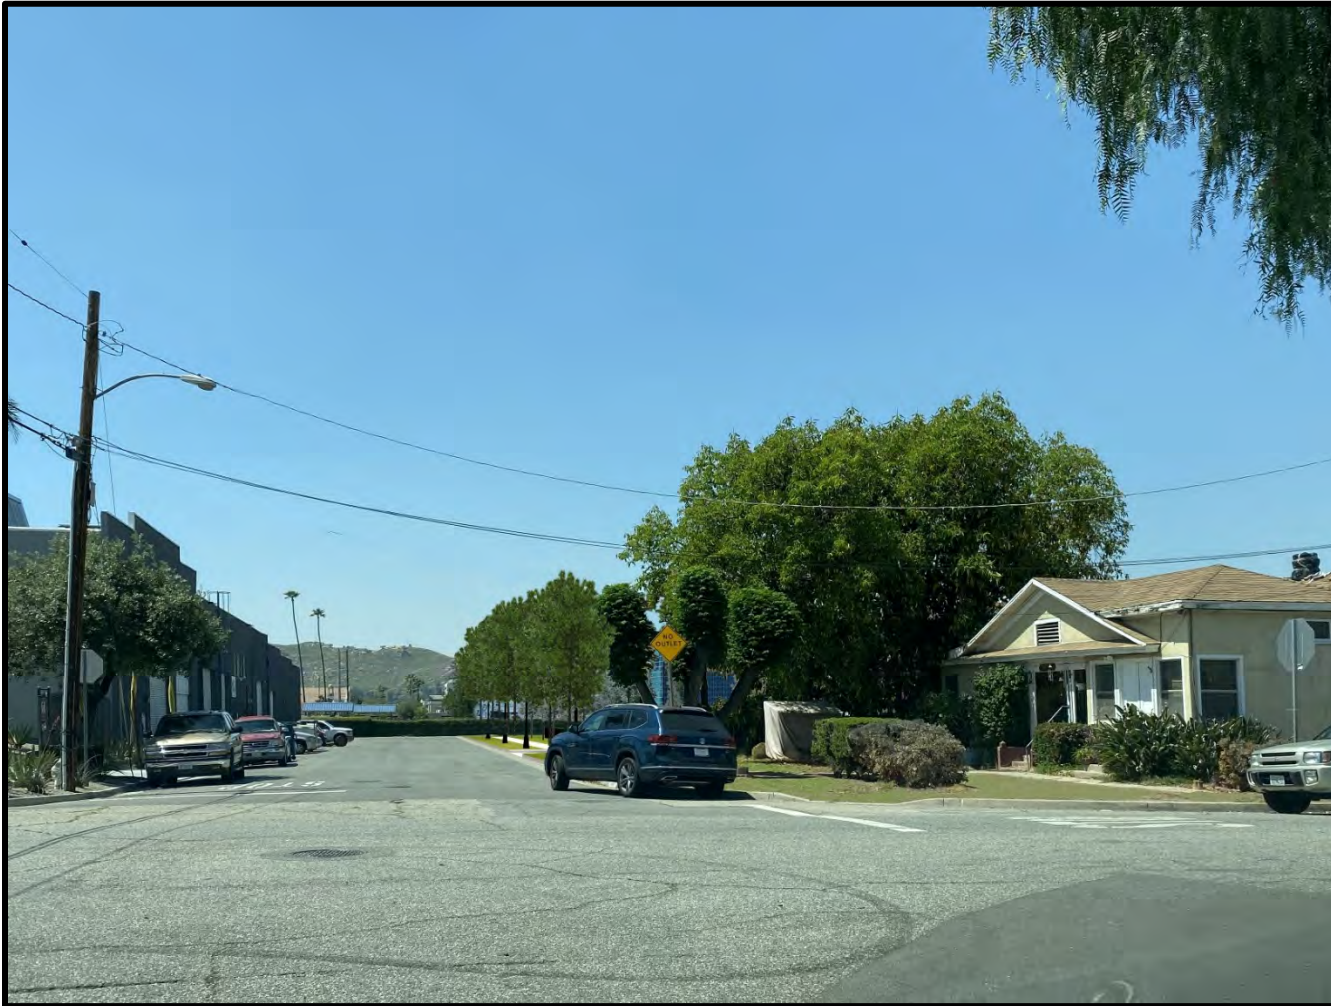
**Figure D-5. 12<sup>th</sup>/Howard Street with Project (Proposed –Option 1B)**

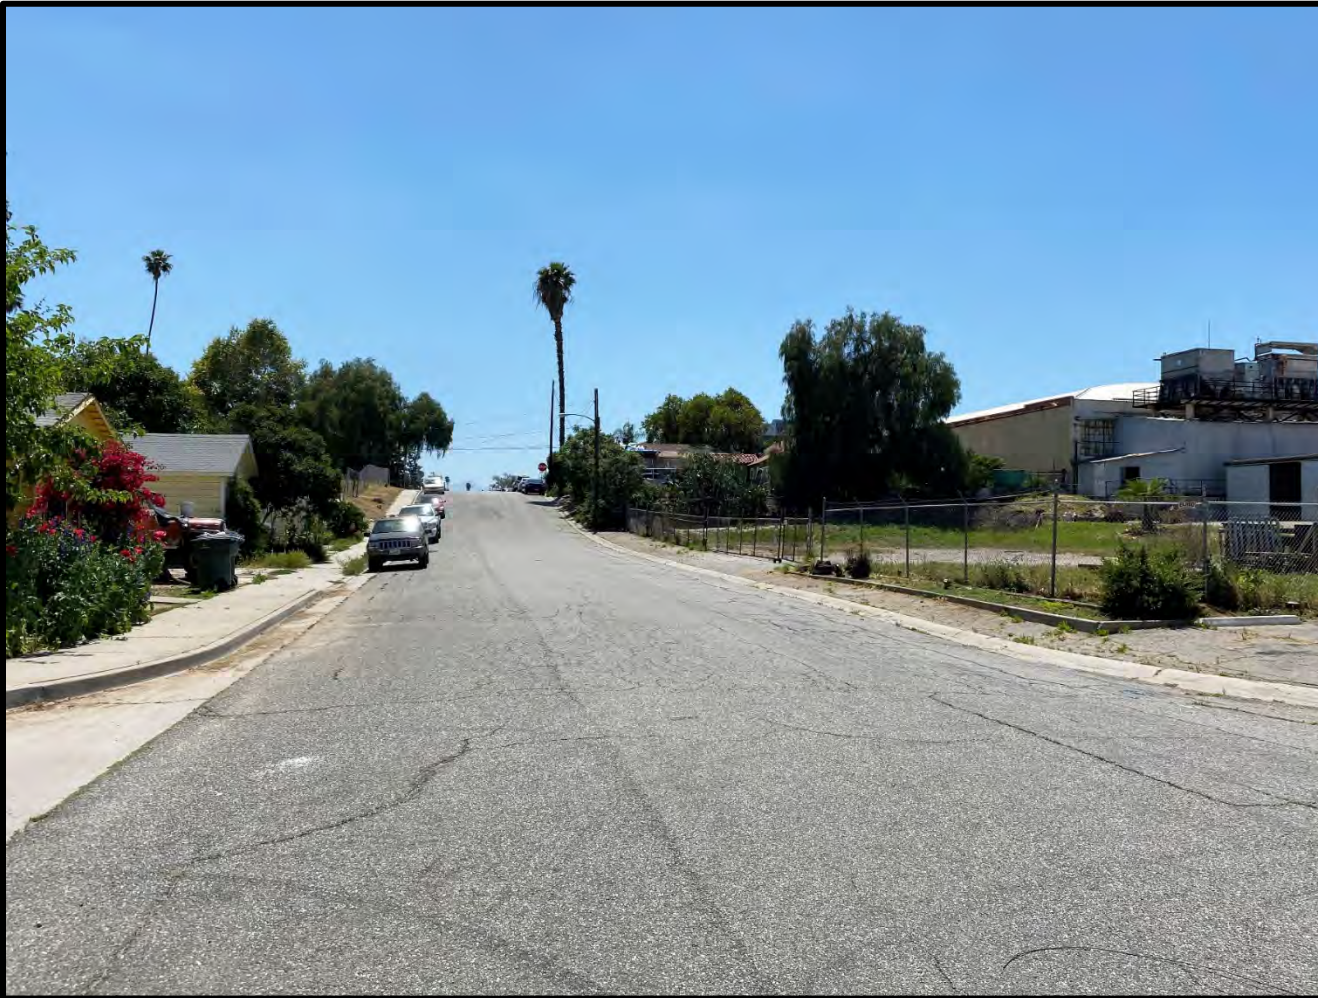
**Figure D-6. 11<sup>th</sup> and Howard Avenue Looking South (Existing)**
