# Historic Resources Report for the Riverside-Downtown Station Improvements Project

4066 Vine Street, Riverside, California 92507

**July 2021**

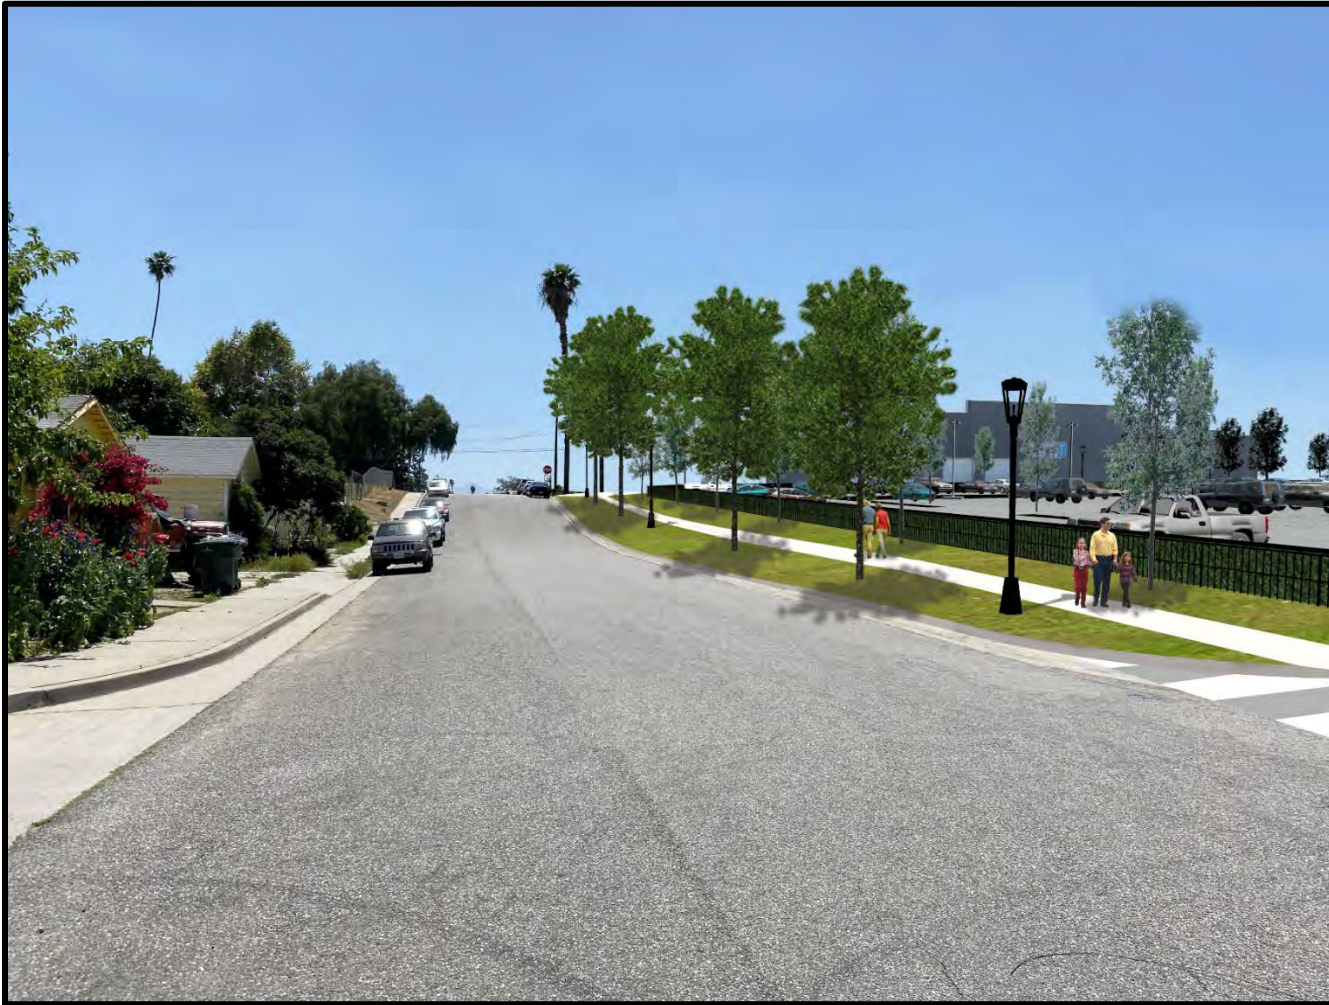
**Figure D-7. 11<sup>th</sup> and Howard Avenue with Project (Proposed – Option 1A and 1B)**

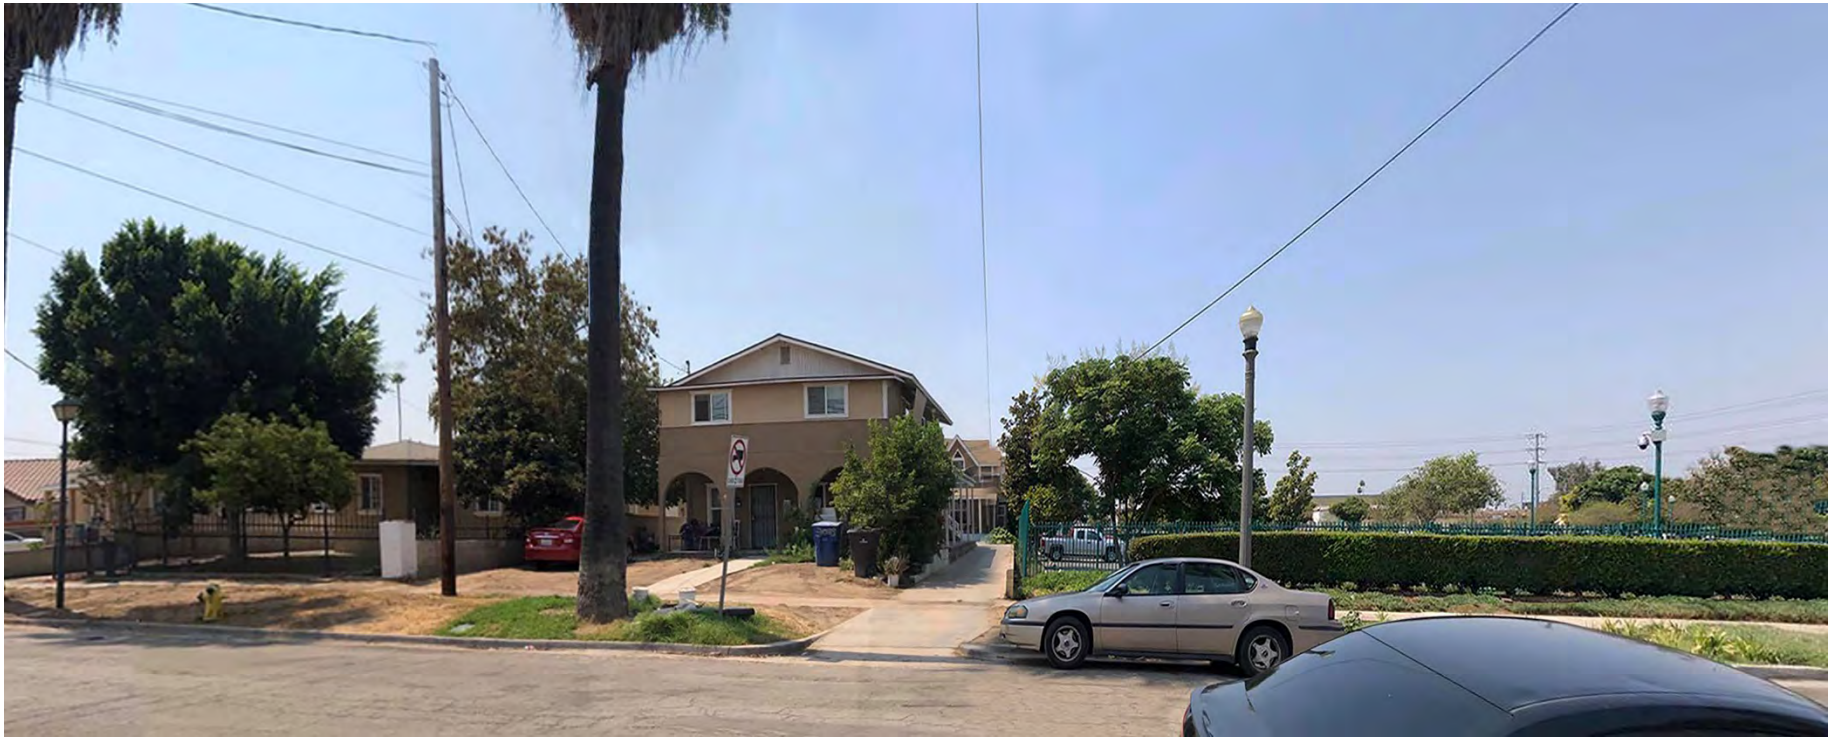
**Figure D-8. 9<sup>th</sup> and Howard Avenue (Existing)**

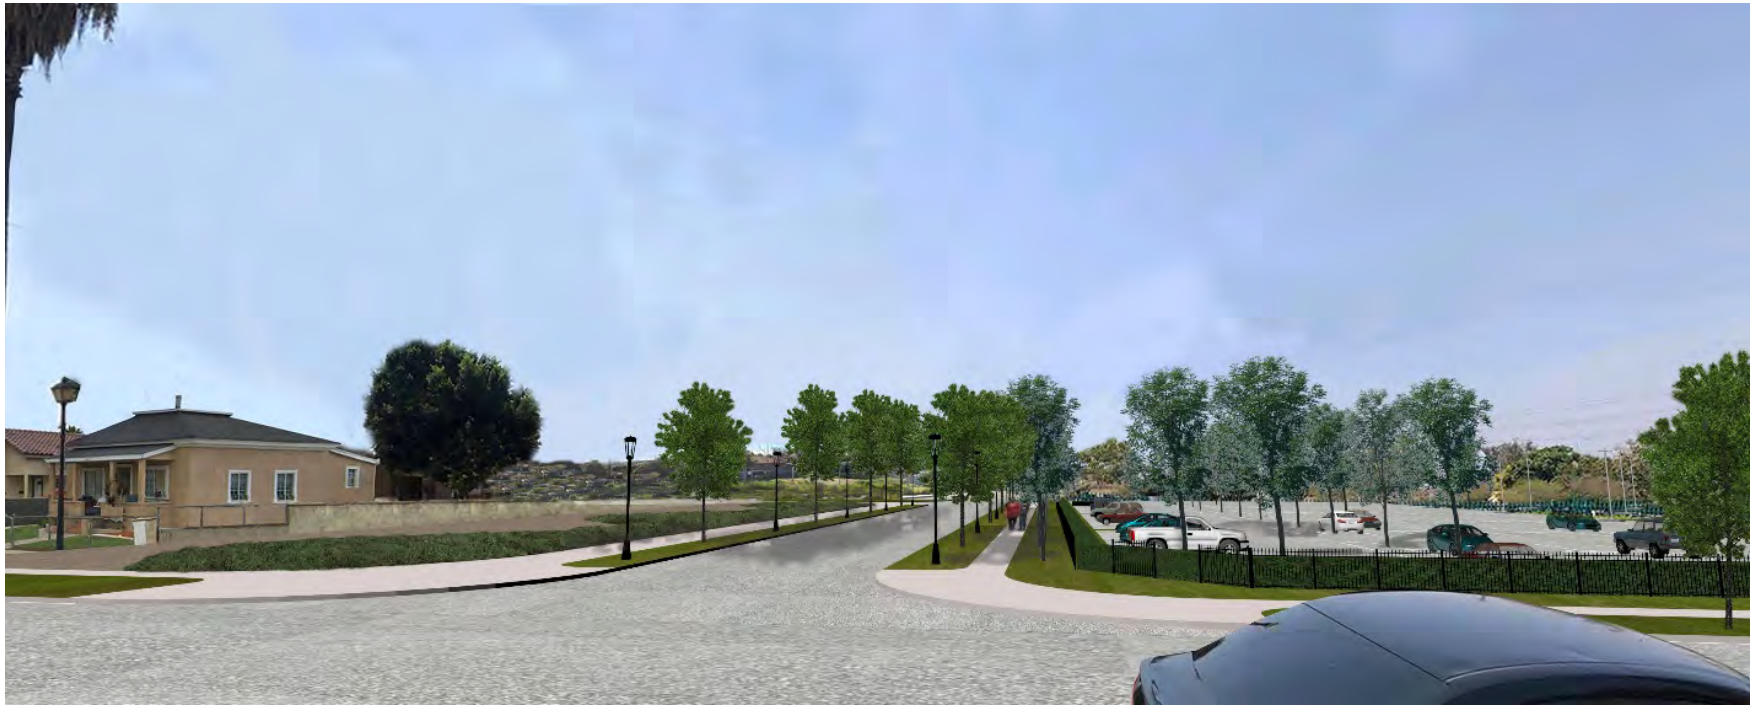
**Figure D-9. 9<sup>th</sup> and Howard Avenue with Design Options 2A and 2B**

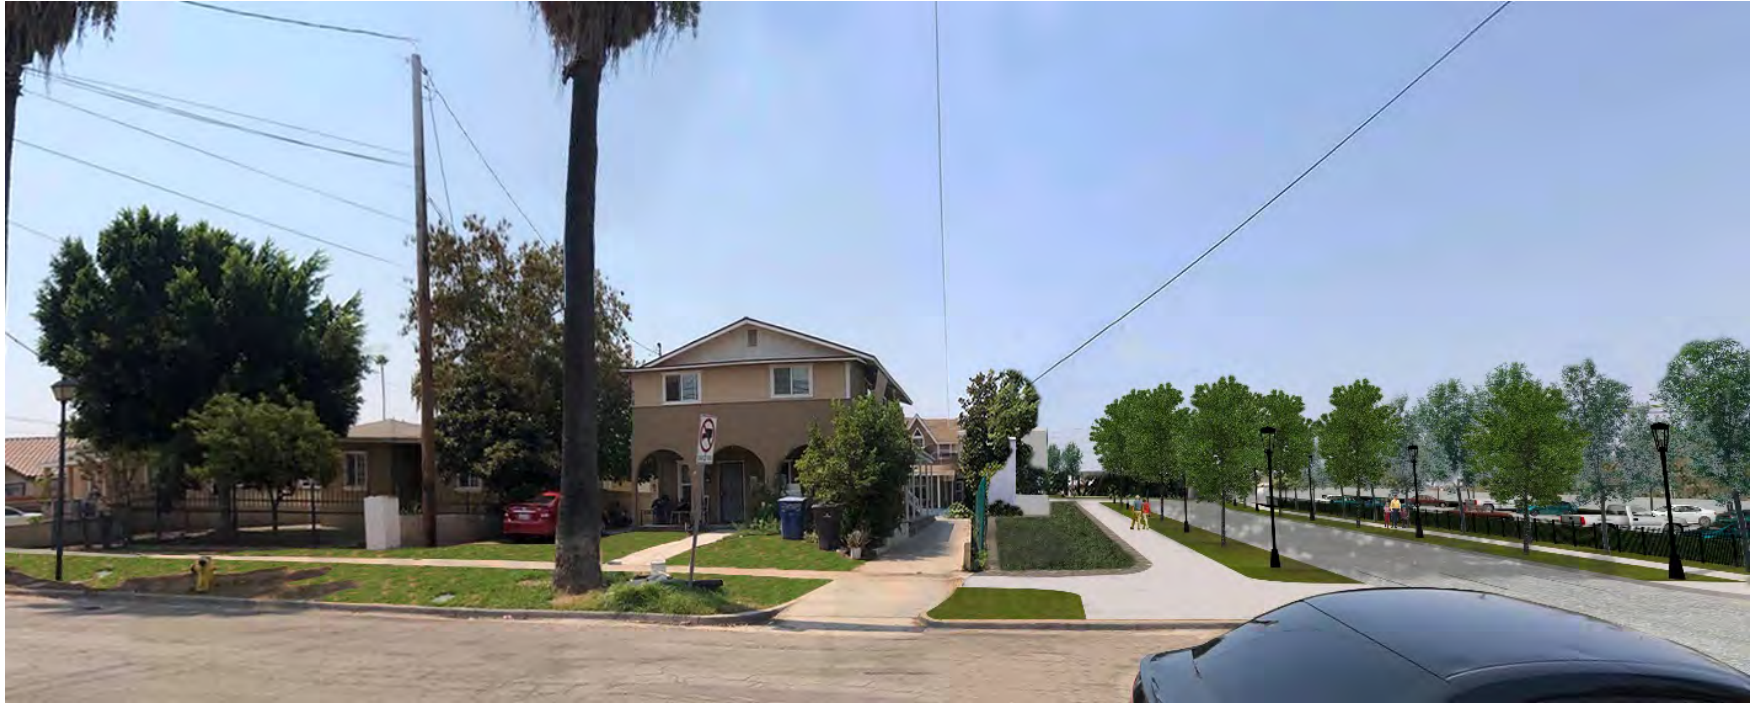
**Figure D-10. 9<sup>th</sup> and Howard Avenue with Design Options 3A and 3B**

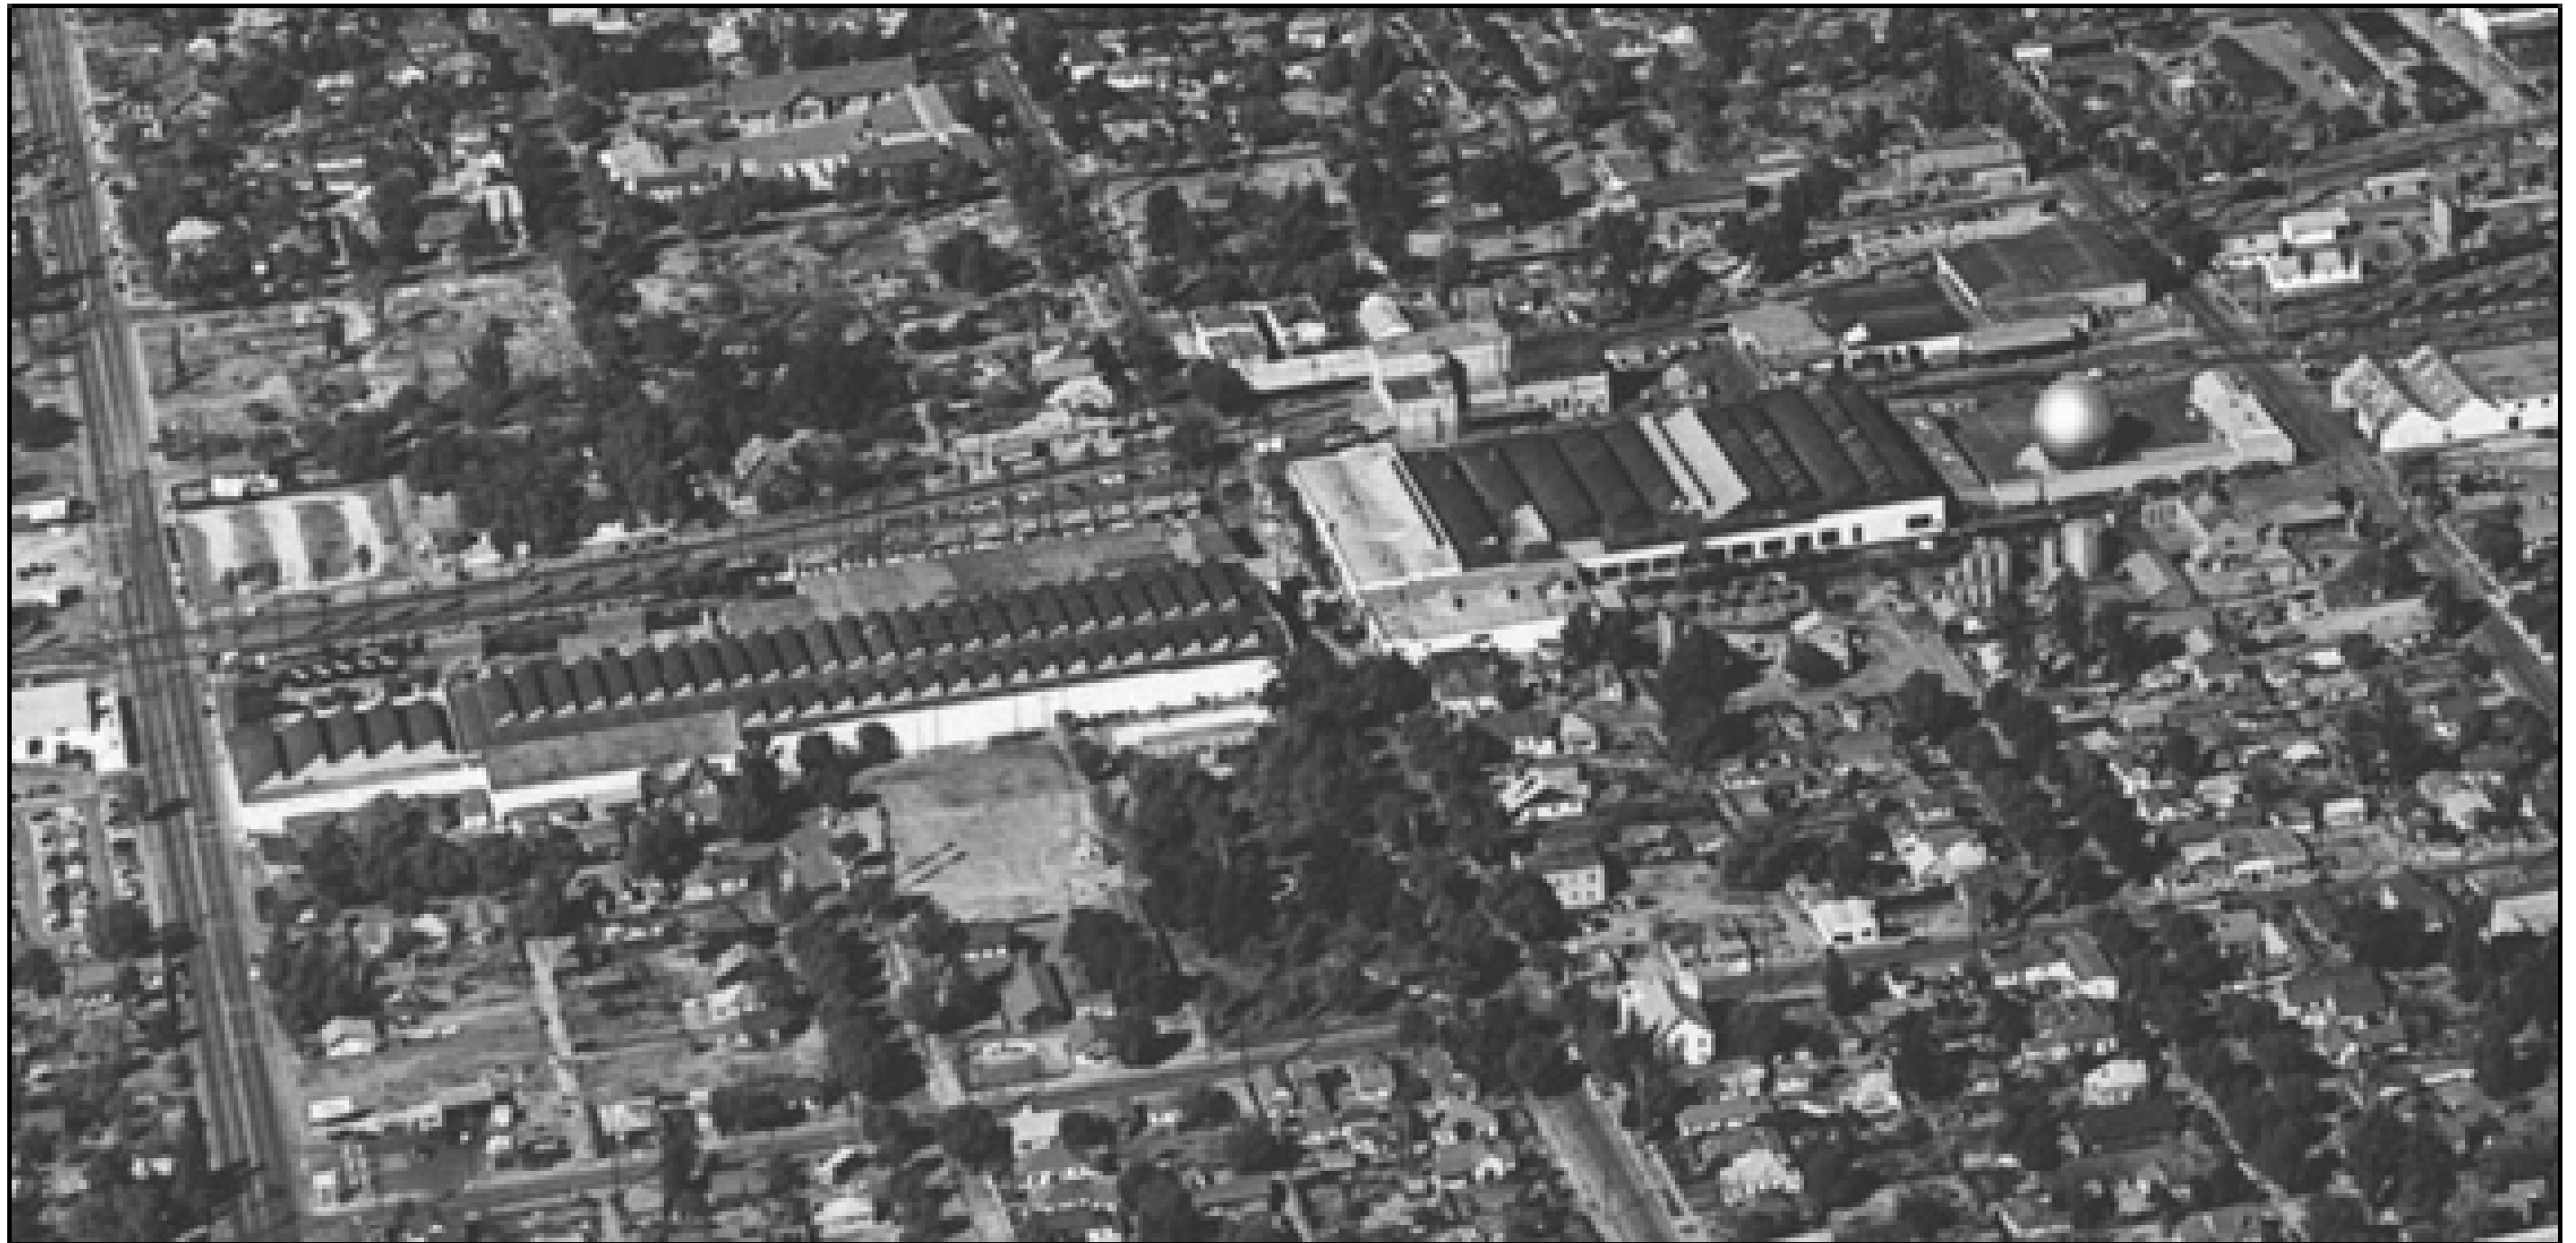
**Figure 4-2. FMC Complex, Looking West, November 1955**

*Spence Photo Archives, University of California, Los Angeles. Courtesy: Chattel Architecture, Planning, and Preservation, Inc. Illustrates the urban fabric surrounding the APE from 1955.*

In its current configuration, the FMC comprises a complex of seven buildings, additions, and numerous associated sheds and canopies on multiple parcels encompassing almost 15 acres. The complex runs from 14th Street to the south to 10th Street to the north. The complex is bounded on the west by the BNSF Railroad corridor and the Metrolink transit platform. On the east side of the complex, the neighborhood comprises single family dwellings, a city park, and older commercial and industrial buildings. Figure 1 provides an overview of the complex as it appeared in 1955, during the peak of FMC operations and the period of its maximum buildout.

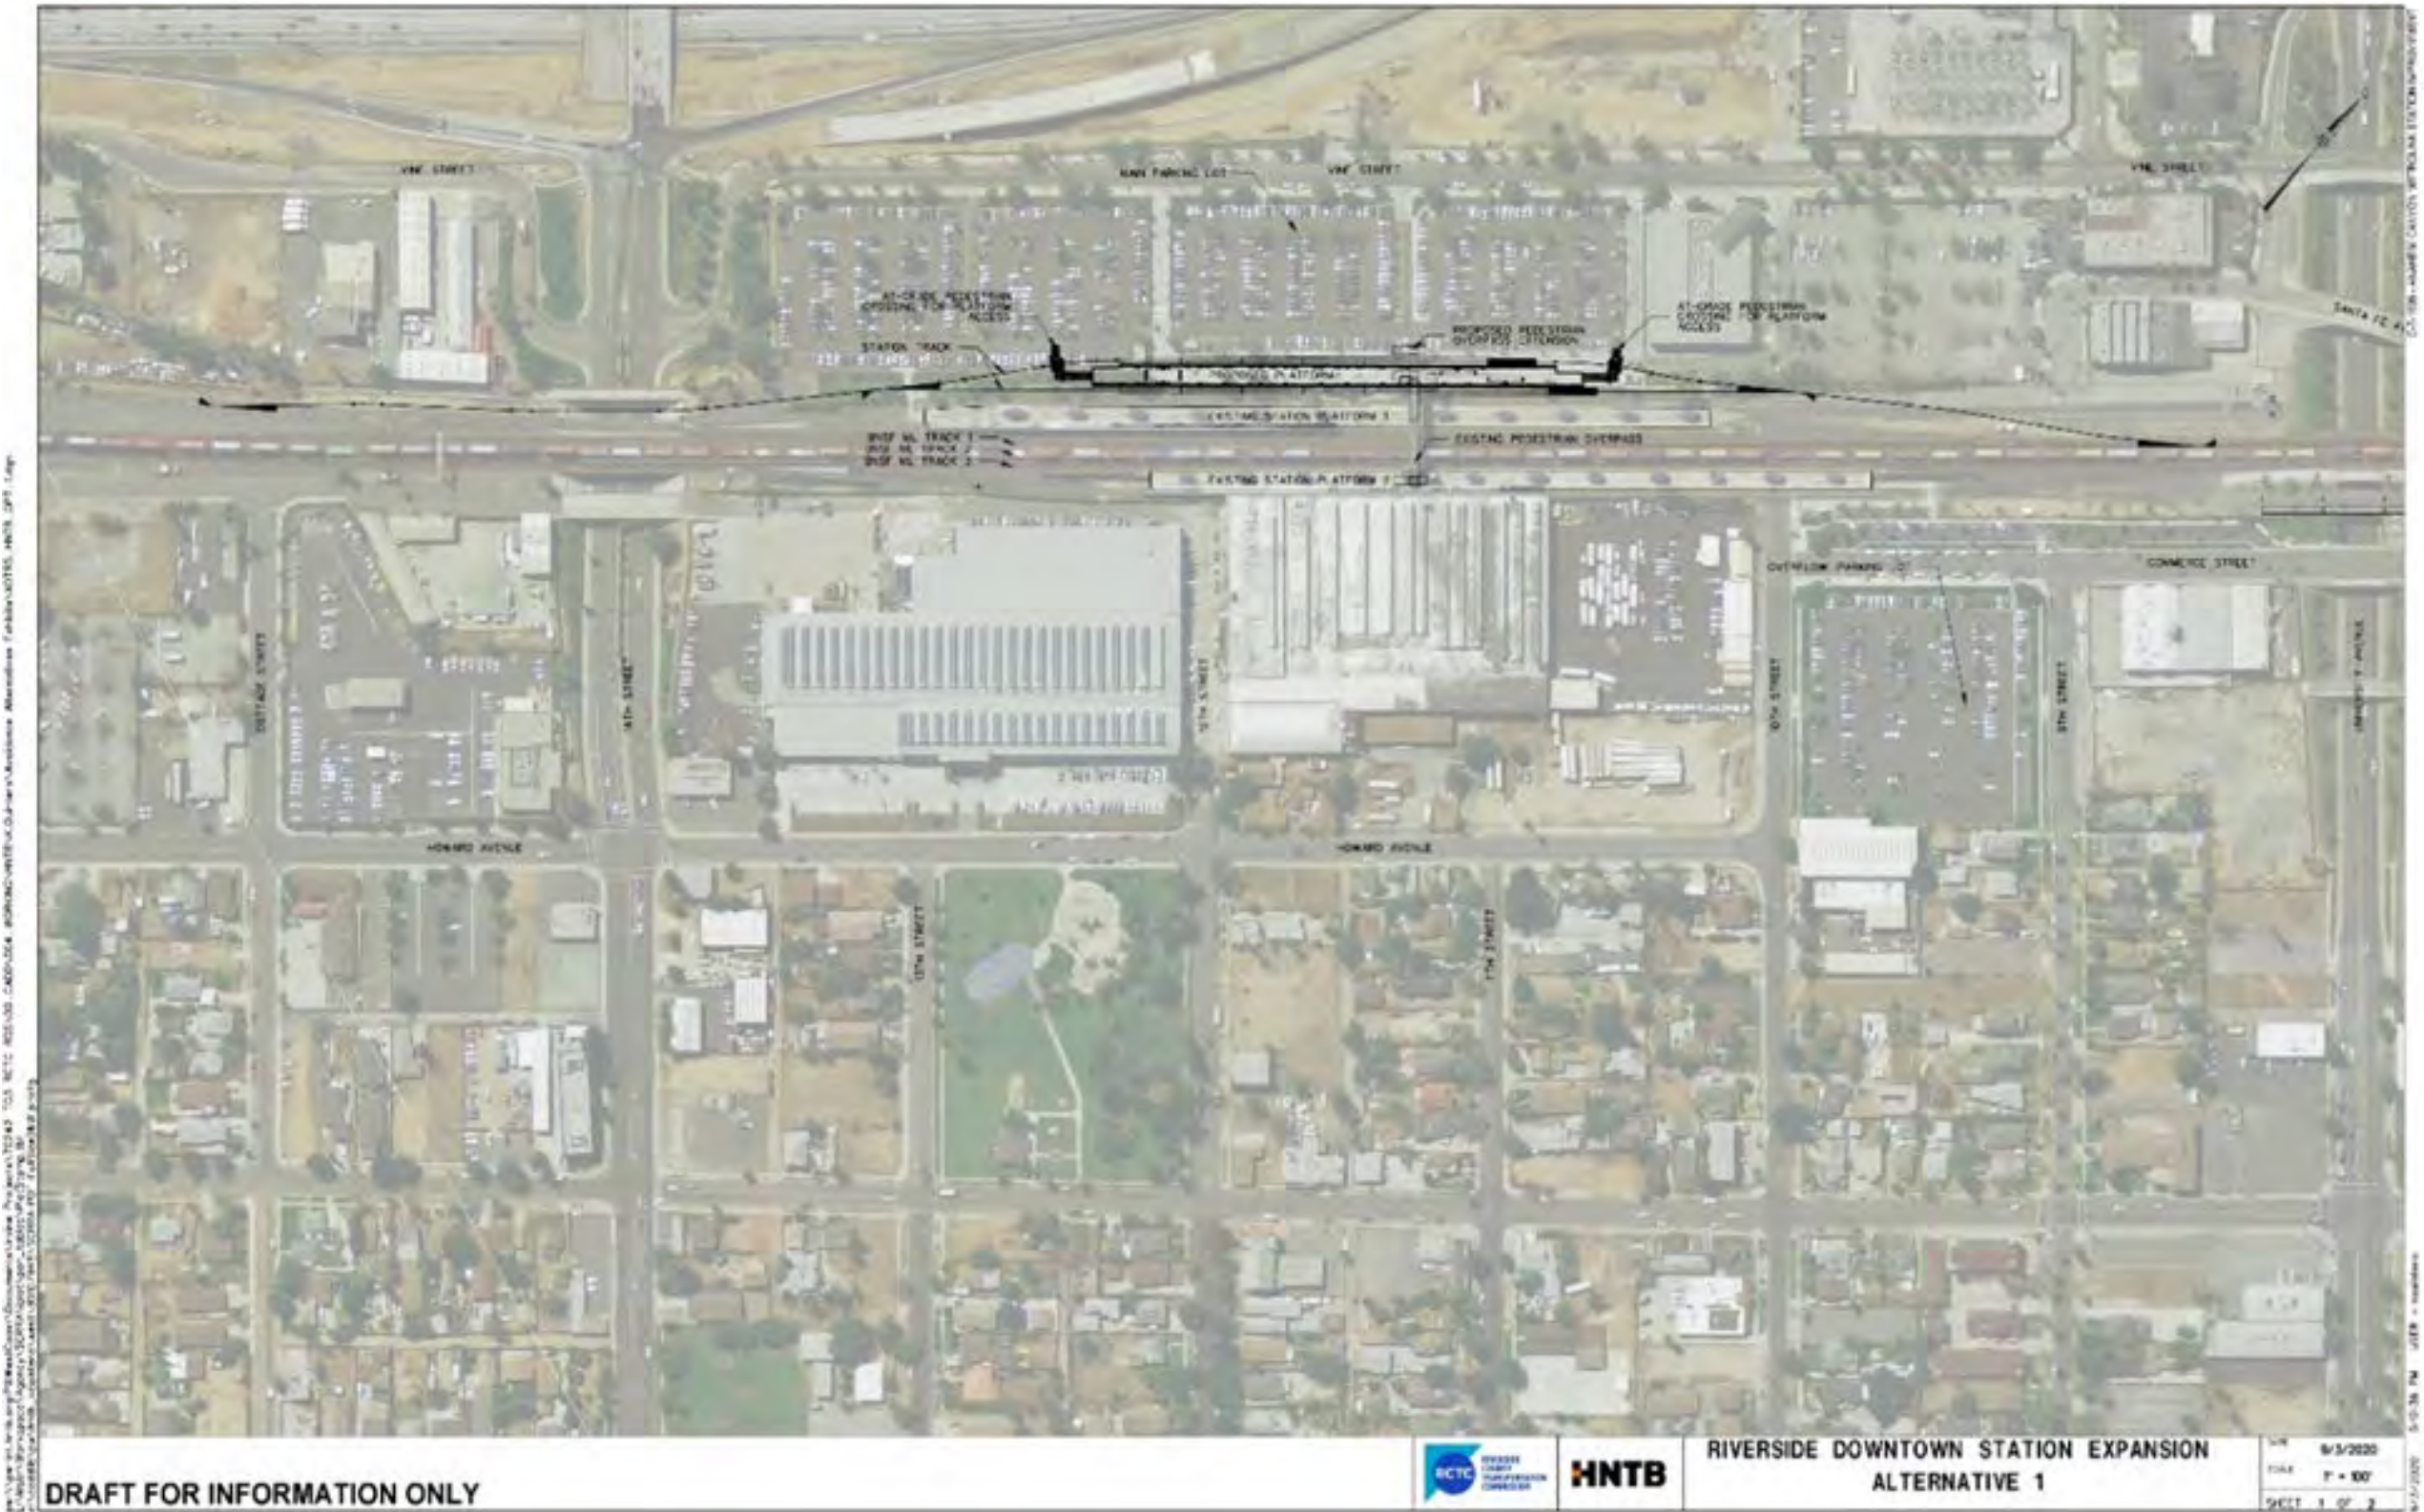
Figure 5-1. Avoidance Alternative 1

Figure 5-1. Avoidance Alternative 1

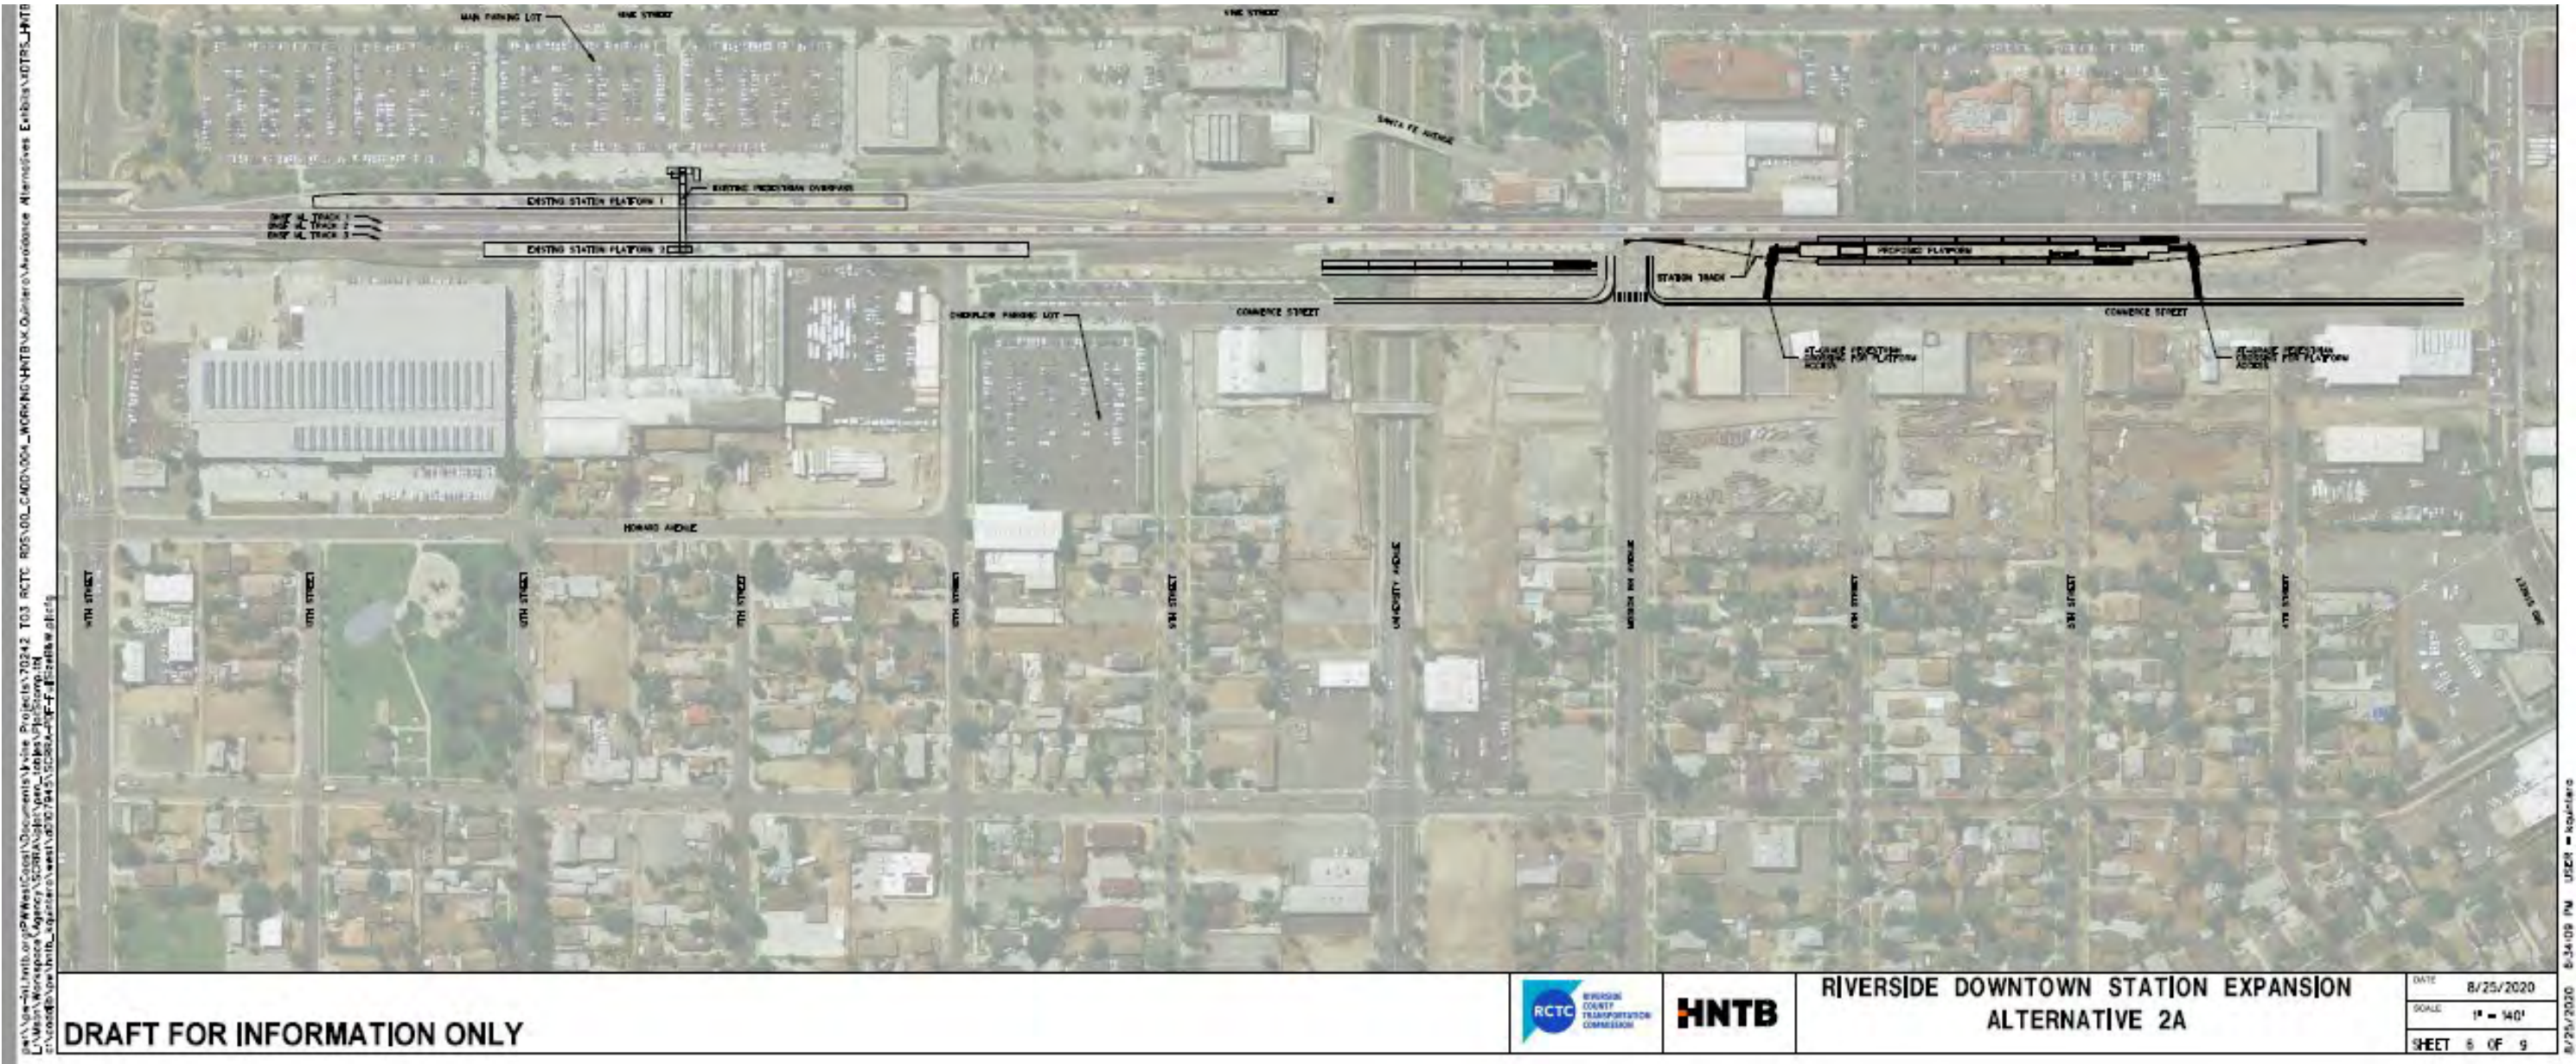
Figure 5-4. Avoidance Alternative 2A

Avoidance Alternative 2A avoids the FMC Complex (Plant 1 and Plant 2) and the two existing layover tracks on the east side of the station by shifting improvements north of Mission Inn Avenue (Figure 5-4). This avoidance alternative would provide a new platform and tracks on the east side of the existing station, and pedestrian grade crossings would be provided at both ends of the new platform.

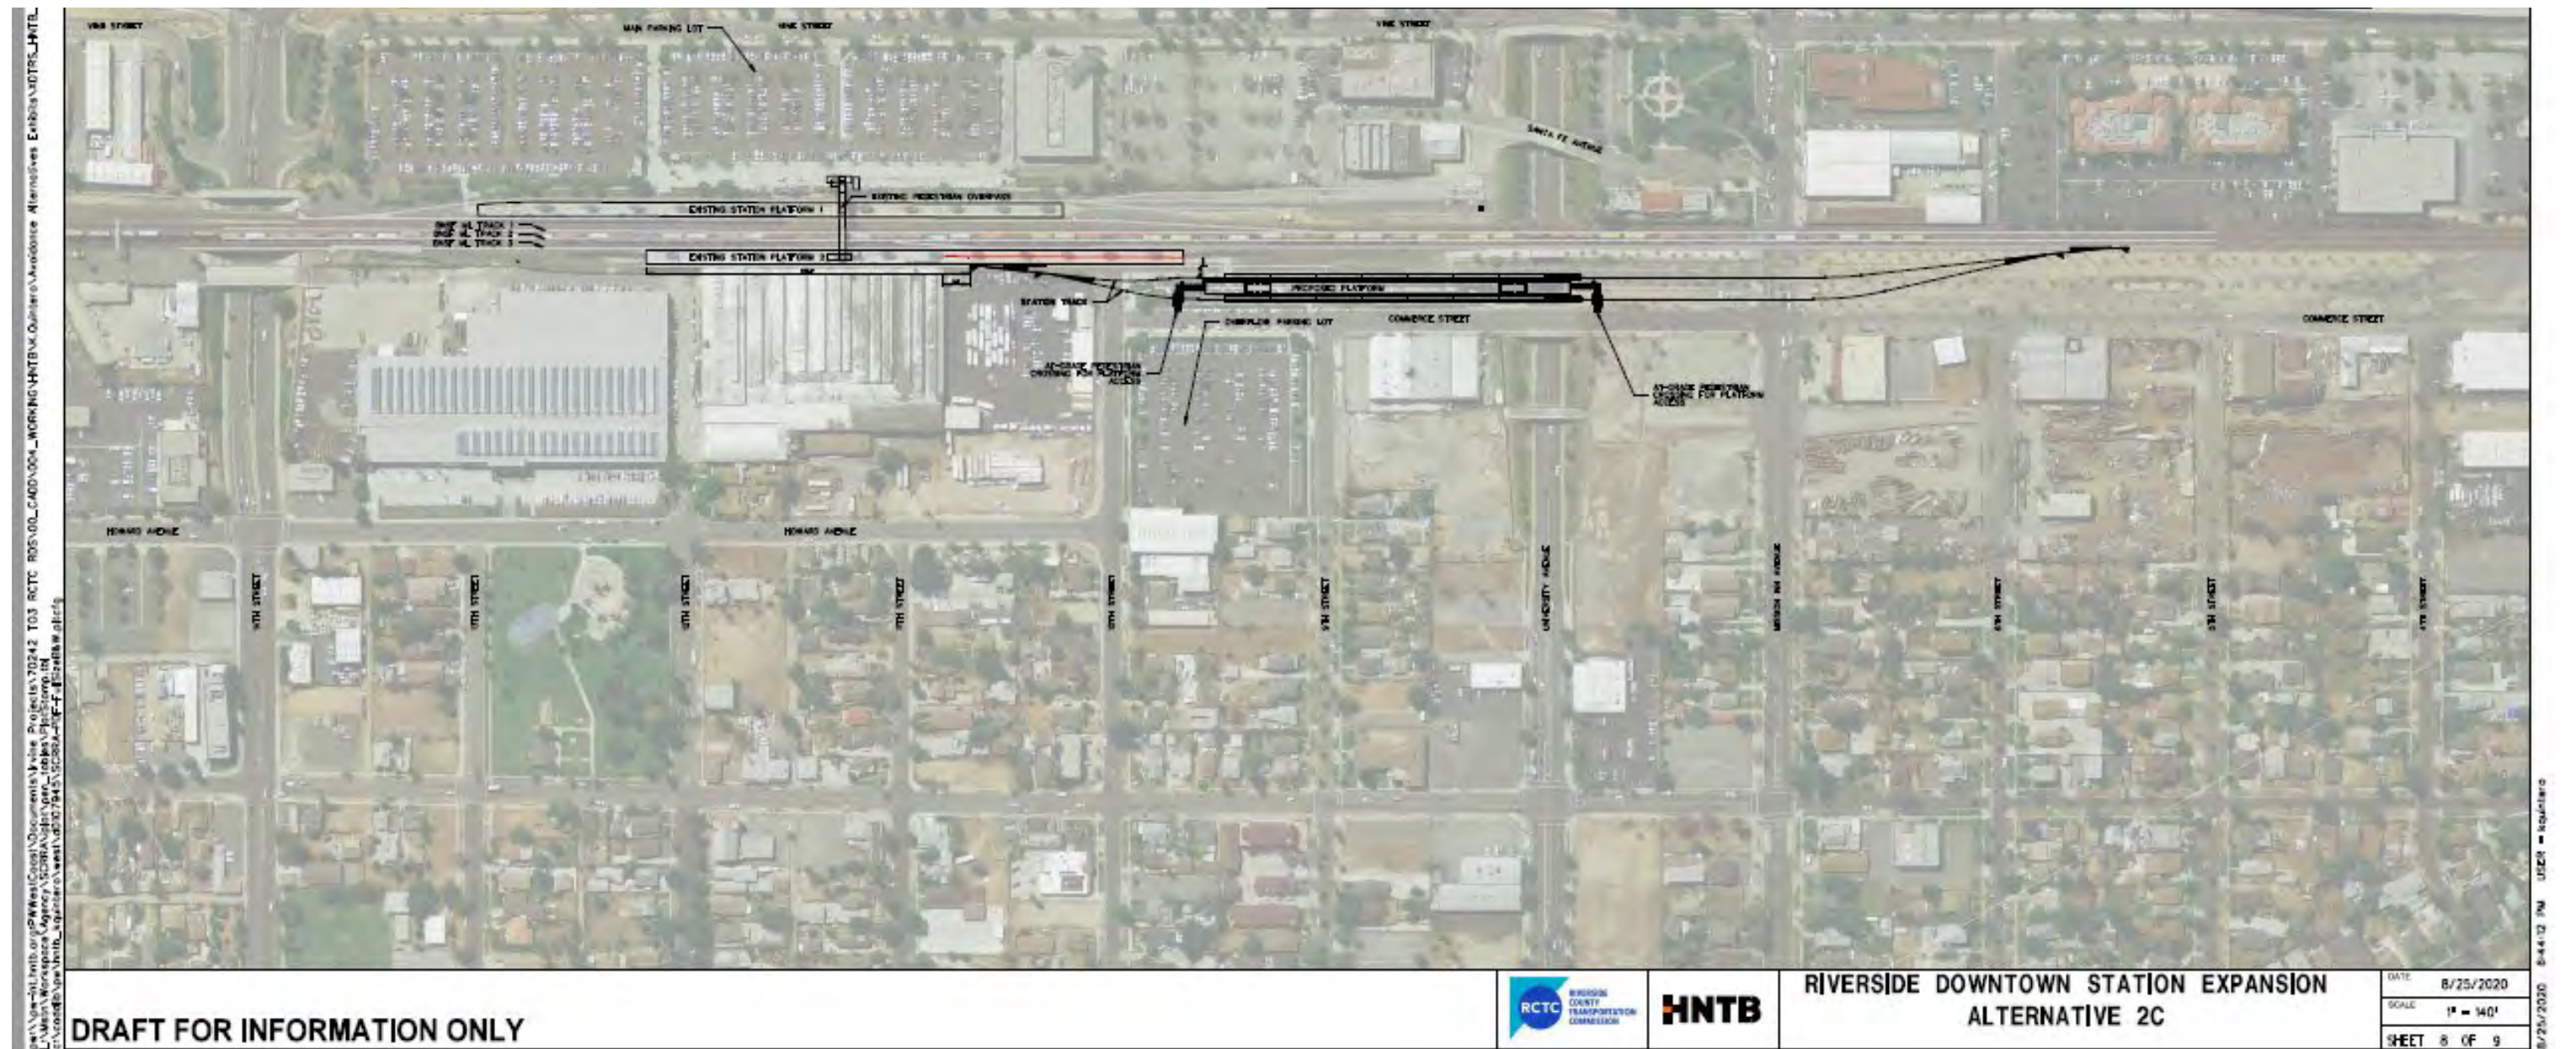
**Figure 5-6. Avoidance Alternative 2C**

Avoidance Alternative 2C avoids the FMC Complex (Plant 1 and Plant 2) on the east side of the station by shifting the improvements just north of the FMC Complex (Figure 5-6). This avoidance alternative would provide a new platform and tracks just north of RDS, and pedestrian grade crossings would be provided at both ends of the new platform.
