Evaluation of Physical Barriers – Pedley Station

Address: 6001 Pedley Rd, Riverside, CA 92509

Evaluation Date: 08-05-2021

RCTC ADA Self-Evaluation and Transition Plan - Attachment 6E

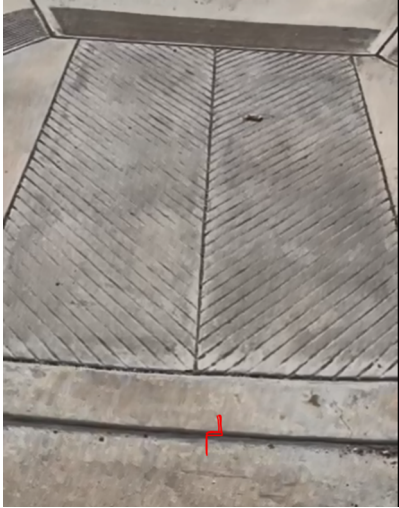
Issues/ Barrier Identified	Recommendations	Comments/ ADA Requirements
<p>1. Curb Ramps</p> <p>1a, 1b - OK 2a- OK 2b- Gutter Slope exceeds 1:20 3a, 3b, 3c, 4a, 4b, 5a, 5b: Slope of ramp exceeds 8.33% and slope of flared sides exceed 1:10. Detectable Warning Surface (DWS) is missing. 6a, 6b, 7a, 7b: Level changes exceed ¼" without bevel, DWS is missing.</p> <div data-bbox="102 483 481 967">

</div> <p>Typical 6a thru 7b</p> <div data-bbox="515 499 1072 967">

</div> <p>Typical 3a thru 5b</p>	<p>2B: Confirm the slope of the gutter with appropriate instrument and repair as required.</p> <p>Curb ramps 3a through 5b need to be replaced to comply with applicable ADA requirements by City of Riverside.</p> <p>Repair curb ramp 4a which is the main accessible entry route.</p> <p>Curb ramps 6a thru 7b – Examine and repair to eliminate level changes and apply DWS.</p>	<p>Curb ramps are labeled on the aerial view on page 1</p> <p>See item 3a also for other ADA requirements</p> <p>This evaluation does not include curb ramps outside the RCTC boundary. RCTC is not responsible for maintaining the accessible routes outside of RCTC boundary.</p> <p>When repairs begin, use proper and precise instruments (4-foot smart level and 2-foot smart level) to fit within the curb ramp width and the adjacent gutter to measure ramp slopes, cross slopes, and counter slopes at all curb ramps (all stations). The long slope of ramp shall not exceed 1:12 (8.33%). Slope of flared sides shall not exceed 1:10 (10%), the gutter slope shall not exceed 1:20 (5%). Cross slope of the ramp and landing shall not exceed 1:50 (2%)</p> <p>Use smart level instruments, calibrated in accordance with manufacturer's instructions before taking measurements.</p> <div data-bbox="1609 715 2262 856">

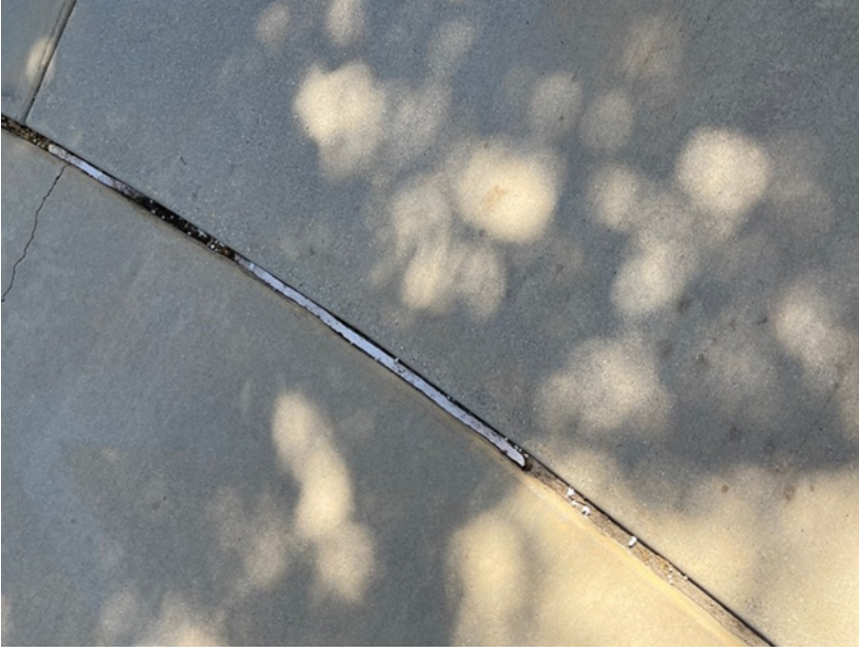
Issues/ Barrier Identified	Recommendations	Comments/ ADA Requirements
3. Accessible Routes		
a) Walking surface		
<p>i. General: There are uneven joints and cracks observed in the concrete walkway along the accessible route. Sealant/filler in some deep joints is missing. This causes trip hazards and creates openings deeper than ¼" and wider than ½ inch.</p>

<p>Examine all joints, cracks, and level changes along the accessible route.</p> <p>Every joint in concrete deeper than ¼" and wider than ½" shall be filled.</p> <p>Every level change along the accessible route greater than ¼" and less than ½" height needs to be beveled (1:2) slope or repaired.</p> <p>Every level change greater than ½" needs to have a ramped surface with (1:12) slope.</p>

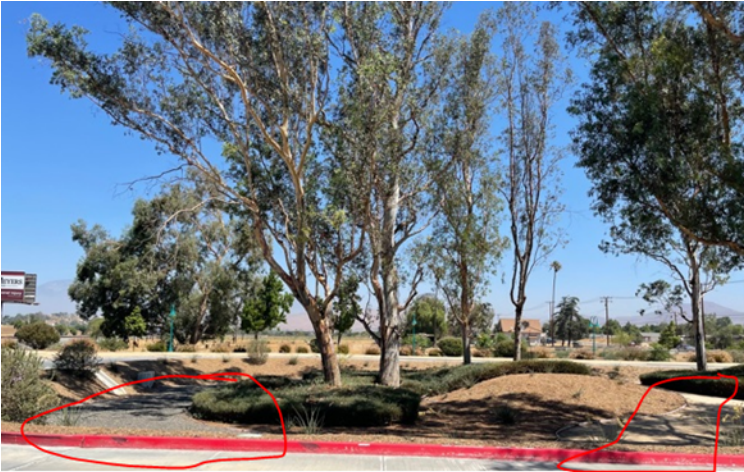
<p>Trails in the landscaped areas at the bus stops are not accessible. No accessible route leads to them and the walking path surface is not firm.</p>

<p>If the park is not open for public use either, add signage prohibiting public access.</p>

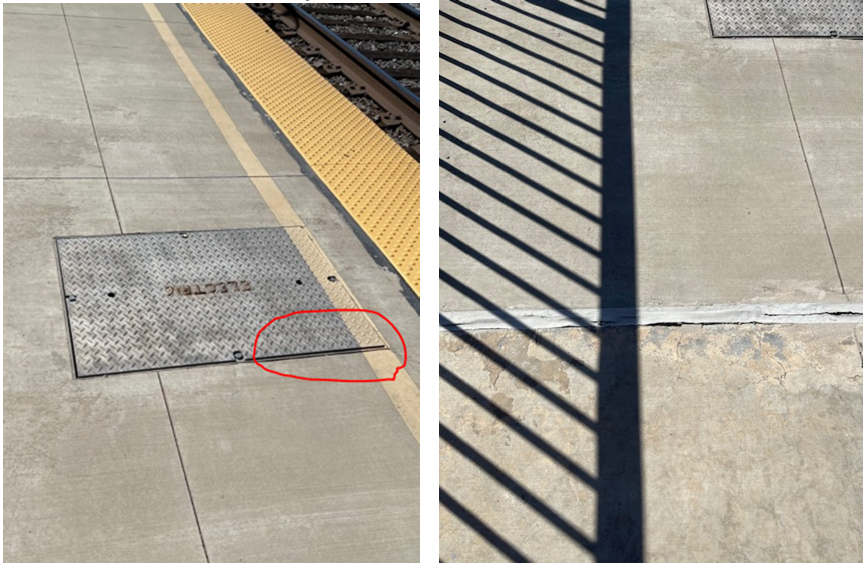
Issues/ Barrier Identified	Recommendations	Comments/ ADA Requirements
b) Elevator		
Not Applicable		
c) Pedestrian Bridge		
Not Applicable	No action by RCTC	
d) Stairs		
Not Applicable	No action by RCTC	
e) Ramps		
Not Applicable	No action by RCTC	
4. Platforms		
a. Walking Surfaces		
i. General: Joints. Level changes and gaps in concrete and closure plates to be repaired or maintained for compliance with 302.3, 303.2, and 303.3.

Examine all pedestrian routes and repair all cracks and open joints Every joint in concrete deeper than ¼” and wider than ½” shall be filled. Every level change along the accessible route greater than ¼” and less than ½” height needs to be beveled (1:2) slope or repaired. Every level change greater than ½” needs to have a ramped surface (1:12) slope.	Same as Item 3a

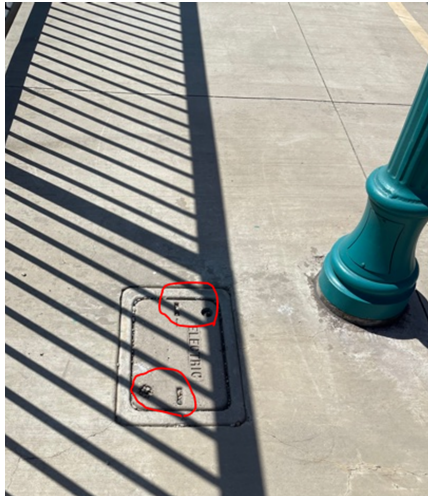
Issues/ Barrier Identified	Recommendations	Comments/ ADA Requirements
<p>i. Utility covers are not ADA compliant due to missing filler pieces in lifting holes.</p>

<p>Add filler pieces in all holes exceeding ½” diameter.</p>	
<p>b. Mini High Platforms</p>		
<p>No issues found.</p>		
<p>5. Pedestrian Rail Crossings</p>		
<p>i. Detectable Warning Surface (DWS) is missing at the pedestrian rail crossing which is the only accessible route to get to the other platform.</p>

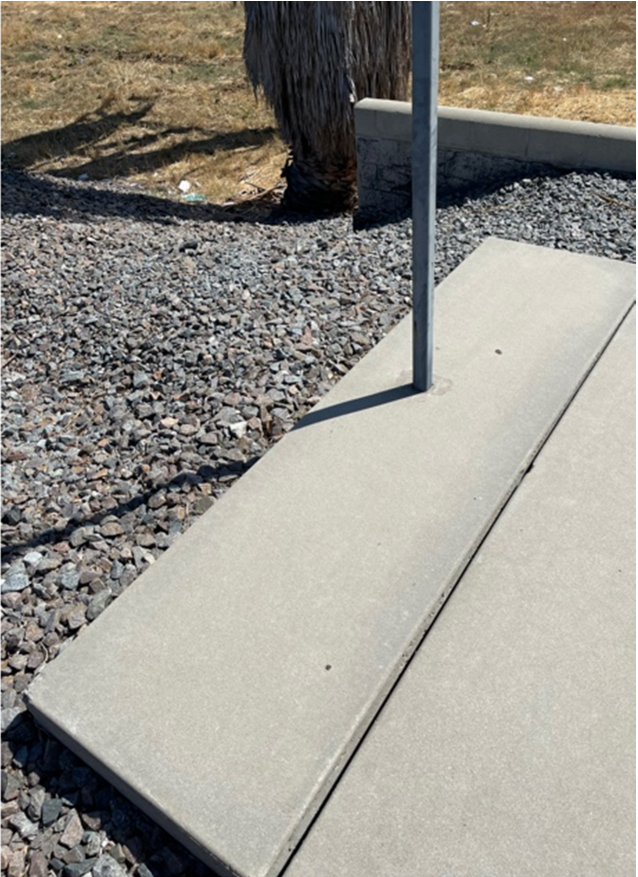
Issues/ Barrier Identified	Recommendations	Comments/ ADA Requirements
<p>ii. Drop off at the edges of pedestrian crossing landing exceeds 4 inches. This is not only a CA building code violation, but also and a fall hazard.</p>

<p>Provide required correction (6 inch high curb) or a preventive barrier per DIB 82-06 4.3.11 and Title 24 11B-303.5</p>	<p>DIB 82-06 4.3.11: (1) Abrupt changes in level exceeding 4 inches in a vertical dimension between walks, sidewalks or other pedestrian ways and adjacent surfaces or features shall be identified by warning curbs at least 6 inches in height above the walk or sidewalk surface. Exception: a warning curb is not required between a walk or sidewalk and an adjacent street or driveway. [Title 24 11B-303.5 including Exception #1]</p>
<p>iii. Trip hazards exist at asphalt and concrete interface at the track crossing.</p>

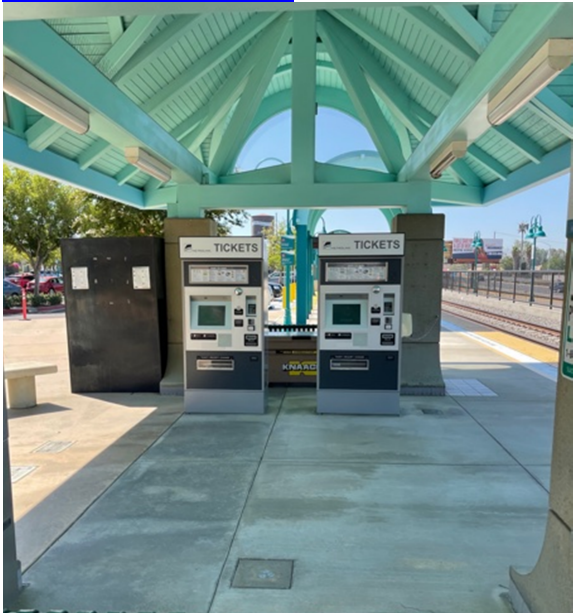
Issues/ Barrier Identified	Recommendations	Comments/ ADA Requirements
6. Amenities		
a) TVM's		
<p>TVM's are not in RCTC's scope. However, they are considered as being compliant to ADA requirements per information found on website https://metrolinktrains.com/ticketsOverview/where-to-buy/ticket-machines/</p>

<p>Adequate clear space is provided at TVM's. No action.</p>

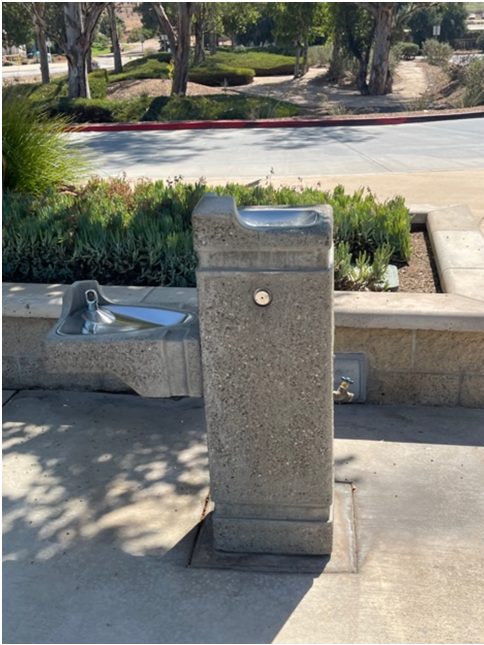
b) Drinking Fountains		
<p>Drinking Fountain: Water flow to be tested</p>

<p>Adjust water flow.</p>	<p>602.6 Water Flow. The spout shall provide a flow of water 4 inches (100 mm) high minimum and shall be located 5 inches (125 mm) maximum from the front of the unit. The angle of the water stream shall be measured horizontally relative to the front face of the unit. Where spouts are located less than 3 inches (75 mm) of the front of the unit, the angle of the water stream shall be 30 degrees maximum. Where spouts are located between 3 inches (75 mm) and 5 inches (125 mm) maximum from the front of the unit, the angle of the water stream shall be 15 degrees maximum.</p>

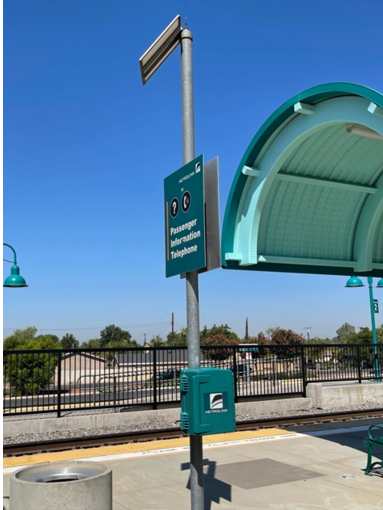
Issues/ Barrier Identified	Recommendations	Comments/ ADA Requirements
c) Telephones/ Communication Systems	See Attachment 9, Action Plan for recommendations	Clear space and reach ranges are found to be compliant. All instruments are to be tested regularly for compliance by the responsible authorities.
<div>i. Passenger Information Phone: Clear space and reach ranges are found to be compliant</div> <div>

</div>		
<div>ii. Blue Emergency Phone. Not applicable at this station.</div>		
<div>iii. Yellow call boxes: No issues found. One of the two phones is on an accessible route.</div> <div>

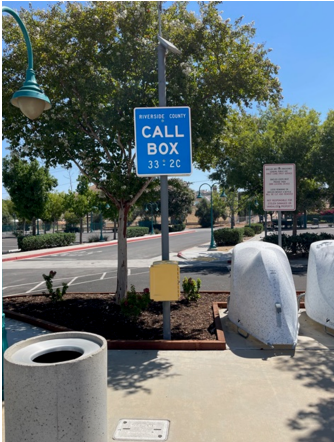
Issues/ Barrier Identified	Recommendations	Comments/ ADA Requirements
d) Trash cans		
<div>No issues found with the height of trash cans</div> <div>

</div>	No action by RCTC

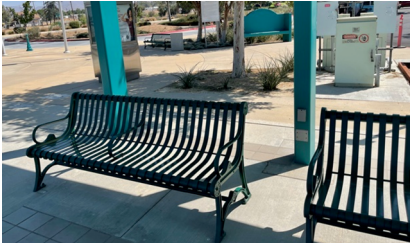
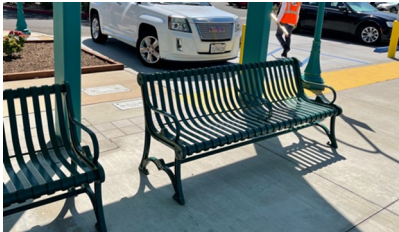
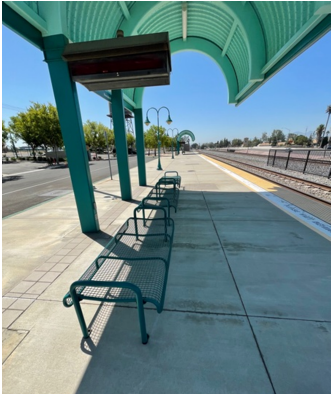
</div> <div>Sheltered waiting area at entrance does not have clear space adjacent to the 50% of benches (with back support) under the shelter.</div>	<div>Relocate bench to provide clear space adjacent to that bench.</div> <div>Recommend providing some benches with back support on platforms</div>	<div>

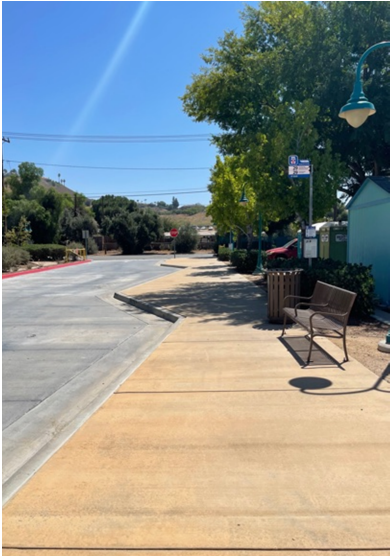
Issues/ Barrier Identified	Recommendations	Comments/ ADA Requirements
<p>8. Bus Stop</p> <p>No issues found. Movement/weathering of concrete pavement may cause trip hazards and requires routine inspection and maintenance.</p>

<p>Maintain accessible routes to permit safe ambulation to all stops.</p>	
<p>9. Signage</p> <p>a) Post mounted signs in the accessible route were evaluated to confirm minimum/ maximum projections and minimum clearances from the finished floor. Standard station signage is required to comply with SCRRRA /Metrolink standard details (ES 3000) found at this link. https://metrolinktrains.com/globalassets/about/engineering/3000-stations.pdf</p>	<p>No action BY RCTC. Signage is by SCRRRA/Metrolink</p>	<p>810.6 Rail Station Signs. Rail station signs shall comply with 810.6. EXCEPTION. Signs shall not be required to comply with 810.6.1 and 810.6.2 where audible signs are remotely transmitted to hand-held receivers, or are user- or proximity-actuated.</p> <p>SCRRRA/Mertolink is responsible for the signage.</p>

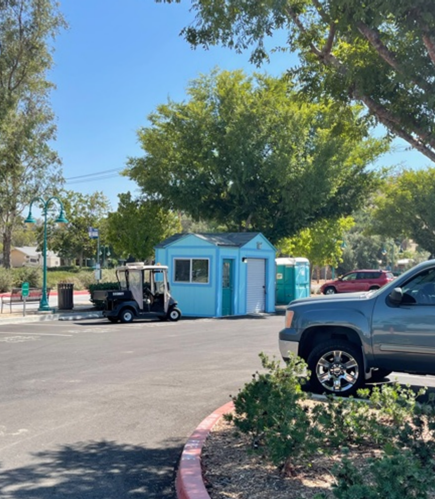
Issues/ Barrier Identified	Recommendations	Comments/ ADA Requirements
11. Staff Facilities		
a) Security Staff Facilities		
<p>The guard booth is provided as a shelter against weather and for use during breaks by security staff, who are expected to walk around the station site and physically address emergency situations.</p>

<p>Inform all contractors of their ADA obligations</p>	<p>Station Security services are contracted out and an ADA evaluation of the facilities used by the station security was not conducted as it is not Public Accessible and the Security Contractor requirements require the guards to be able to walk around the station site and physically address emergency situations.</p>

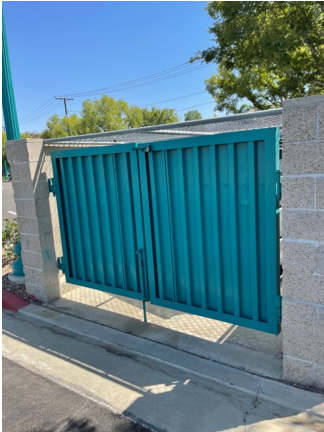
b) <u>Trash / Dumpster Enclosure</u>		
<p>The trash dumpster is not on an ADA compliant route and gate does not appear to be accessible.</p>

<p>Provide accessible dumpster enclosure on an accessible route.</p>	<p>203.9 Employee Work Areas. Spaces and elements within employee work areas shall only be required to comply with 206.2.8, 207.1, and 215.3 and shall be designed and constructed so that individuals with disabilities can approach, enter, and exit the employee work area.</p>
