# Evaluation of Physical Barriers- Hunter Park Station

Address: Hunter Park Metrolink Station, CA 92507

Evaluation Date: 08-03-2021

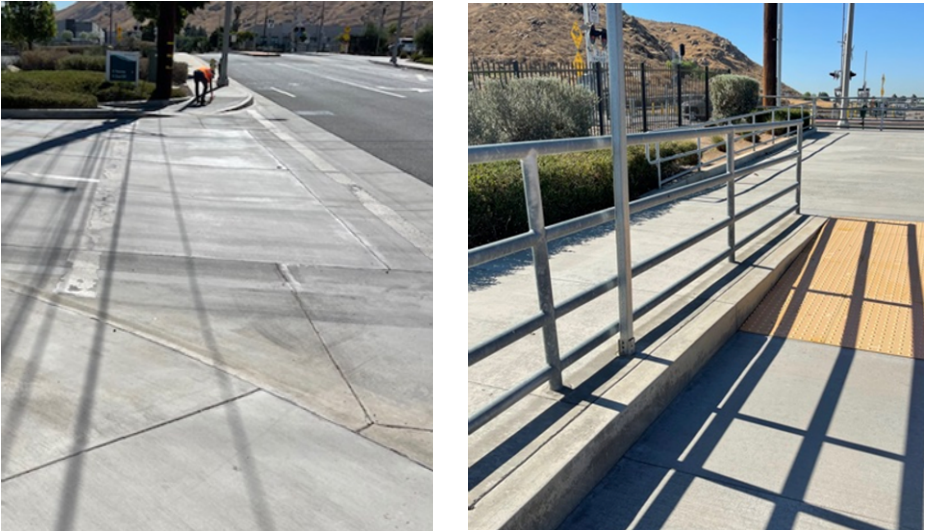
Issues/ Barriers Identified	Recommendations	Comments/ ADA Requirements
<div>1. Curb Ramps</div> <div>1a, 1b OK 1c, 1d -OK 2a, 2b- OK 3a, 3b, 4a, 4b- (Not in RCTC's scope. Detectable Warning Surface (DWS) is missing. 5a, 5b, 5c- OK (Handrail on one side only at 5b) 6a, 6b- OK 6c 6d OK</div> <div><div>3a,3b</div><div>5b</div><div>

</div></div>	<div>No action.</div> <div>At 3a, 3b, 4a and 4b, City to apply missing Detectable Warning Surfaces as per applicable DOT/ FHWA/Caltrans requirements and R208, PROWAG</div> <div>5b – No action.</div>	<div>Ramps at 5a and 5c have a rise more than 6 inches. No handrails are provided. Ramp at 5b is 198 inches wide with a 6% slope. The railing is provided only on one side. This is still compliant with PROWAG R409 for exterior pedestrian circulation paths.</div> <div><b>R208 Detectable Warning Surfaces (DWS)</b> R208.1 Where Required Detectable warning surfaces complying with R305 shall be provided at the following locations on pedestrian access routes and at transit stops: Curb ramps and blended transitions at pedestrian street crossings; Pedestrian refuge islands; Pedestrian at-grade rail crossings not located within a street or highway; Boarding platforms at transit stops for buses and rail vehicles where the edges of the boarding platform are not protected by screens or guards; and Boarding and alighting areas at sidewalk or street level transit stops for rail vehicles where the side of the boarding and alighting areas facing the rail vehicles is not protected by screens or guards</div> <div>This evaluation does not include curb ramps outside the RCTC boundary. RCTC is not responsible for maintaining the accessible routes outside of RCTC boundary.</div> <div>When repairs begin, use proper and precise instruments (4-foot smart level and 2-foot smart level) to fit within the curb ramp width and the adjacent gutter to measure ramp slopes, cross slopes, and counter slopes at all curb ramps (all stations). The long slope of ramp shall not exceed 1:12 (8.33%). Slope of flared sides shall not exceed 1:10 (10%), the gutter slope shall not exceed 1:20 (5%). Cross slope of the ramp and landing shall not exceed 1:50 (2%)</div> <div>Use smart level instruments, calibrated in accordance with manufacturer's instructions before taking measurements.</div>

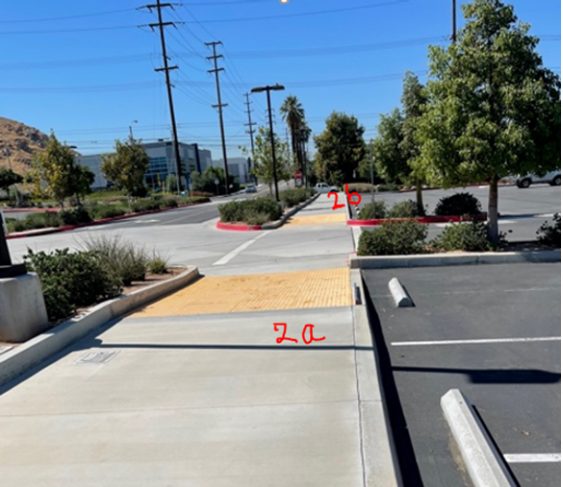
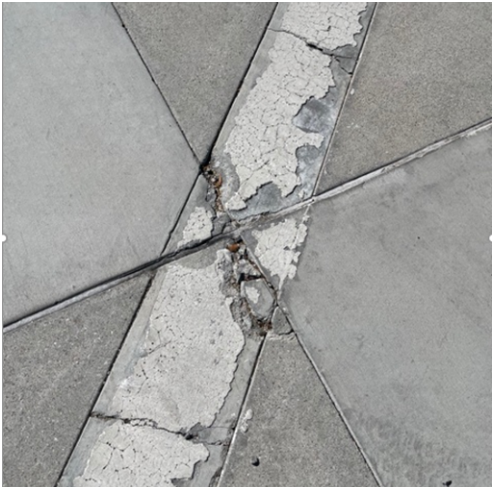
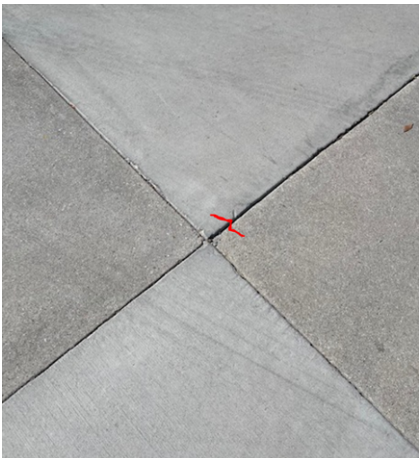
Issues/ Barriers Identified	Recommendations	Comments/ ADA Requirements
<p><b>2. Pedestrian Road crossings</b></p> <p>Pedestrian crossing at 2a, 2b has cracks, level changes more than ¼" high, and gaps in excess of ½" wide and ¼" deep.</p>

<p>Examine all pedestrian crossings and repair all cracks.</p> <p>Every joint in concrete deeper than ¼" and wider than ½" shall be filled.</p> <p>Every level change along the accessible route greater than ¼" and less than ½" height needs to be beveled (1:2) slope or repaired.</p> <p>Every level change greater than ½" needs to have a ramped surface (1:12) slope.</p>

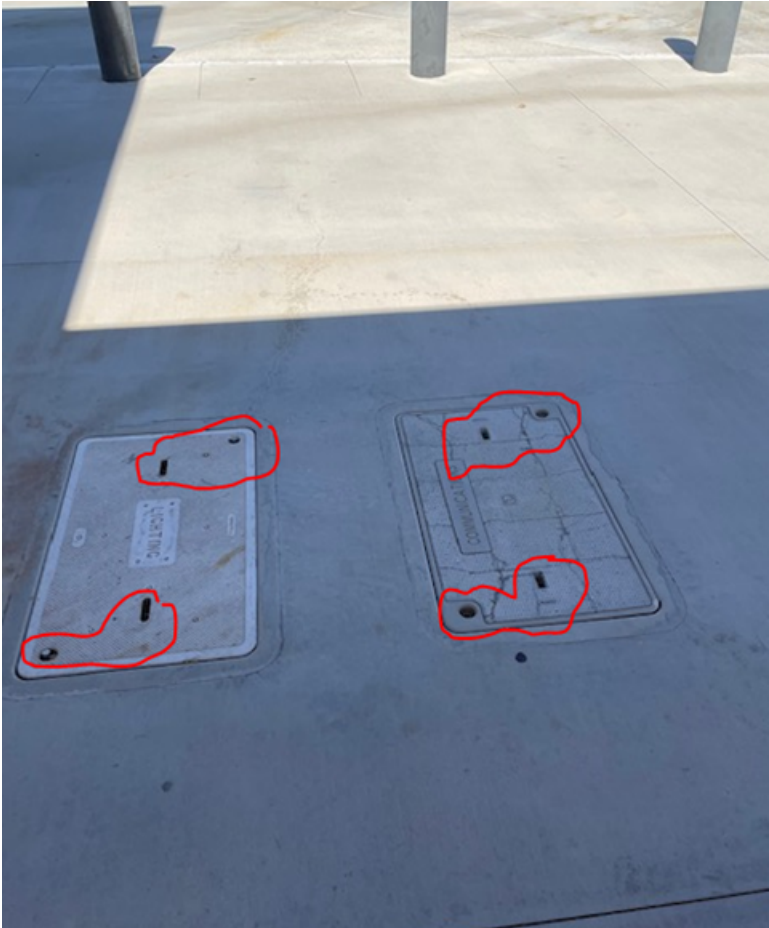
Issues/ Barriers Identified		Recommendations	Comments/ ADA Requirements
ii. Utility covers have gaps/openings wider than 1/2" and deeper than 1/4"

Close gaps and openings wider than 1/2" and deeper than 1/4", and, remove trip hazards in the accessible route or replace with ADA complaint covers.	Same as item 2 above
<b>4. Platforms</b>			
a. Walking Surfaces			
i. General: Joints and gaps in concrete to be maintained for compliance with 302.3, 303.2, and 303.3.		<p>Examine all pedestrian crossings and repair all cracks.</p> <p>Every joint in concrete deeper than 1/4" and wider than 1/2" shall be filled.</p> <p>Every level change along the accessible route greater than 1/4" and less than 1/2" height needs to be beveled (1:2) slope or repaired.</p> <p>Every level change greater than 1/2" needs to have a ramped surface (1:12) slope.</p>	Same as item 2 above

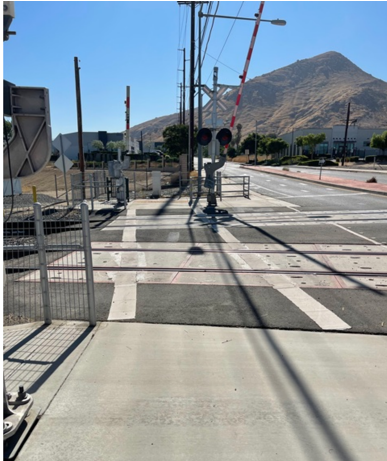
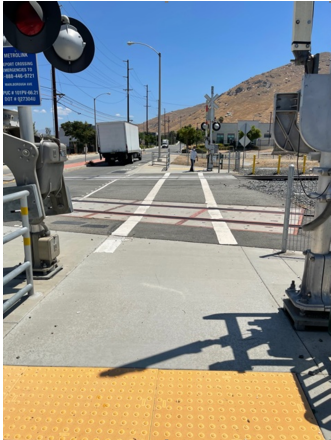
</div> <div><b>1a/1b</b> At 1a/1b the wheel flangeway filler is placed outside of the marked crossing. The flange gap in the marked crossing exceeds 2 ½”</div>	<div>Clarify that the accessible route is within the marked crossing directly in front of the DWS.</div> <div>Examine and repair gaps at all track crossings.</div> <div>Replace flangeway fillers to allow the wheel flange gap to be no greater than 2½” wide within the marked crossing.</div>	<div>

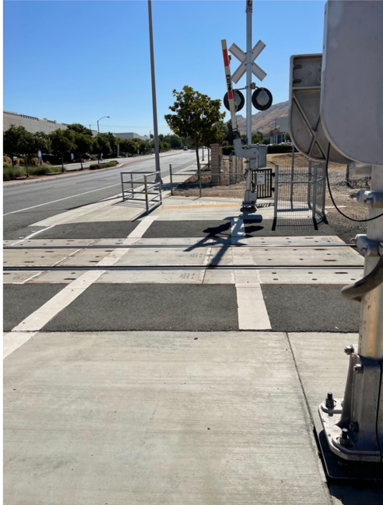
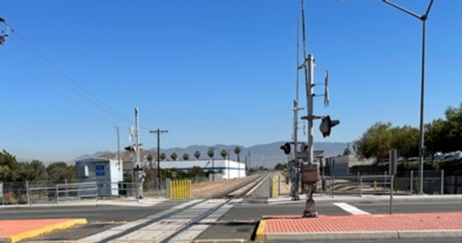
</div> <div><b>6a/6b</b></div> <div><b>6c/6d</b></div>	<div>Examine and repair gaps at all track crossings.</div> <div>Flangeway filler needs to be replaced/maintained regularly to make sure that gap measures no greater than 2½”.</div>	<div>Cross slope is less than 2% at all crossings, which is compliant.</div>

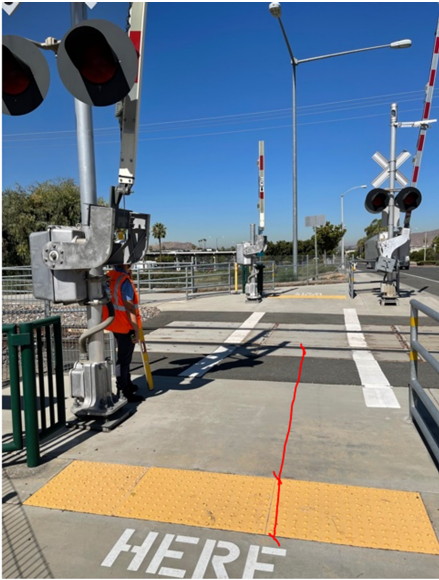
Issues/ Barriers Identified	Recommendations	Comments/ ADA Requirements
<p>b. Placement of the DWS exceeds the allowed 15 feet maximum and does not comply with PROWAG R305.2.5</p>

<p>Add additional DWS to comply with requirements.</p> <p>Examine the distance of the DWS at all track crossings and provide compliant placement, depth, and width.</p>	<p><b>R305.2.5 Pedestrian At-Grade Rail Crossings</b> <a href="#">↗</a></p> <p>At pedestrian at-grade rail crossings not located within a street or highway, detectable warning surfaces shall be placed on each side of the rail crossing. The edge of the detectable warning surface nearest the rail crossing shall be 1.8 m (6.0 ft) minimum and 4.6 m (15.0 ft) maximum from the centerline of the nearest rail. Where pedestrian gates are provided, detectable warning surfaces shall be placed on the side of the gates opposite the rail.</p> <p><b>Figure R305.2.5 Pedestrian At-Grade Rail Crossings</b></p>

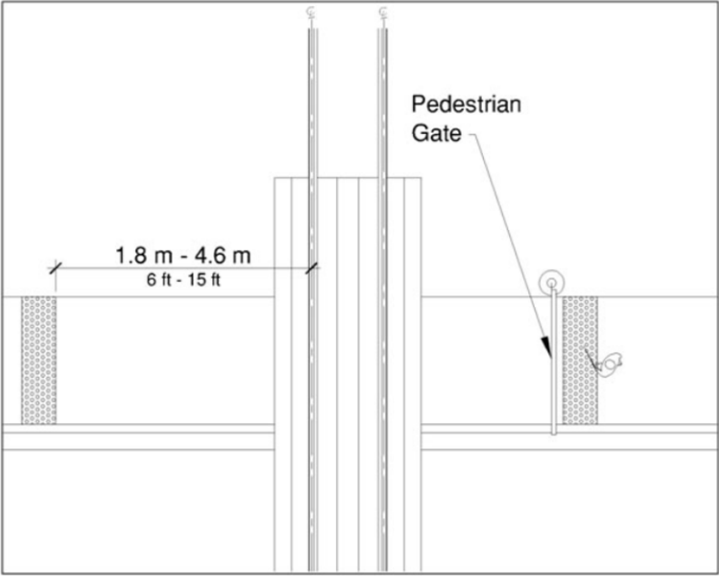
<p>c. DWS appears to not extend 36 inches in the direction of travel. 24 inches is allowed per 2010 ADA Standards</p>	<p>Examine DWS at all track crossing locations and provide 36 inches wide DWS, located no more than 15 feet from center of nearest track in accordance with DIB-82-06 per Caltrans</p>	<p><b>DIB-82—06 4.3.14:</b> Detectable warning surfaces shall extend 3 feet in the direction of pedestrian travel.</p>
<p>d. Level changes in excess of ¼” were observed in the asphalt adjacent to the crossing, creating a trip hazard.</p>	<p>Remove trip hazards on all accessible routes.</p>

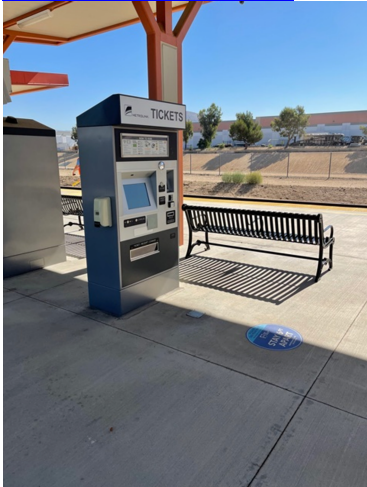
Issues/ Barriers Identified	Recommendations	Comments/ ADA Requirements
<b>6. Amenities</b>		
a) TVM's		
<p>TVM's are not in RCTC's scope. However, they are considered as being compliant to ADA requirements per information found on website <a href="https://metrolinktrains.com/ticketsOverview/where-to-buy/ticket-machines/">https://metrolinktrains.com/ticketsOverview/where-to-buy/ticket-machines/</a></p>

<p>Adequate clear space is provided at TVM's. No action.</p>

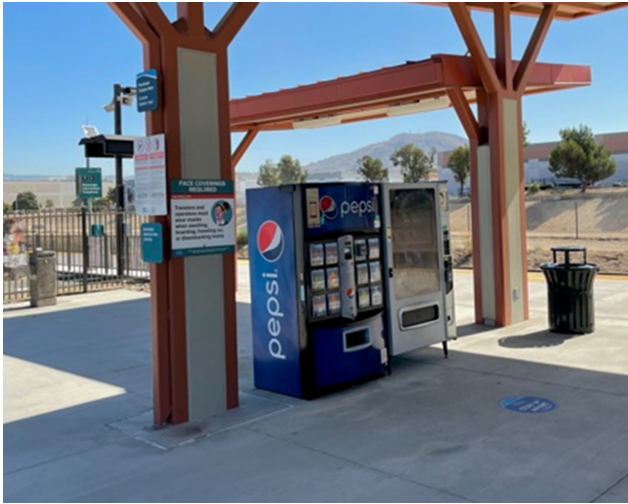
b) Drinking Fountains		
<p>Drinking Fountain: Water flow to be tested</p>

<p>Adjust water flow.</p>	<p>602.6 Water Flow. The spout shall provide a flow of water 4 inches (100 mm) high minimum and shall be located 5 inches (125 mm) maximum from the front of the unit. The angle of the water stream shall be measured horizontally relative to the front face of the unit. Where spouts are located less than 3 inches (75 mm) of the front of the unit, the angle of the water stream shall be 30 degrees maximum. Where spouts are located between 3 inches (75 mm) and 5 inches (125 mm) maximum from the front of the unit, the angle of the water stream shall be 15 degrees maximum.</p>

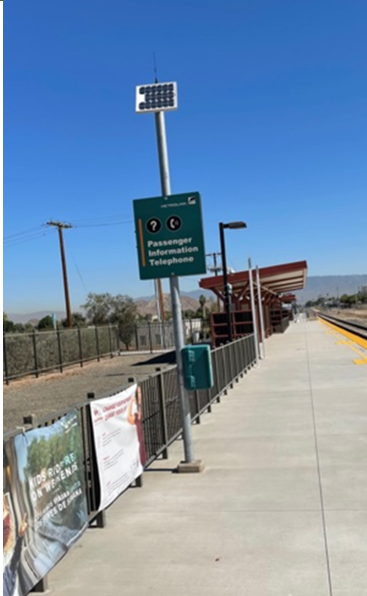
i. Passenger Information Phone:		No action by RCTC	<p>704.2.1 Clear Floor or Ground Space. A clear floor or ground space complying with 305 shall be provided. The clear floor or ground space shall not be obstructed by bases, enclosures, or seats.</p> <p>704.2.2 Operable Parts. Operable parts shall comply with 309. Telephones shall have push-button controls where such service is available.</p>

No action by RCTC

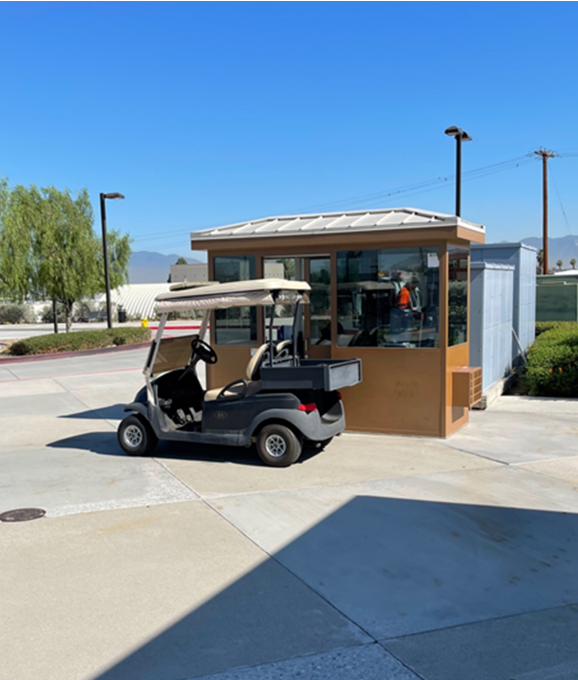
a) Security Staff Facilities		
<p>The guard booth is provided as a shelter against weather and for use during breaks by security staff, who are expected to walk around the station site and physically address emergency situations.</p>

Inform all contractors of their ADA obligations	Station Security services are contracted out and an ADA evaluation of the facilities used by the station security was not conducted as it is not Public Accessible and the Security Contractor requirements require the guards to be able to walk around the station site and physically address emergency situations.
