Evaluation of Physical Barriers – West Corona Station

Address: 155 Auto Center Dr, Corona, CA 92880

Evaluation Date: 07-27-2021

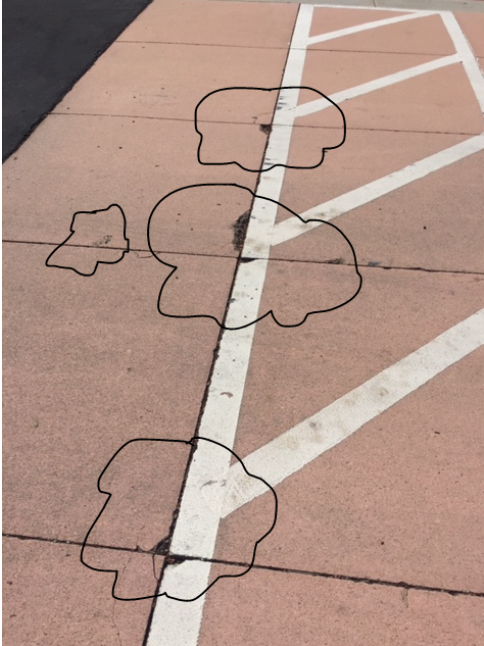
Issues/Barriers Identified	Recommendations	Comments
2. Pedestrian Road crossings Pedestrian crossing at 3a, 3b has multiple cracks and gaps in excess of ½” wide and ¼” deep.

<p>Examine all pedestrian crossings and repair all cracks.</p> <p>Every joint in concrete deeper than ¼” and wider than ½” shall be filled.</p> <p>Every level change along the accessible route greater than ¼” and less than ½” height needs to be beveled (1:2) slope or repaired.</p> <p>Every level change greater than ½” needs to have a ramped surface (1:12) slope.</p>	See item 3a
a) Pedestrian Push Button- Not Applicable	No action by RCTC

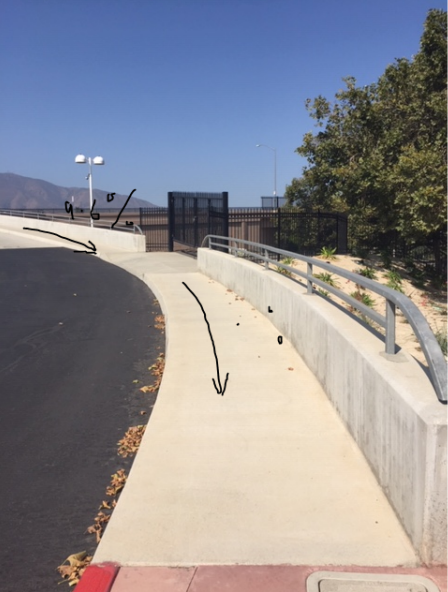
<p>i) and ii)</p>

Issues/Barriers Identified	Recommendations	Comments
3. Accessible Routes		
a) Walking surface		
<p>i. From curb ramp 5a, a sidewalk entering the facility is provided. The slope of the sidewalk is measured as 9.6% which matches the grade of the road but exceeds the maximum allowed slope for accessible ramps.</p> <p>ii. A vehicular ramp into the gated areas is perpendicular to the sidewalk described above. This causes a steep drop and excessive cross slope for the already steeply sloping sidewalk.</p> <p>iii. General: There are uneven joints and cracks observed in the concrete on the platforms and along accessible route. Sealant/filler in some deep joints is missing. This causes trip hazards and creates openings deeper than ¼” and wider than ½ inch that do not comply with 302.3 and 303.3. (Figure on previous page)</p> <p>iv. Manhole covers create trip hazards and have gaps/openings wider than ½ inch.</p> <p>v. Signage designating the accessible route is missing at main entry.</p>	<p>i) The grade of the sidewalk along the road complies with the requirements of City of Corona, DIB-82-06 and PROWAG if the ramp is considered a public street. If the ramp is considered to be an entry to private property, then these requirements are not applicable, and this ramp is considered out of compliance.</p> <p>RCTC being a public agency, it can be assumed that the commuter rail stations owned by RCTC would be public property. It is recommended prior to initiating any repairs on the ramp, that this issue be reviewed by an ADA legal expert to determine final resolution.</p> <p>ii) Same as above. An alternate accessible route is required.</p> <p>iii) and iv) Repair all level changes. Close gaps and openings wider than ½” and deeper than ¼”, and remove trip hazards in the accessible route.</p> <p>v) Provide signage designating the accessible route.</p>	<div>

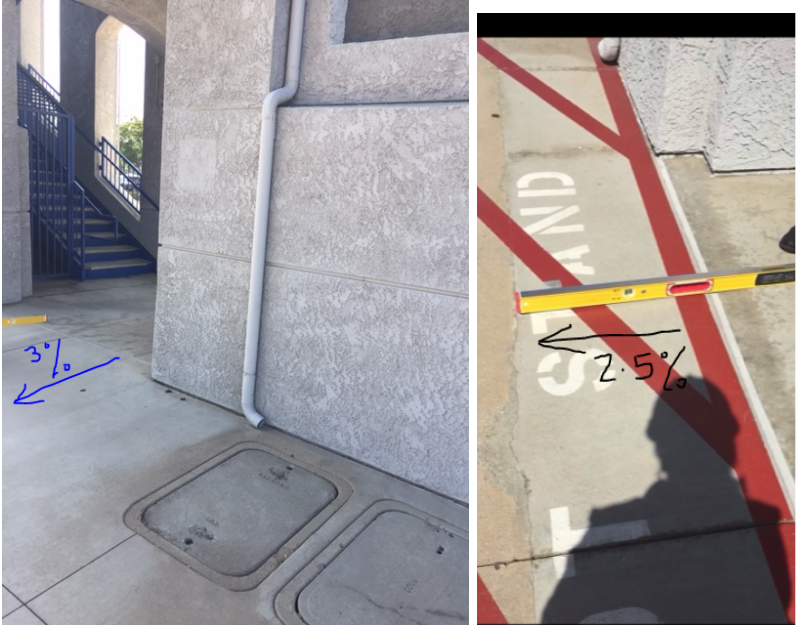
Issues/Barriers Identified	Recommendations	Comments
No ramps. No issues found	No action by RCTC	
4. Platforms		
a) Walking Surfaces		
<div><div>i. On both sides, the route from the elevator lobby slopes 2.5 % or 3% towards the platform. So, the cross slope of the platform exceeds 2% in this portion creating a barrier for people having disabilities traveling along this route.</div><div>

</div></div>	<div><div>An accessible route (at least 36 inches wide, but preferably 48 inches wide) with compliant cross slopes should be provided and marked. If a path cannot be demarcated, cross slopes need to be repaired.</div><div>

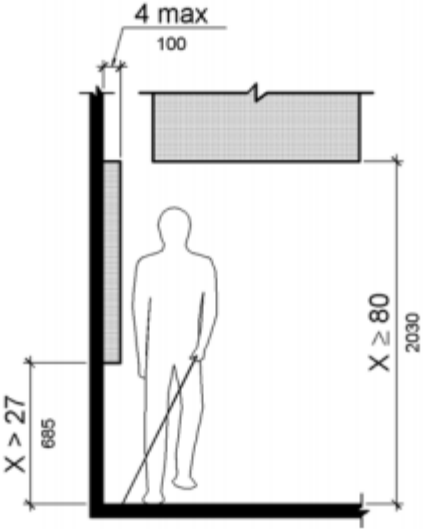
<div><div>ii. Downspouts protrudes in the accessible circulation path</div></div>	<div><div>Provide 48 inches wide accessible path with a compliant cross slope, clear of the downspout.</div></div>	<div><div>

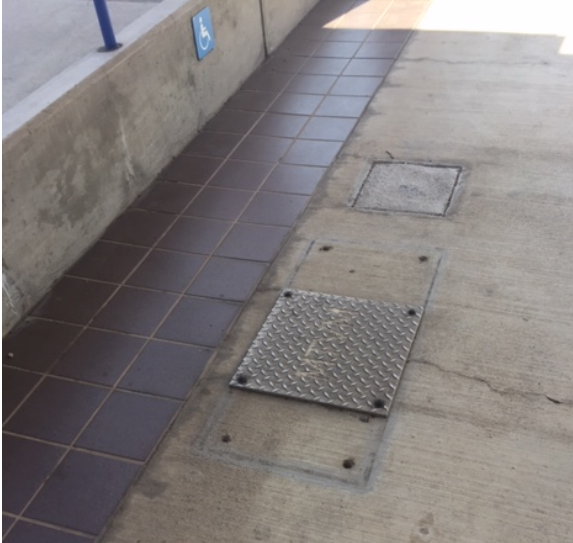
Issues/Barriers Identified	Recommendations	Comments
<p>iii. Downspouts will discharge water onto the accessible route.</p>	<p>Ensure that the rainwater will drain away and will not pond. Eliminate any low spots or uneven pavement. To ensure compliance with 405.10, Wet Conditions, Landings subject to wet conditions shall be designed to prevent the accumulation of water, ensure that the area is in compliance with 403.3 Slope.</p>	<p>405.10 Wet Conditions. Landings subject to wet conditions shall be designed to prevent the accumulation of water.</p>
<p>iv. A trip hazard is created due to a diamond plate cover behind the west mini high platform on track 2</p>

<p>Remove and replace with a recessed cover</p>	
<p>v. Cross slope on Track 1 platform near the west mini high platform exceeds 2%</p>

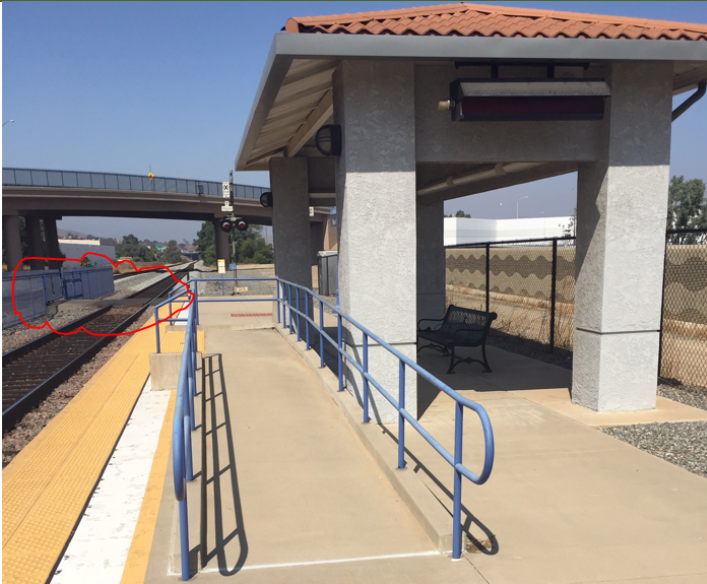
No action by RCTC	Rail crossing at this station is not on an accessible route and is not meant for public use during normal conditions
6. Amenities			
a) TVM's			
<p>TVM's are not in RCTC's scope. However, they are considered as being compliant to ADA requirements per information found on website https://metrolinktrains.com/ticketsOverview/where-to-buy/ticket-machines/</p>

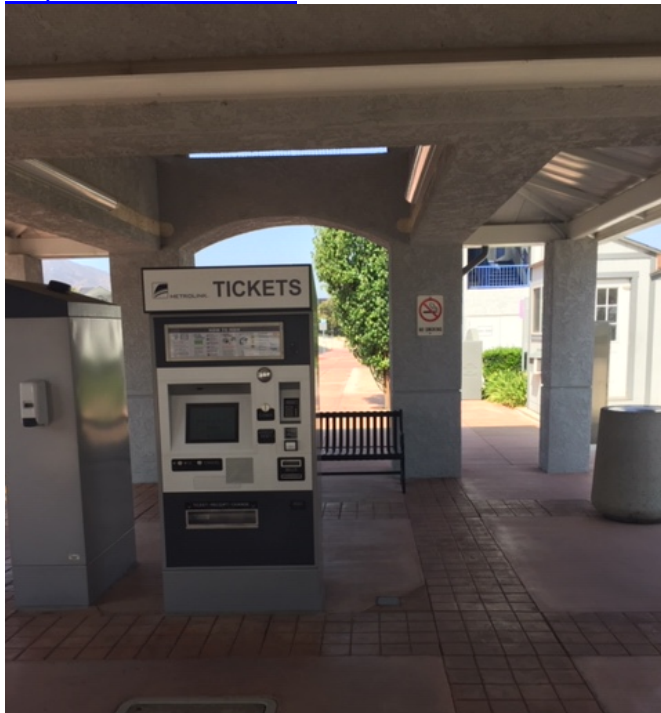
Adequate clear space is provided at TVM's. No action.

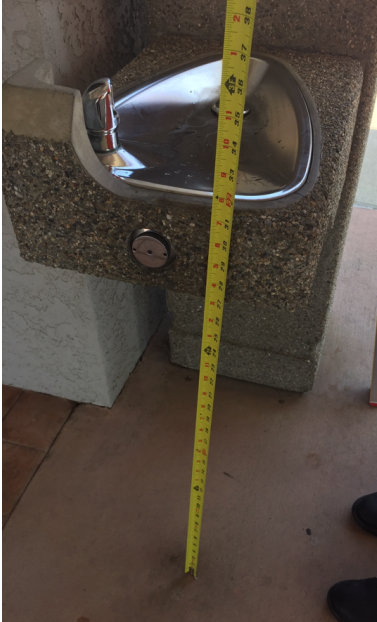
Issues/Barriers Identified	Recommendations	Comments
<p>b) Drinking Fountains</p> <p>Drinking Fountain: Water flow to be tested</p>

Adjust water flow.	<p>602.6 Water Flow. The spout shall provide a flow of water 4 inches (100 mm) high minimum and shall be located 5 inches (125 mm) maximum from the front of the unit. The angle of the water stream shall be measured horizontally relative to the front face of the unit. Where spouts are located less than 3 inches (75 mm) of the front of the unit, the angle of the water stream shall be 30 degrees maximum. Where spouts are located between 3 inches (75 mm) and 5 inches (125 mm) maximum from the front of the unit, the angle of the water stream shall be 15 degrees maximum.</p>

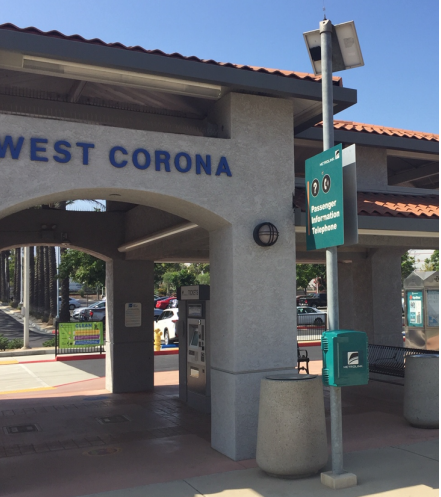
c) Telephones/ Communication Systems	See Attachment 9, Action Plan for recommendations	Clear space and reach ranges are found to be compliant. All instruments are to be tested regularly for compliance by the responsible authorities.
<p>i. Passenger Information Phone:</p>

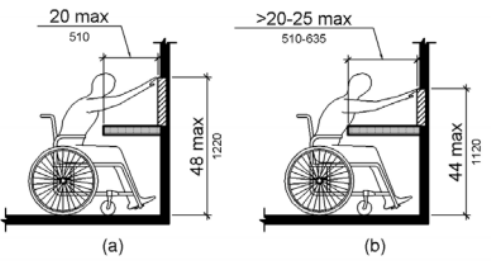
<p>Figure 308.2.2 Obstructed High Forward Reach</p> </div> </div>

ii. Blue Emergency Phone. Not applicable at this station.		
iii. Yellow call boxes: In the parking area these phones are not on an accessible route.	Provide accessible emergency phones on the accessible route also.

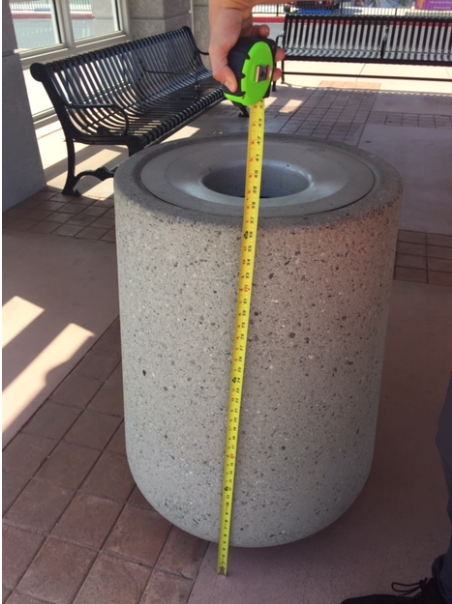
Issues/Barriers Identified	Recommendations	Comments
<p>d) Trash cans</p> <p>Trash cans are not accessible due to being 36 inches tall where the opening is located more than 10 inches from the edge.</p>

<p>Provide 34 inches high accessible trash cans allowing reach ranges per 308.3.2</p>

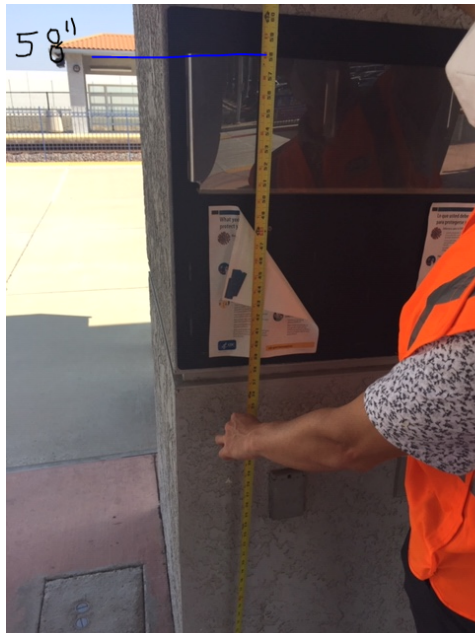
Issues/Barriers Identified	Recommendations	Comments																																																				
<div>g) Rack for Flyers</div> <div>The rack for flyers and brochures is mounted too high at 58 inches.</div> <div>

</div>	<div>Relocate the holder no more than 48 inches high.</div>	<div>

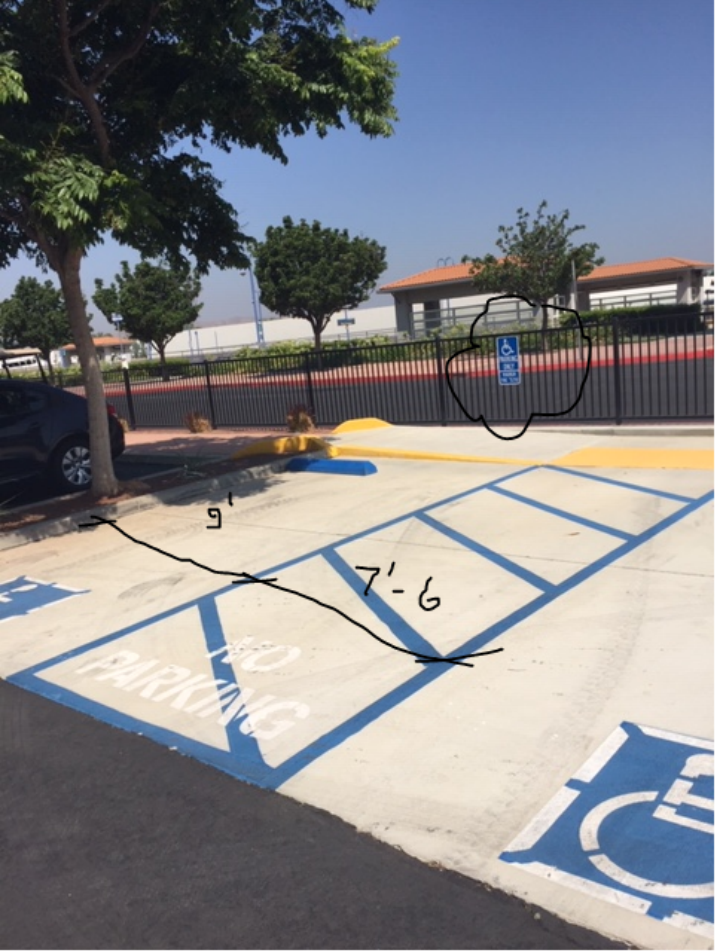
Issues/Barriers Identified	Recommendations	Comments
<p>i. Size of van accessible parking aisles does not comply with the 96" (8 ft) minimum requirement per 502.2 and DIB 82-06. The parking stall is 9 feet wide. The parking aisle is non compliant with 2010 standards for van accessible spaces.</p>

<p>Restripe as required to provide the required sizes and required number of accessible parking.</p>	<p>parking space or access aisle.</p> <p>502.2 Vehicle Spaces. Car parking spaces shall be 96 inches (2440 mm) wide minimum and van parking spaces shall be 132 inches (3350 mm) wide minimum, shall be marked to define the width, and shall have an adjacent access aisle complying with 502.3.</p> <p>EXCEPTION: Van parking spaces shall be permitted to be 96 inches (2440 mm) wide minimum where the access aisle is 96 inches (2440 mm) wide minimum.</p>

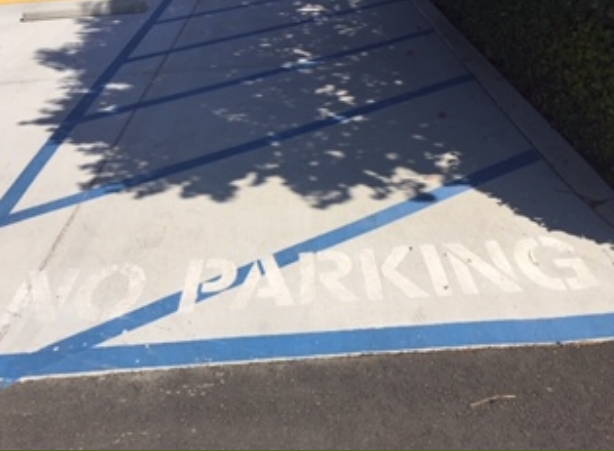
Issues/Barriers Identified	Recommendations	Comments
<p>iii. White colored “NO PARKING” letters on the light concrete surface of access aisles do not offer a visual contrast</p>

<p>It is a recommendation to rectify the visual contrast at text descriptors in parking aisles.</p>	<p>503.3.3 Marking. Access aisles shall be marked so as to discourage parking in them.</p> <p>703.5.1 Finish and Contrast. Characters and their background shall have a non-glare finish. Characters shall contrast with their background with either light characters on a dark background or dark characters on a light background.</p> <p>Advisory 703.5.1 Finish and Contrast. Signs are more legible for persons with low vision when characters contrast as much as possible with their background. Additional factors affecting the ease with which the text can be distinguished from its background include shadows cast by lighting sources, surface glare, and the uniformity of the text and its background colors and textures</p>

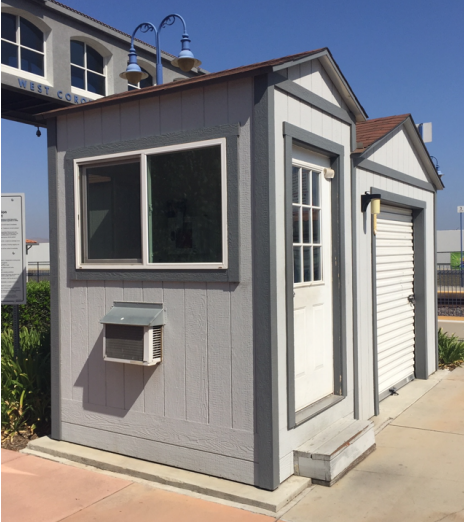
11. Staff Facilities		
a) Security Staff Facilities		
<p>The guard booth is provided as a shelter against weather and for use during breaks by security staff, who are expected to walk around the station site and physically address emergency situations.</p>

Inform all contractors of their ADA obligations	Station Security services are contracted out and an ADA evaluation of the facilities used by the station security was not conducted as it is not Public Accessible and the Security Contractor requirements require the guards to be able to walk around the station site and physically address emergency situations.

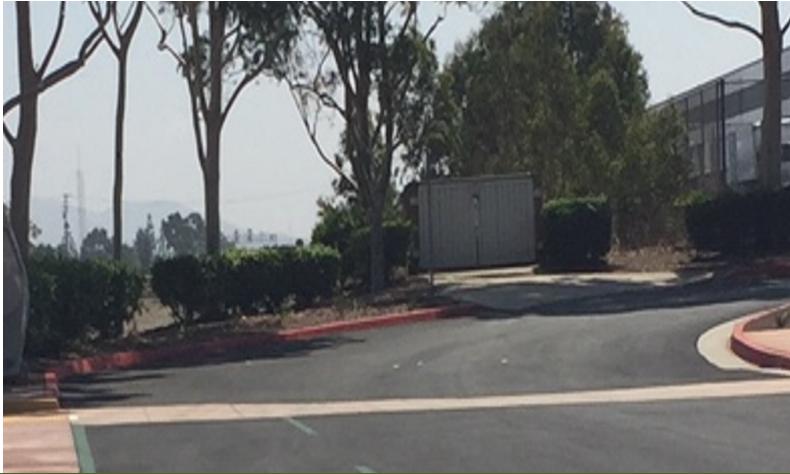
b) <u>Trash / Dumpster Enclosure</u>		
<p>The trash dumpster is not on an ADA compliant route and gate does not appear to be accessible.</p>

Provide accessible dumpster enclosure on an accessible route or provide reasonable accommodation for employees having disabilities.	<p>203.9 Employee Work Areas. Spaces and elements within employee work areas shall only be required to comply with 206.2.8, 207.1, and 215.3 and shall be designed and constructed so that individuals with disabilities can approach, enter, and exit the employee work area.</p> <p>1991 Standards. 4.1.1 (3) (3)* Areas Used Only by Employees as Work Areas. Areas that are used only as work areas shall be designed and constructed so that individuals with disabilities can approach, enter, and exit the areas. These guidelines do not require that any areas used only as work areas be constructed to permit maneuvering within the work area or be constructed or equipped (i.e., with racks or shelves) to be accessible</p>
