## **Evaluation of Physical Barriers - South Perris Station**

Address: South Perris Blvd, Perris, CA 92570

**RCTC ADA Self-Evaluation and Transition Plan - Attachment 6I** 01 July, 2022 These elements were assessed to identify any physical barriers:

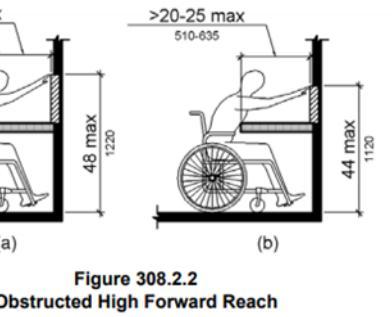
c) Telephones/ Communication Systems	See Attachment 9, Action Plan for recommendations	Clear space and reach ranges are found to be compliant. All compliance by the responsible authorities.

09. Telephones shall have push-button controls

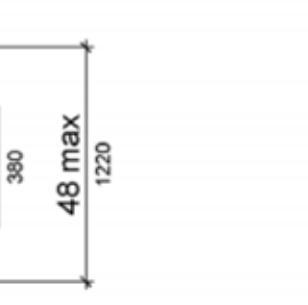
ucted, the high forward reach shall be 48 Il be 15 inches (380 mm) minimum above
