Riverside County Transportation Commission
ADA Transition Plan -
Fourth Year Update
June 2026

RCTC ADA Transition Plan - Fourth Year Update June 2026

Riverside County Transportation Commission
ADA Self- Evaluation and Transition Plan
Updated: June 2026

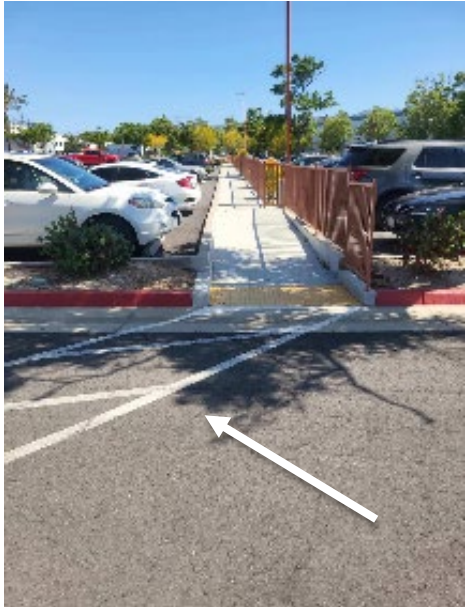
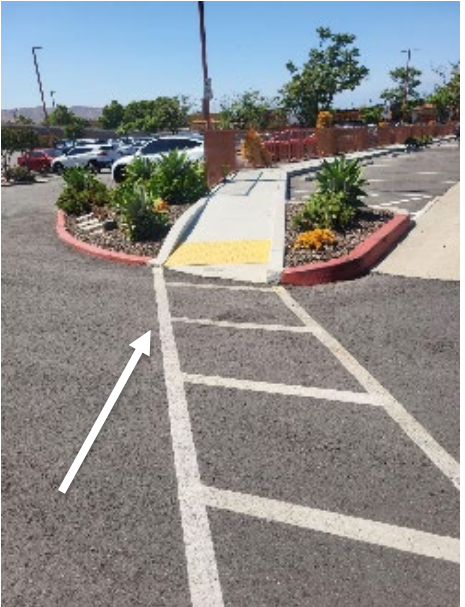
Facility/Area	Access Issue	Solution	Comments	Resolution Status
West Corona Station			See Attachment 6A for curb ramp locations, images of barriers, recommendations, and ADA requirements.	
1. Pedestrian Entry	The slope of the sidewalk at the pedestrian entry is measured at 9.6% which makes it an inaccessible route.	<ul style="list-style-type: none"> a. Provide an alternate accessible pedestrian entry route including five feet wide concrete sidewalk and marked road crossings b. Provide signage for the designated accessible route. 	An alternate route through the parking area is possible and should be considered.	<p>A. Complete</p> <p>An accessible path was constructed from the street to the parking lot. Measurements were taken and were compliant to ADA standards.</p> <div style="display: flex; justify-content: space-around;">

Facility/Area	Access Issue	Solution	Comments	Resolution Status
West Corona Station			See Attachment 6A for curb ramp locations, images of barriers, recommendations, and ADA requirements.	
				<p>B. Complete</p> <p>ADA signage installed along the designated accessible path.</p>

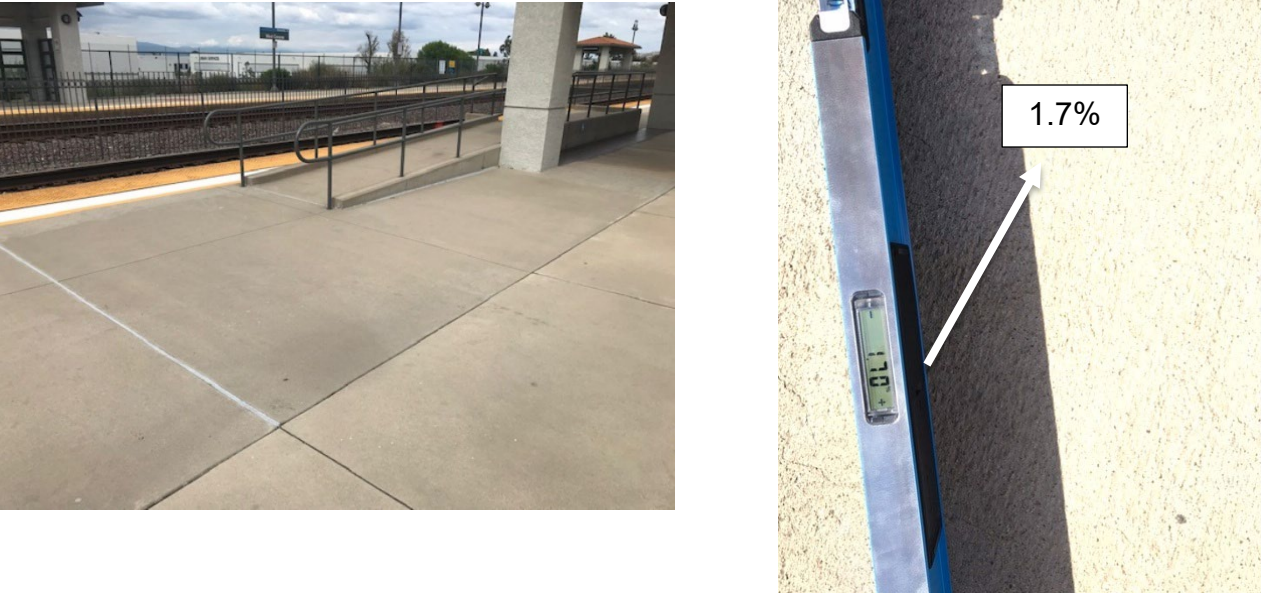
13. Platform	The cross slope of the platform, just outside the West mini-high platform exceeds 2% .	Repair cross slopes on accessible routes using grinding tools and/or levelling compounds.		<p>Complete</p> <p>Platform has been repaired for cross slope to meet ADA standards.</p>

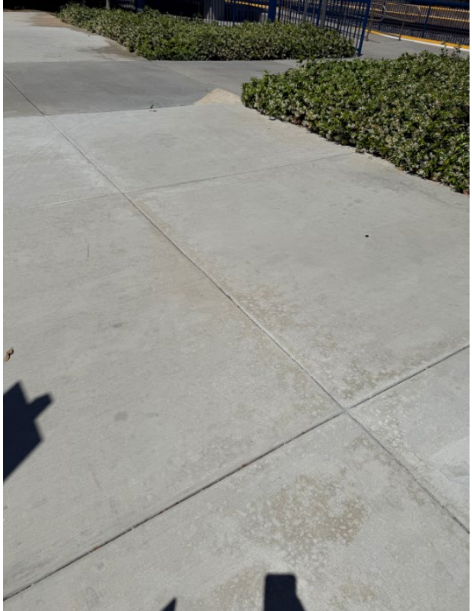
41.General Accessible Paths	There are uneven joints and cracks observed in concrete along the accessible route, and sealant/filler in deep joints is missing.	<p>Examine and repair accessible routes where there are uneven joints and cracks observed in concrete along the accessible route, and where sealant/filler in deep joints is missing.</p> <p>Every joint deeper than 1/4" and wider than 1/2" shall be filled with concrete and crack fillers as required.</p> <p>Every level change along the accessible route greater than 1/4" and less than 1/2" height needs to be</p>	Create a maintenance plan for ongoing routine inspections and repairs of all components of the accessible route.	<p>Complete</p> <p>Accessible paths have been reconstructed to meet ADA standards.</p> <div style="text-align: center;">

Facility/Area	Access Issue	Solution	Comments	Resolution Status
La Sierra Station			See Attachment 6C for curb ramp locations, images of barriers, recommendations, and ADA requirements.	
		beveled (1:2 slope) or repaired using grinding tools and/or levelling compounds. Every level change greater than ½” needs to have a ramped surface (1:12) slope .

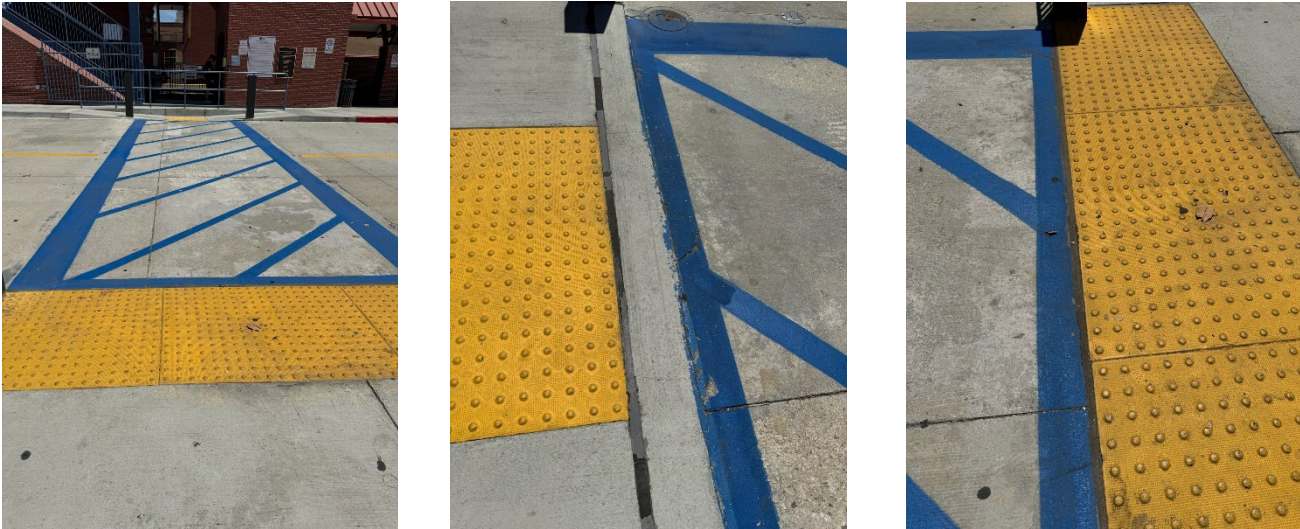
Facility/Area	Access Issue	Solution	Comments	Resolution Status
Riverside Downtown Station			See Attachment 6D for curb ramp locations, images of barriers, recommendations, and ADA requirements.	
		<p>and less than 1/2" height needs to be beveled (1:2 slope) or repaired using grinding tools and/or levelling compounds.</p> <p>Every level change greater than 1/2" needs to have a ramped surface (1:12) slope .</p>		<div style="display: flex; justify-content: space-around;">

</div> <p>ii. In Progress – Space around utility cover</p> <p>Planned completion: Winter 2026</p> <p>iii/iv. Complete – ADA accessible route cross slope of ramp. ADA access is accessible, cross slope confirmed to be ADA compliant.</p> <div style="display: flex; justify-content: space-around;">

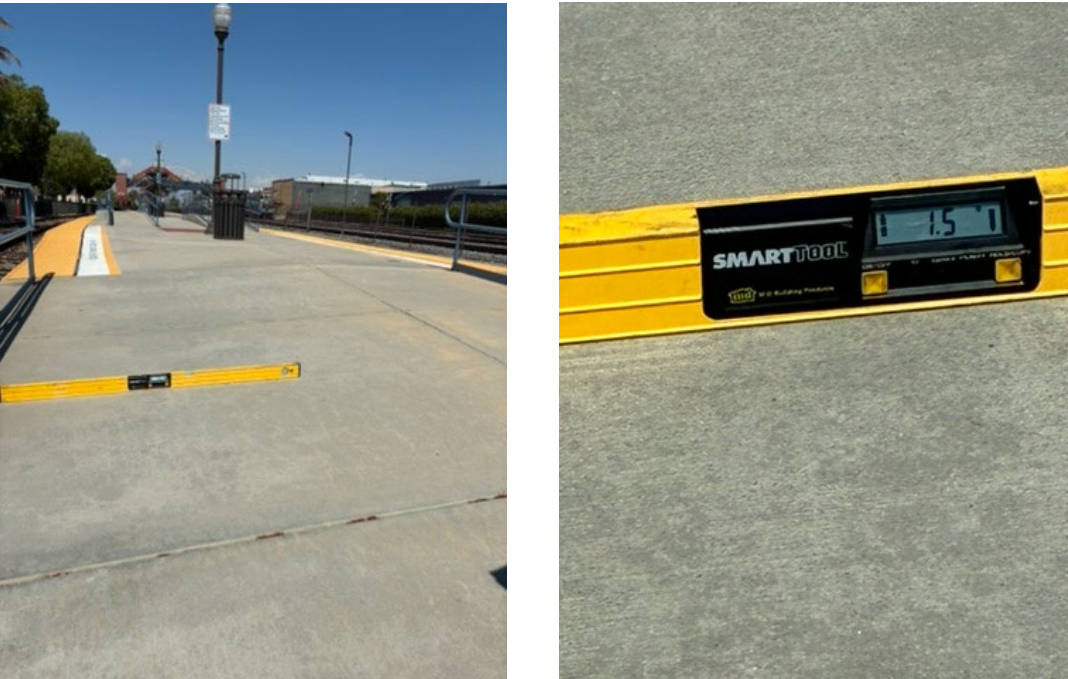
56. Platform	The wide ramp at rail crossing (towards SOC) has a cross slope exceeding 2% (3.3%)	Repair cross slope or provide new ramp if required. Apply DWS.		<p>Complete</p> <p>Platform ramps have been repaired to meet ADA standards.</p>

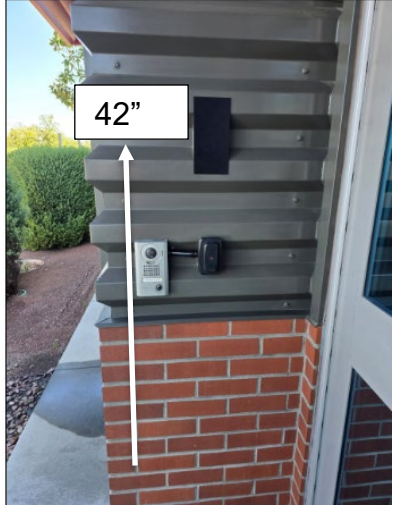
63. Staff Facility- SOC	Entrance Call Button for Telephone is higher than 48 inches and not compliant with the reach range requirements.	Replace with a compliant system with operable parts no higher than 48 inches		Complete Entrance call button has been adjusted to meet ADA standards.

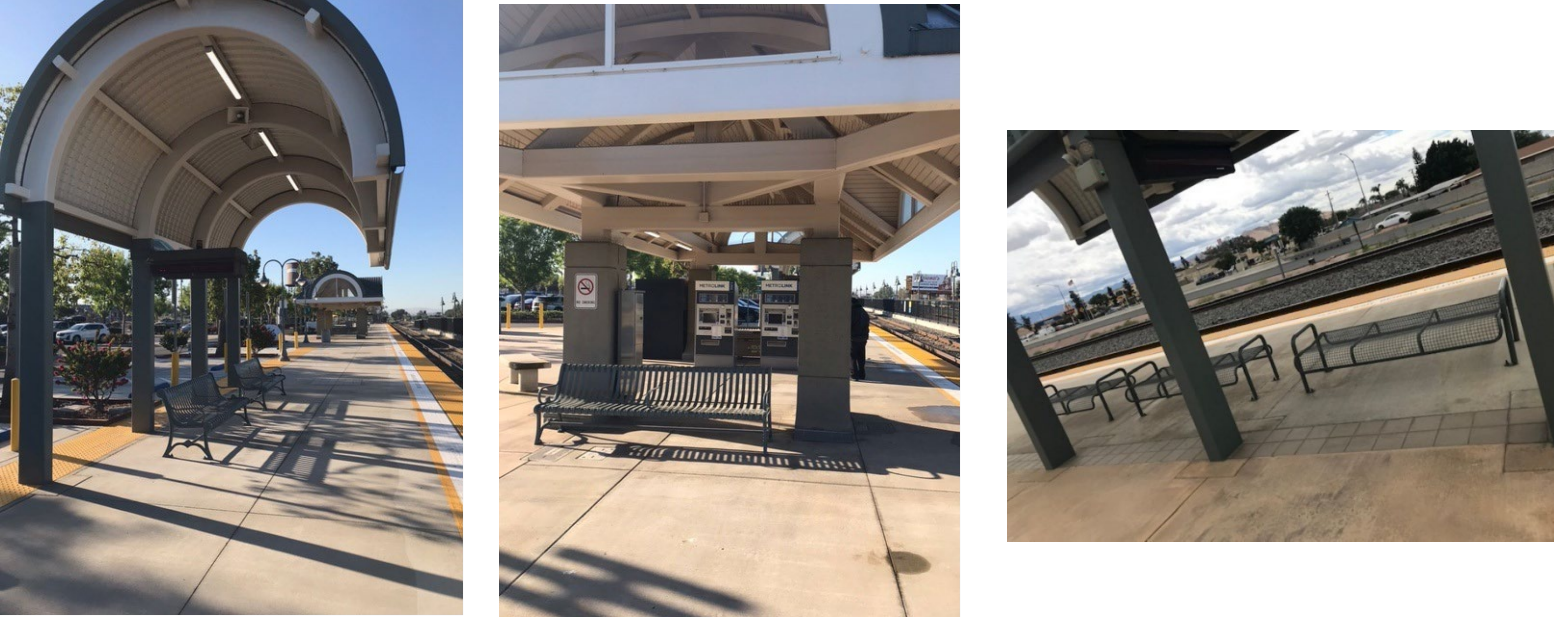
70.General Accessible Paths	There are uneven joints and cracks observed in concrete along the accessible route, and sealant/filler in deep joints is missing.	<p>Examine and repair accessible routes where there are uneven joints and cracks observed in concrete along the accessible route, and where sealant/filler in deep joints is missing.</p> <p>Every joint deeper than ¼" and wider than ½" shall be filled with concrete and crack fillers as required. Every level change along the accessible route greater than ¼" and less than ½" height needs to be beveled (1:2 slope) or repaired using grinding tools and/or levelling compounds.</p>	Create a maintenance plan for ongoing routine inspections and repairs of all components of the accessible route.	<p>Complete</p> <p>A maintenance plan consisting of routine visual inspections and quarterly audits has been initiated to ensure the facility meets ADA standards.</p>

Facility/Area	Access Issue	Solution	Comments	Resolution Status
Pedley Station			See Attachment 6E for curb ramp locations, images of barriers, recommendations, and ADA requirements.	
		Every level change greater than 1/2" needs to have a ramped surface (1:12) slope .

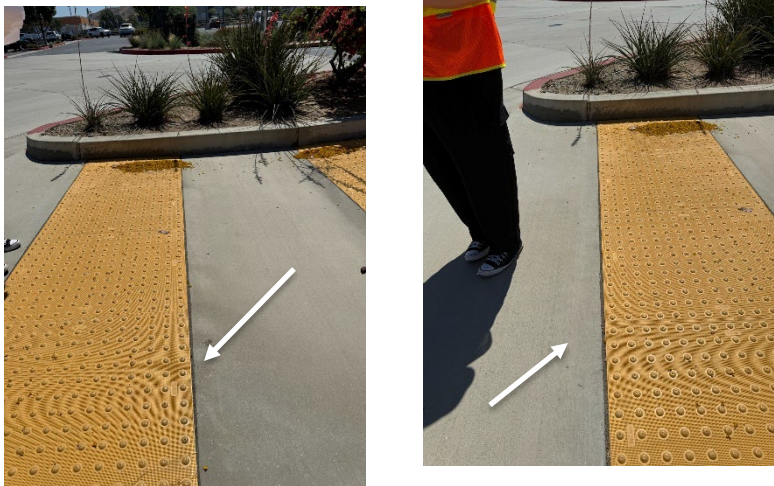
87. Pedestrian Crossing 2a-2b	Pedestrian crossing at 2a, 2b has cracks, level changes more than 1/4" high, and gaps in excess of 1/2" wide and 1/4" deep	<p>Every joint deeper than 1/4" and wider than 1/2" shall be filled with concrete and crack fillers as required.</p> <p>Every level change along the accessible route greater than 1/4" and less than 1/2" height needs to be beveled (1:2 slope) or repaired using grinding tools and/or levelling compounds.</p> <p>Every level change greater than 1/2" needs to have a ramped surface (1:12) slope</p>		<p>2A. Complete</p> <p>Pedestrian crossing 2A has been repaired to ADA standards.</p> <div style="display: flex; justify-content: space-around;">

</div> <p>2B. In Progress</p> <p>Planned completion: Winter 2026</p>

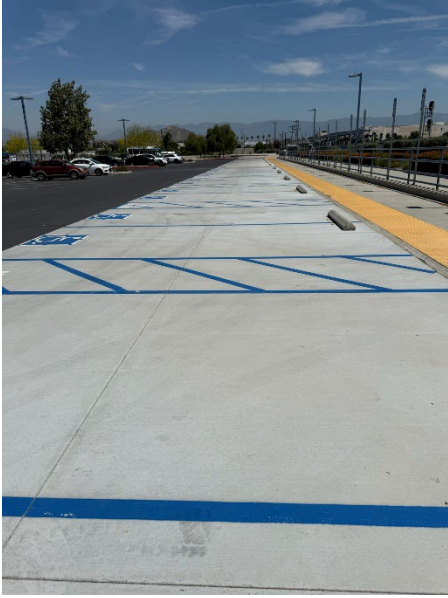
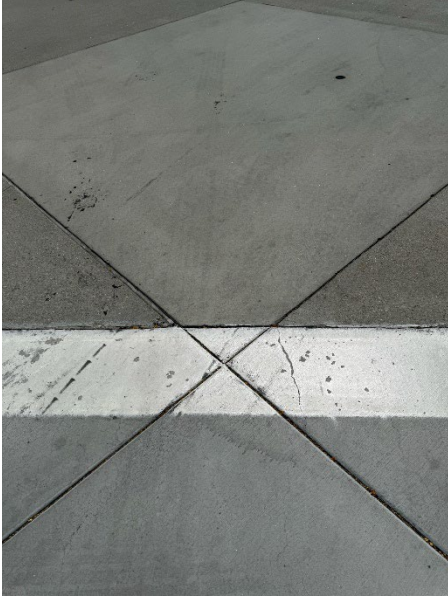
88.General Accessible Paths	There are uneven joints and cracks observed in concrete along the accessible route, and sealant/filler in deep joints is missing.	Same as above.	Update the maintenance plan for ongoing routine inspections and repairs of all components of the accessible route.	<p>Complete</p> <p>Accessible paths have been paved and repaired to meet ADA standards.</p> <div style="display: flex; justify-content: space-around;">

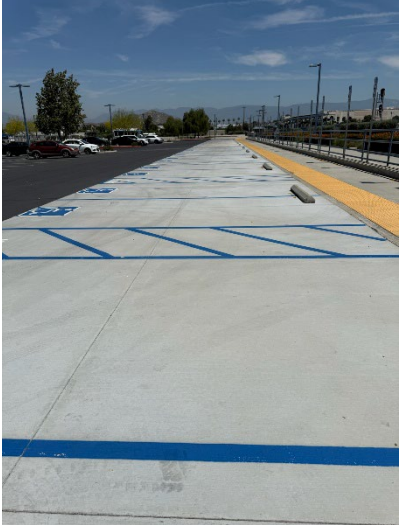
89.Parking aisles	Access aisles at parking stalls have cracks and level changes more than 1/4" high and gaps in excess of 1/2" wide and 1/4" deep.	<p>Every joint deeper than 1/4" and wider than 1/2" shall be filled with elastomeric fillers and sealed</p> <p>Every level change along the accessible route greater than 1/4" and less than 1/2" height needs to be beveled (1:2 slope) or repaired using grinding tools, filler and sealer.</p> <p>Every level change greater than 1/2" needs to have a ramped surface (1:12) slope.</p>		<p>Complete</p> <p>Access aisles and parking stalls have been repaved and recemented.</p> <div style="text-align: center;">

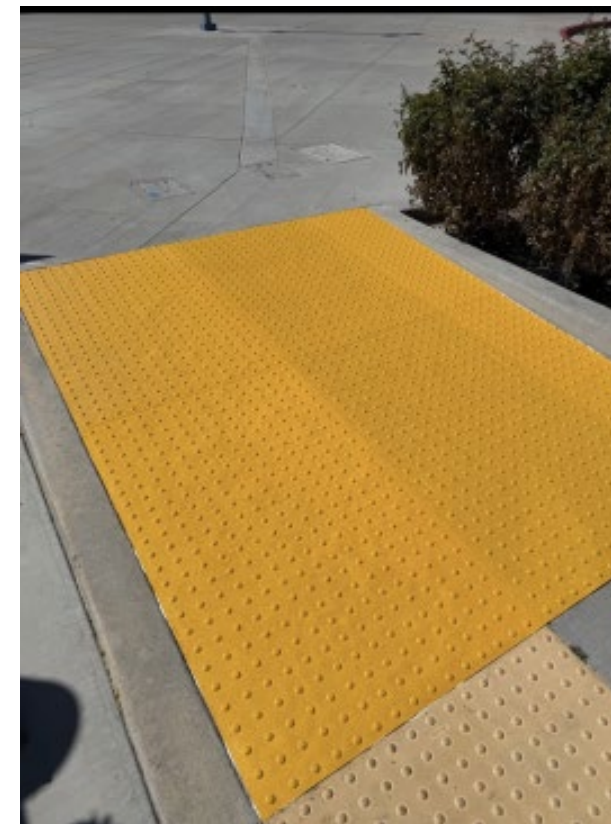
102. General Accessible	There are uneven joints and cracks	Every joint deeper than 1/4" and wider

Facility/Area	Access Issue	Solution	Target Date	Comments	Resolution Status
South Perris Station				See Attachment 6I for curb ramp locations, images of barriers, recommendations, and ADA requirements.	
Paths and Platforms	observed in concrete along the accessible route, and sealant/filler in deep joints is missing.	<p>than 1/2" shall be filled with concrete and crack fillers as required.</p> <p>Every level change along the accessible route greater than 1/4" and less than 1/2" height needs to be beveled (1:2 slope) or repaired using grinding tools and/or levelling compounds.</p> <p>Every level change greater than 1/2" needs to have a ramped surface (1:12) slope.</p>			<p>In Progress</p> <p>Planned completion: Winter 2026</p>
