Evaluation of Physical Barriers – Downtown Perris Station

Address: 121 S C street St, Perris, CA 92570

Year of Construction: 2013 Applicable ADA Standards: DOT's ADA standards (2006), and DOJ 2010 ADA Standards. Note: Criteria used to assess the elements were based on DOJ 2010 standards, DOT's ADA standards (2006), DIB 82-06, and PROWAG.

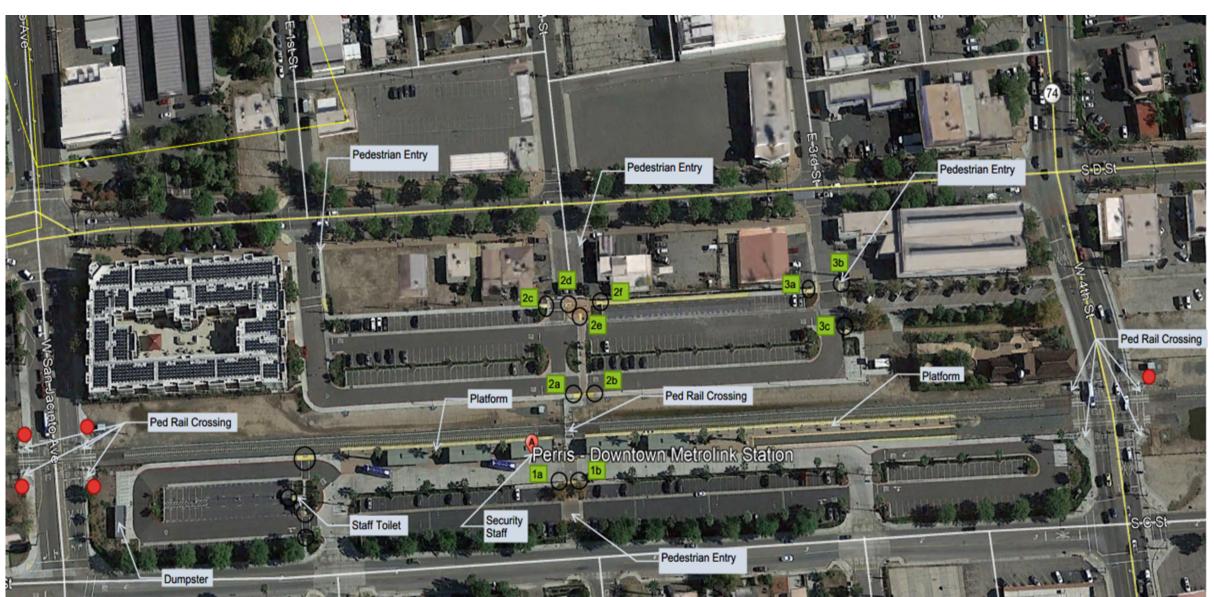
Issues/Barriers Identified	Recommendations	Comments/ADA Re
1. Curb Ramps		Curb ramps are labeled on the aerial view on page 1
All sidewalk curb ramp slopes are found to be OK. Detectable Warning Surface (DWS) tiles have developed level changes at some locations which currently do not exceed ¼" but they need to be maintained to eliminate any trip hazards. Curb ramps along the C and D streets are not evaluated as these are not under RCTC's authority.	Examine and repair DWS to eliminate level changes.	See item 3 for ADA requirements This evaluation does not include curb ramps outside the RC maintaining the accessible routes outside of RCTC boundary When repairs begin, use proper and precise instruments (4-f the curb ramp width and the adjacent gutter to measure ram curb ramps (all stations). The long slope of ramp shall not ex exceed 1:10 (10%), the gutter slope shall not exceed 1:20 (5 exceed 1:50 (2%) Use smart level instruments, calibrated in accordance with m measurements.

- 1. Curb ramps (1a-1b, 2a-2b, 2c-2d, 3a-3b,5a, 4a-4b)
- 2. Pedestrian road crossings
 - a. Pedestrian push button signals (where applicable)
- 3. Accessible routes a. Walking surfaces
- 4. Platforms
 - a. Walking surfaces
 - b. Mini High platforms and ramps
- 5. Pedestrian rail crossings
- 6. Access to public amenities
 - a. Ticket Vending/validation machines (TVM),
 - b. Drinking fountain
 - c. Communication Systemspassenger information phones, blue emergency phones, yellow call boxes, service phones, emergency phones.
 - d. Trash cans,
 - e. Vending machines
 - f. Benches
 - q. Rack of flyers
- 7. Accessible parking spaces
- 8. Bus stops
- 9. Signage
- 10. Public Address Systems
- 11. Staff facilities
 - a. Security Staff Facility
 - b. Staff Toilet
 - c. Dumpster.
