## **Evaluation of Physical Barriers- Moreno Valley / March Field Station**

Address: 14160 Meridian Pkwy, Riverside, CA 92518

Year of Construction: Station- 03/12/2010

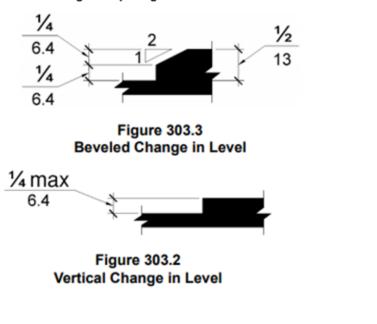
Recommendations Comments Issues 4. Platforms a. Walking Surfaces General: Joints and gaps in concrete to be repaired or maintained for Examine all pedestrian compliance with 302.3, 303.2, and 303.3. routes and repair all dominant direction of travel cracks. Every joint in concrete deeper than 1/4" and wider than ½" shall be filled. long dimension perpendicular to dominant direction of travel Every level change along the accessible route greater than 1/4" and less than 1/2" height needs to be beveled (1:2) slope or repaired. ½ max Every level change greater than 1/2" needs to Figure 302.3 have a ramped surface **Elongated Openings in Floor or Ground Surfaces** (1:12) slope.

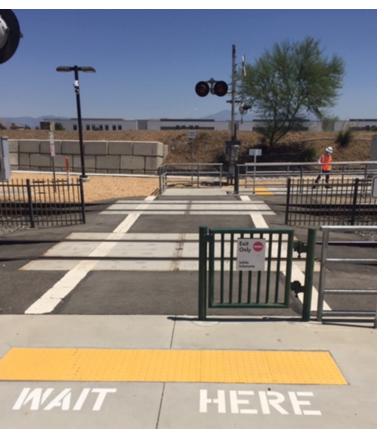
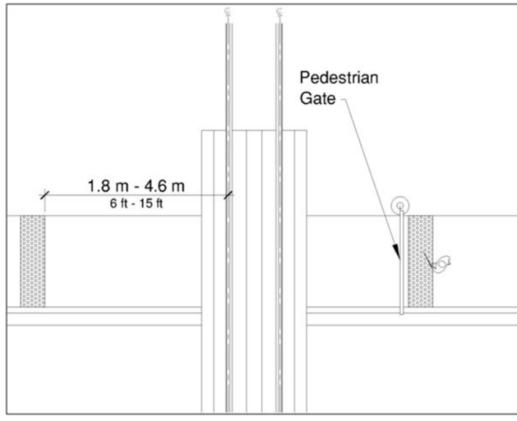
Issues	Recommendations	Comments
b. Mini High Platforms and Ramps	Recommendations	
No Issues found		
5. Pedestrian Rail Crossings		
DWS does not extend 36 inches in the direction of travel as required by DIB-82-06 4.3.14 Detectable Warning Surface. DWS complies per 2010 ADA standards and <b>PROWAG R305.1.4</b>	Provide 36 inches wide DWS to comply with DIB 82-06	R305.2.5 Pedestrian At-Grade Rail Crossings
		At pedestrian at-grade rail crossings not located within a street or highway, detectable warning surfaces shall be placed on each side of the rail crossing. The edge of the detectable warning surface nearest the rail crossing shall be 1.8 m (6.0 ft) minimum and 4.6 m (15.0 ft) maximum from the centerline of the nearest rail. Where pedestrian gates are provided, detectable warning surfaces shall be placed on the side of the gates opposite the rail.
T		Figure R305.2.5 Pedestrian At-Grade Rail Crossings

**PROWAG R305.1.4** Size, Detectable warning surfaces shall extend 610 mm (2.0 ft) minimum in the direction of pedestrian travel.

**DIB-82—06 4.3.14**: Detectable Warning Surface - Detectable warning surfaces shall extend 3 feet in the direction of pedestrian travel.
