Evaluation of Physical Barriers – North Main Corona

Address: East Blaine St, Corona, CA 92880

Evaluation Date: 07-21-2021

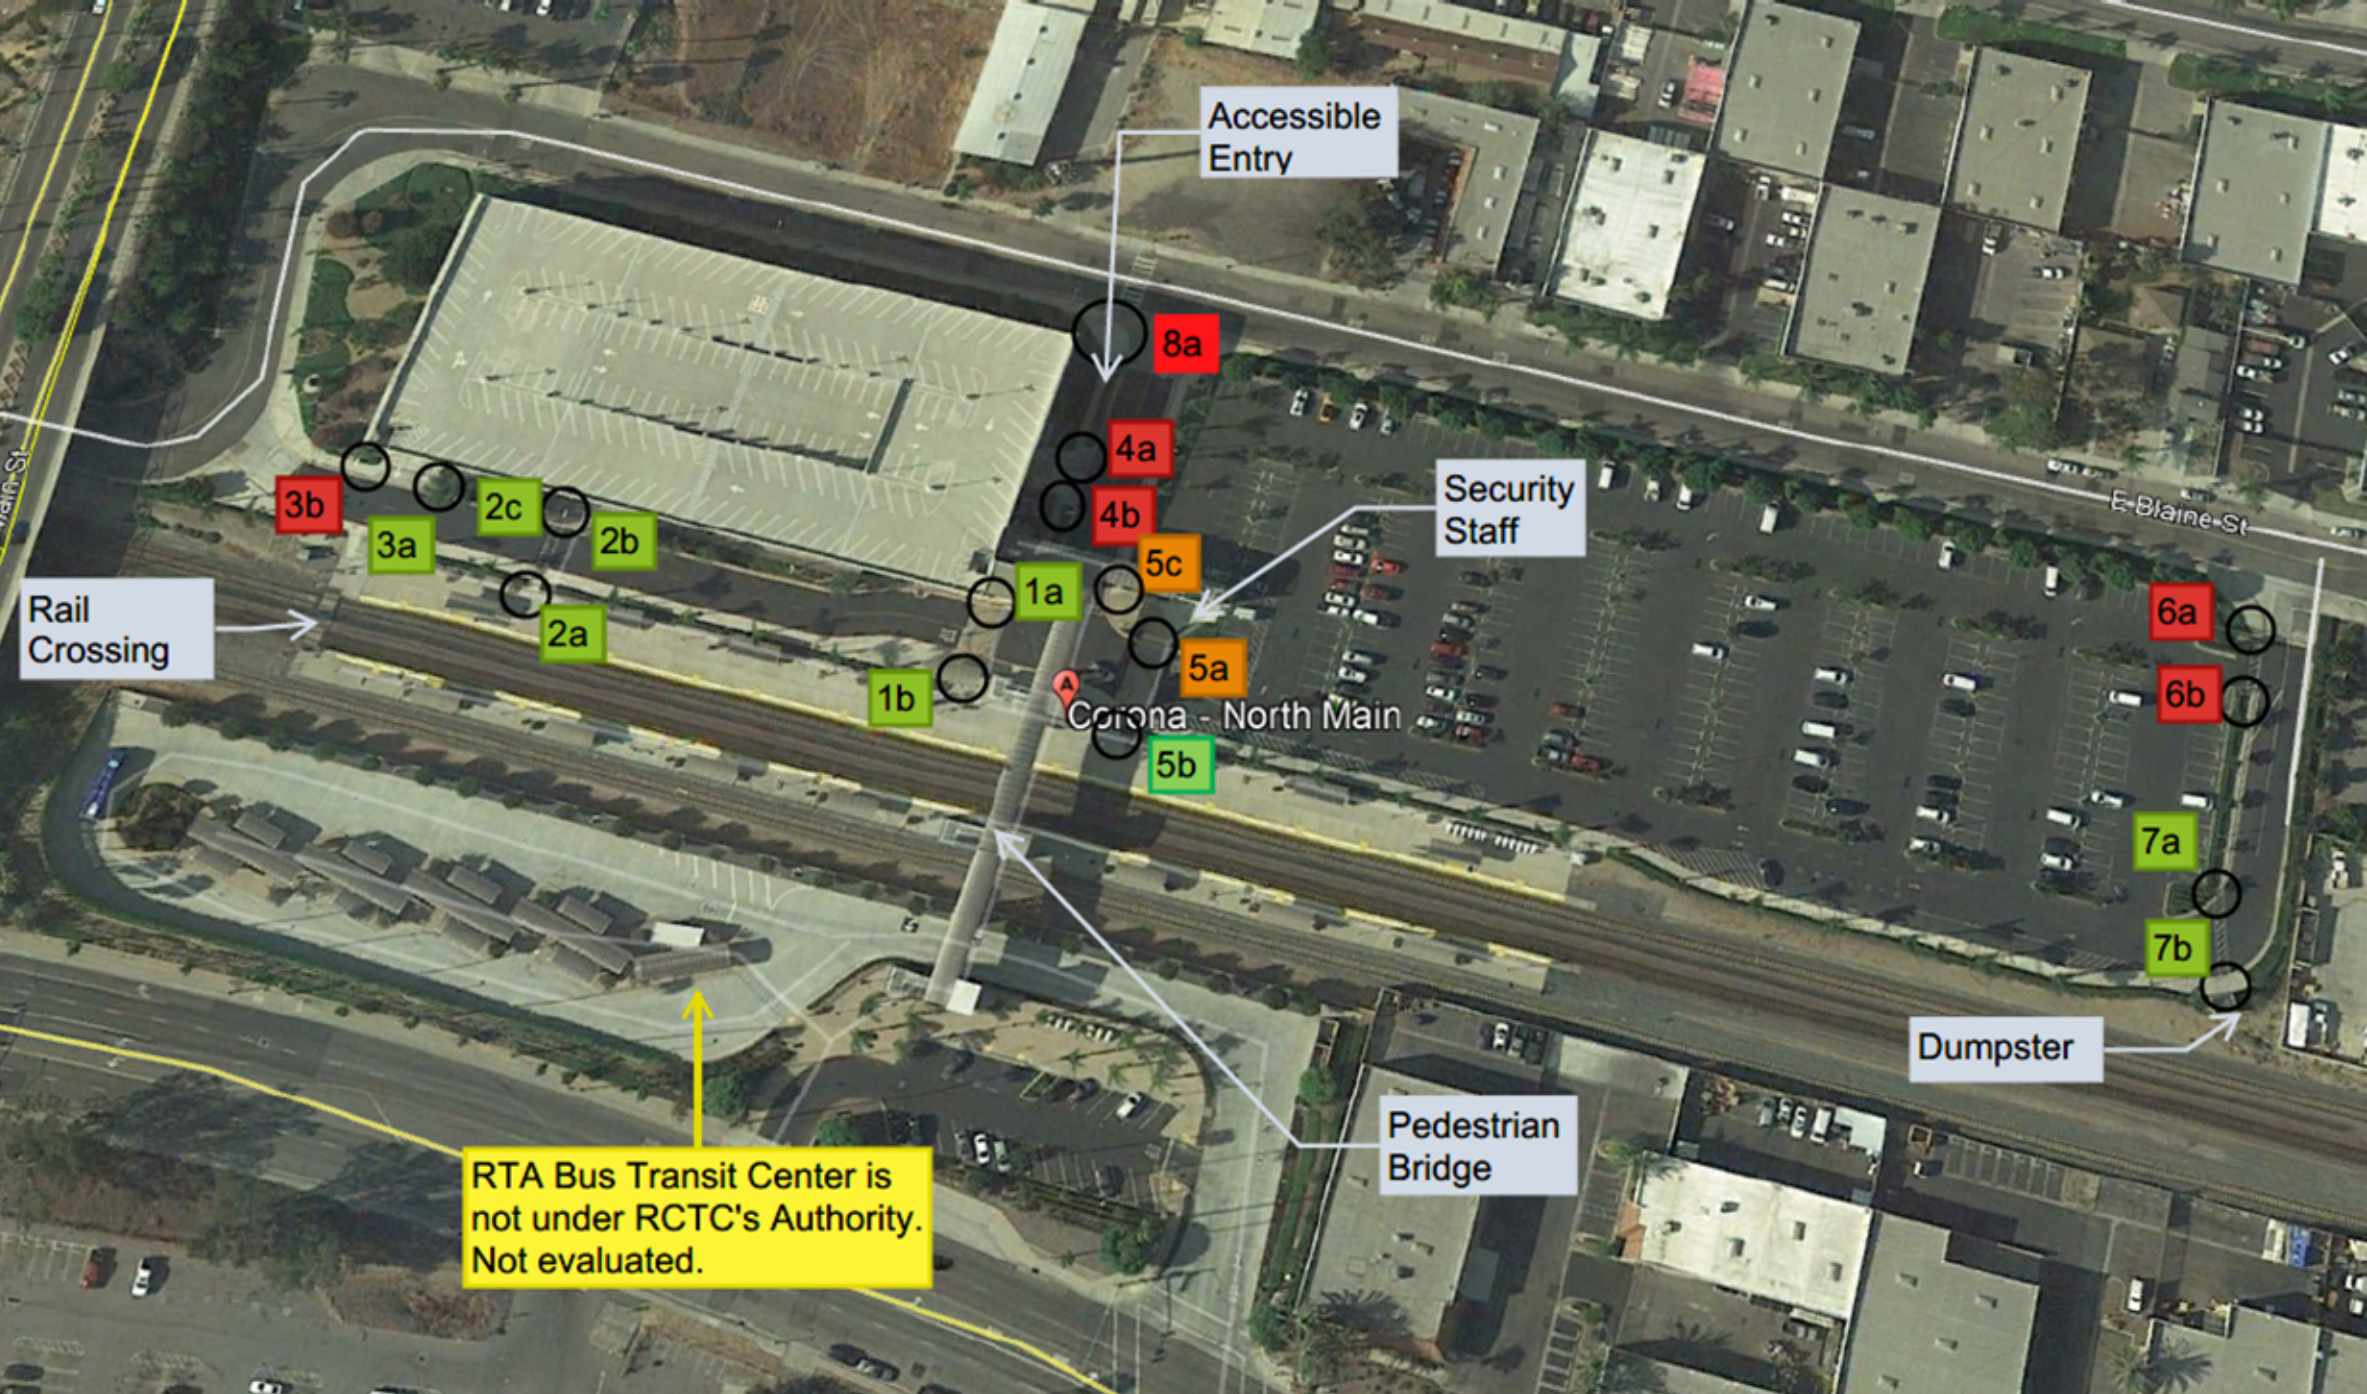
These elements were assessed to identify any physical barriers:

1. Curb ramps (1a-1b, 2a-2b, 2c, 3a-3b, 4a-4b, 5a- 5b, 5c, 6a-6b, 7a-7b, 8a)
2. Pedestrian road crossings
 - a. Pedestrian push button signals (where applicable)
3. Accessible routes
 - a. Walking surfaces
 - b. Elevators
 - c. Pedestrian Bridge
 - d. Stairs
 - e. Ramps
4. Platforms
 - a. Walking surfaces
 - b. Mini High platforms and ramps
5. Pedestrian rail crossings
6. Access to public amenities
 - a. Ticket Vending/validation machines (TVM),
 - b. Drinking fountain
 - c. Communication Systems- passenger information phones, blue emergency phones, yellow call boxes, service phones, emergency phones.
 - d. Trash cans,
 - e. Vending machines
 - f. Benches
7. Accessible parking spaces
8. Bus stops
9. Signage
10. Public Address Systems
11. Staff facilities
 - a. Security Staff Facility
 - b. Dumpster.

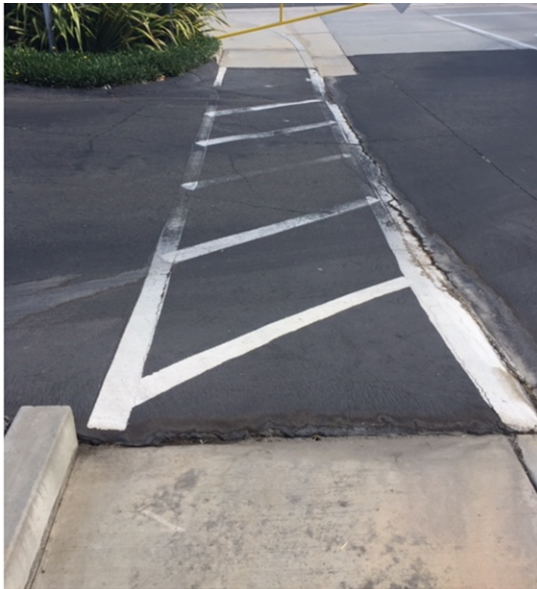
2. Pedestrian Road crossings		
a) Marked crossing at 6a, 6b is blocked due to the gate barrier.

Remove marking if the pedestrian route is now closed to public and other pedestrians. Provide signage for the alternate accessible route.

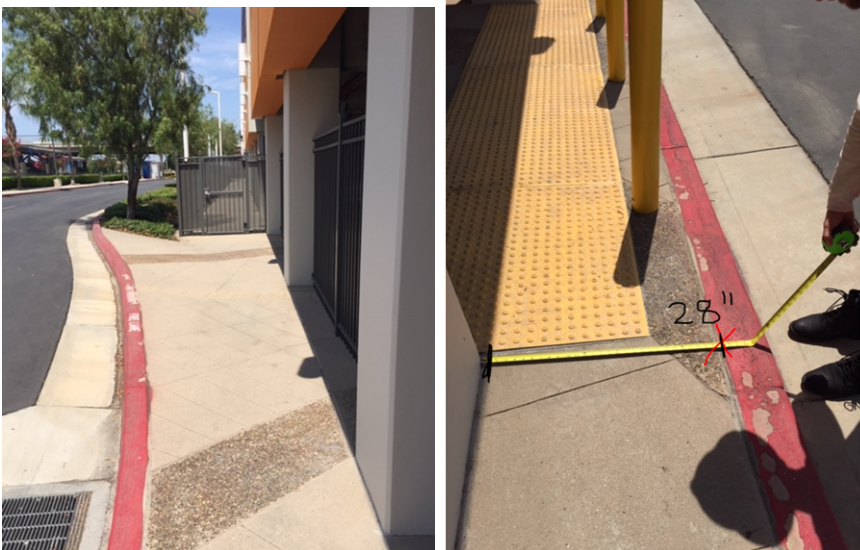
Issues/ Barriers Identified		Recommendations	Comments/ ADA Requirements
<p>iii. Width of accessible route on the ground level (sidewalk) from the garage exit gate going towards the elevators/pedestrian crossing narrows down to 28 inches along the structural columns and bollards. This sidewalk does not meet accessibility requirements for minimum width of 48 inches.</p> <div>

</div>		Provide signage at the gate identifying the alternate accessible route.	
<p>iv. Curved ramps leading to the garage at 2b are not accessible due to the cross slope exceeding ADA requirements of minimum 2%</p> <div>

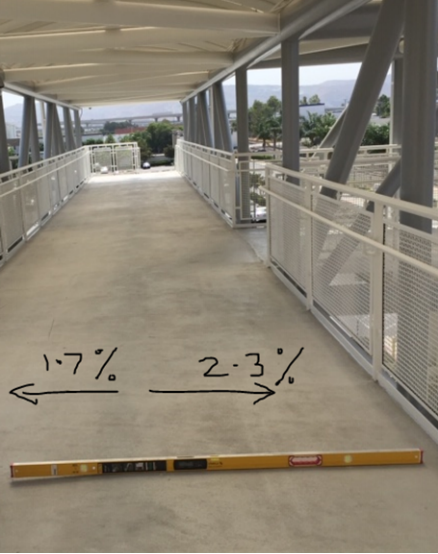
Issues/ Barriers Identified		Recommendations	Comments/ ADA Requirements
c) Pedestrian Bridge			
v. Cross slope of the pedestrian bridge in one half of the bridge longitudinally, exceeds 2 %.		Repair the cross slope to be less than 2%. In the interim, provide signage for accessible route in the half where cross slope does not exceed 2%.	403.3 Slope. The running slope of walking surfaces shall not be steeper than 1:20. The cross slope of walking surfaces shall not be steeper than 1:48.

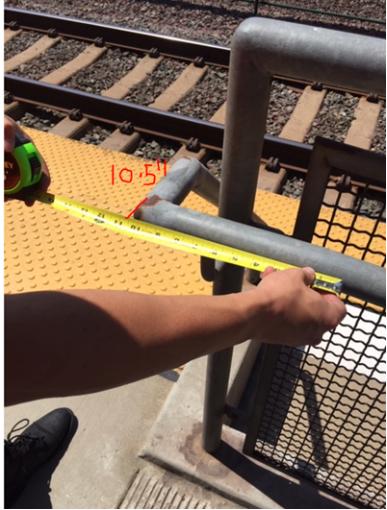
Issues/ Barriers Identified	Recommendations	Comments/ ADA Requirements
<p data-bbox="136 157 609 187">b. Mini High Platforms and Ramps</p> <p data-bbox="136 207 1081 274">i. Top handrail extension of the mini high platform ramps are not 12 inches long as required by 505.10.1.</p>

<p data-bbox="1140 207 1411 274">Provide compliant handrail extensions.</p>

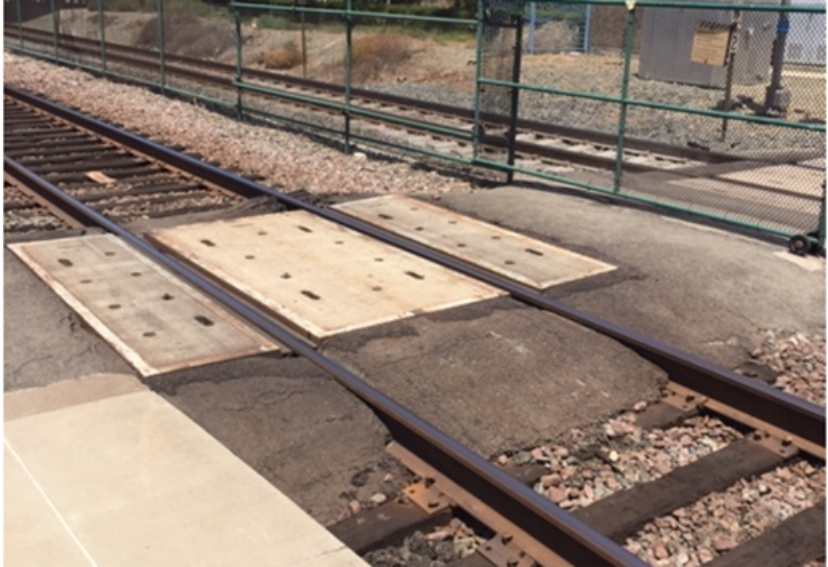
Issues/ Barriers Identified	Recommendations	Comments/ ADA Requirements
<div>5. Pedestrian Rail Crossings</div> <div>Even though pedestrian rail crossing is used for emergencies only , the surface does not appear to be accessible. Detectable warning surface (DWS) is missing. Trip hazards may exist in the asphalt and concrete interface.</div> <div>

</div>	<div>Remove trip hazards and provide detectable warning surface as required.</div>	<div>Rail crossing at this station is not on an accessible route and is not meant for public use during normal conditions</div> <div>PROWAG</div> <div>R305.2.5 Pedestrian At-Grade Rail Crossings Link</div> <div>At pedestrian at-grade rail crossings not located within a street or highway, detectable warning surfaces shall be placed on each side of the rail crossing. The edge of the detectable warning surface nearest the rail crossing shall be 1.8 m (6.0 ft) minimum and 4.6 m (15.0 ft) maximum from the centerline of the nearest rail. Where pedestrian gates are provided, detectable warning surfaces shall be placed on the side of the gates opposite the rail.</div> <div><div>Figure R305.2.5 Pedestrian At-Grade Rail Crossings</div><div>

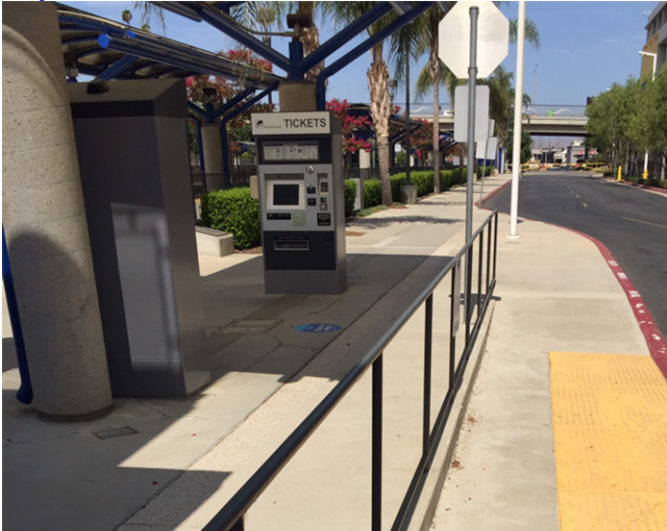
Issues/ Barriers Identified	Recommendations	Comments/ ADA Requirements
6. Amenities		
a) TVM's		
<p>TVM's are not in RCTC's scope. However, they are considered as being compliant to ADA requirements per information found on website https://metrolinktrains.com/ticketsOverview/where-to-buy/ticket-machines/</p>

<p>Adequate clear space is provided at TVM's. No action.</p>

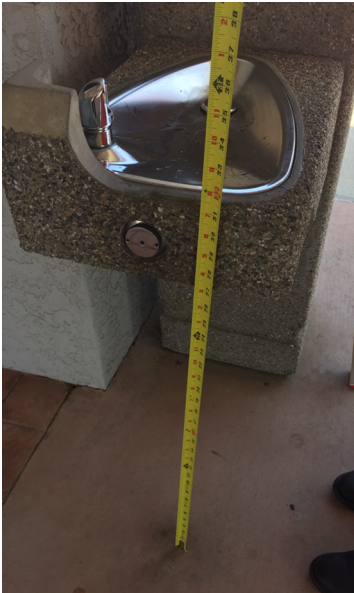
b) Drinking Fountains		
<p>Drinking Fountain: Water flow to be tested</p>

<p>Adjust water flow.</p>	<p>602.6 Water Flow. The spout shall provide a flow of water 4 inches (100 mm) high minimum and shall be located 5 inches (125 mm) maximum from the front of the unit. The angle of the water stream shall be measured horizontally relative to the front face of the unit. Where spouts are located less than 3 inches (75 mm) of the front of the unit, the angle of the water stream shall be 30 degrees maximum. Where spouts are located between 3 inches (75 mm) and 5 inches (125 mm) maximum from the front of the unit, the angle of the water stream shall be 15 degrees maximum.</p>

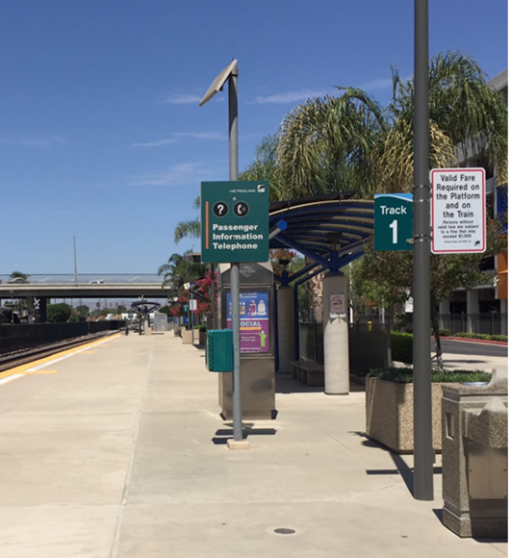
i. Passenger Information Phone:

Issues/ Barriers Identified	Recommendations	Comments/ ADA Requirements
c) Telephones/ Communication Systems	See Attachment 9, Action Plan for recommendations	Clear space and reach ranges are found to be compliant. All instruments are to be tested regularly for compliance by the responsible authorities.

No action by RCTC	<p>704.2.1 Clear Floor or Ground Space. A clear floor or ground space complying with 305 shall be provided. The clear floor or ground space shall not be obstructed by bases, enclosures, or seats.</p> <p>704.2.2 Operable Parts. Operable parts shall comply with 309. Telephones shall have push-button controls where such service is available.</p> <div data-bbox="1578 419 2682 749">

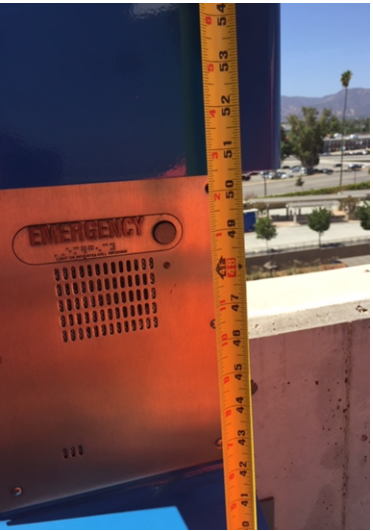
<p>Figure 308.3.2 Obstructed High Side Reach</p> <p>Figure 308.2.2 Obstructed High Forward Reach</p> </div>
ii. Blue Emergency Phones: Control button for emergency telephones in the parking structure is higher than 48 inches.

Provide ADA compliant emergency phones.	<p>308.2 Forward Reach.</p> <p>308.2.1 Unobstructed. Where a forward reach is unobstructed, the high forward reach shall be 48 inches (1220 mm) maximum and the low forward reach shall be 15 inches (380 mm) minimum above the finish floor or ground.</p> <div data-bbox="1951 1024 2418 1421">

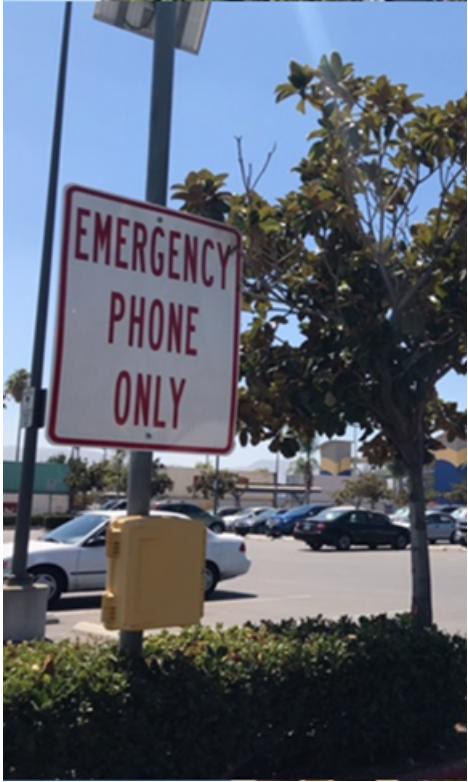
Issues/ Barriers Identified		Recommendations	Comments/ ADA Requirements
<p>iii. Yellow call boxes: The yellow call box is not on an accessible route. Emergency phone is provided near the garage on an accessible path.</p>

No action	
<p>iv. Emergency Phone: No physical access issues found.</p>

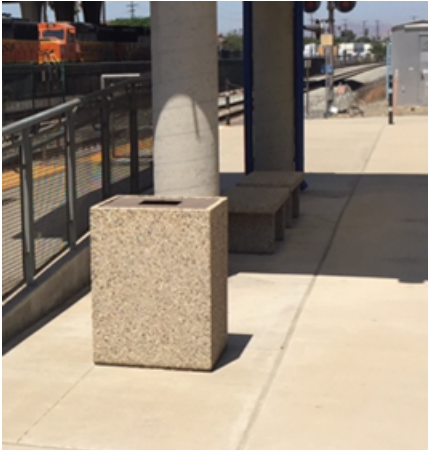
Issues/ Barriers Identified	Recommendations	Comments/ ADA Requirements
<p>d) Trash cans</p> <p>Trash cans are not accessible due to height being taller than 34"and where the opening is located more than 10 inches away from the edge.</p>

<p>Provide 34 inches high accessible trash cans allowing reach ranges per 308.3.2</p>

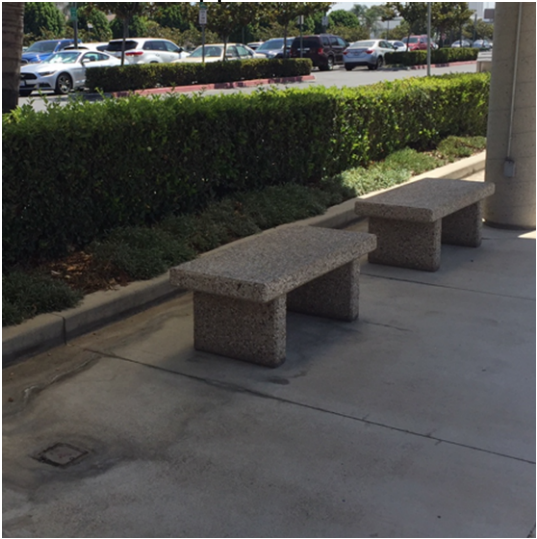
<p>Figure 308.3.2 Obstructed High Side Reach</p>
<p>e) Vending Machines</p> <p>Not under RCTC's authority. No issues found with heights of operable components.</p>	<p>No action by RCTC</p>	<p>The Americans with Disabilities Act (ADA) requires all operable components of the vending machine to be between 15" and 48" up from the floor.</p>
<p>f) Benches</p> <p>Benches: Concrete benches do not comply with ADA Section 903 as there are no back supports. This is technically not a violation as Section 903 applies to indoor benches only.</p>

<p>It is a recommendation to apply Section 903 standards to benches in outdoor public environments, in order to ensure seating opportunities for people of all mobility.</p>

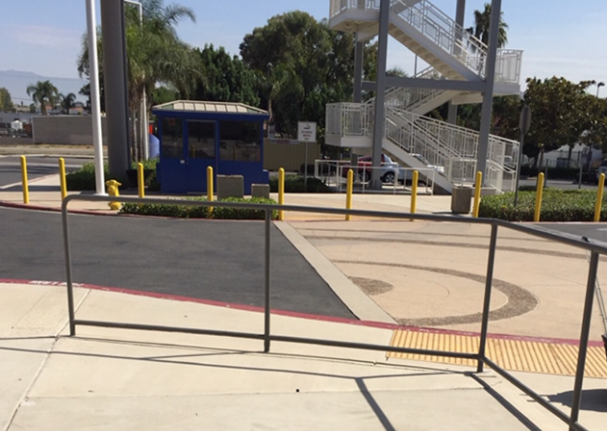
Issues/ Barriers Identified	Recommendations	Comments/ ADA Requirements
11. Staff Facilities		
a) Security Staff Facilities		
<p>The guard booth is provided as a shelter against weather and for use during breaks by security staff, who are expected to walk around the station site and physically address emergency situations.</p>

<p>Inform all contractors of their ADA obligations</p>	<p>Station Security services are contracted out and an ADA evaluation of the facilities used by the station security was not conducted as it is not Public Accessible and the Security Contractor requirements require the guards to be able to walk around the station site and physically address emergency situations.</p>

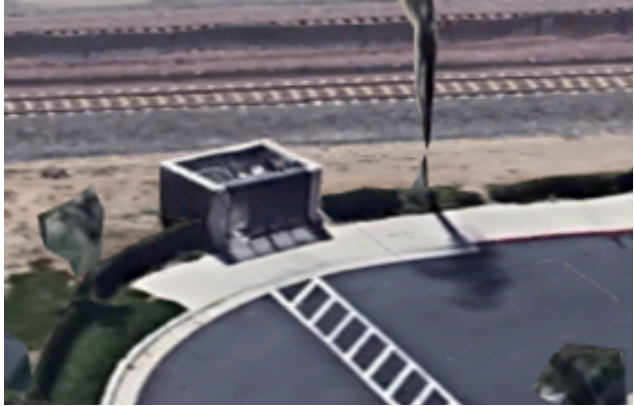
b) <u>Trash / Dumpster Enclosure</u>		
<p>The gate at trash dumpster is on an ADA compliant route but the gate does not appear to be accessible.</p>

<p>Provide accessible gate to dumpster</p>	<p>203.9 Employee Work Areas. Spaces and elements within employee work areas shall only be required to comply with 206.2.8, 207.1, and 215.3 and shall be designed and constructed so that individuals with disabilities can approach, enter, and exit the employee work area.</p> <p>1991 Standards. 4.1.1 (3) (3)* Areas Used Only by Employees as Work Areas. Areas that are used only as work areas shall be designed and constructed so that individuals with disabilities can approach, enter, and exit the areas. These guidelines do not require that any areas used only as work areas be constructed to permit maneuvering within the work area or be constructed or equipped (i.e., with racks or shelves) to be accessible</p>
