Evaluation of Physical Barriers – RCTC Office

Address: 4080 Lemon Street, Riverside, 92501

Evaluation Date: 07-23-2021

FLOOR PLAN OF RCTC OFFICE- 3rd Floor

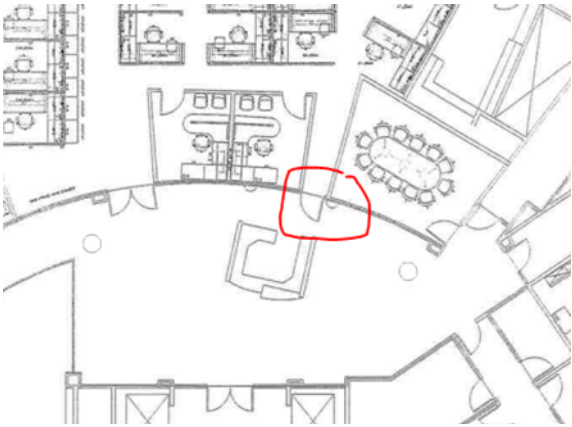
2. Exit Doors		
I. Some doors with closers on accessible routes, close too fast	Adjust door closers on all doors on the accessible route.	404.2.8 Closing Speed. Door and gate closing speed shall comply with 404.2.8. Door closers and gate closers shall be adjusted so that from an open position of 90 degrees, the time required to move the door to a position of 12 degrees from the latch is 5 seconds minimum
II. Maneuvering clearance at the exit door behind reception counter is not compliant with minimum requirements. 12 inches is required for a front approach, push side door.

Provide directional sign pointing to the alternate accessible exit route.

216.4.3 Directional Signs. Signs required by section 1003.2.13.6 of the International Building Code (2000 edition) or section 1007.7 of the International Building Code (2003 edition) (incorporated by reference, see "Referenced Standards" in Chapter 1) to provide directions to accessible means of egress shall comply with 703.5.

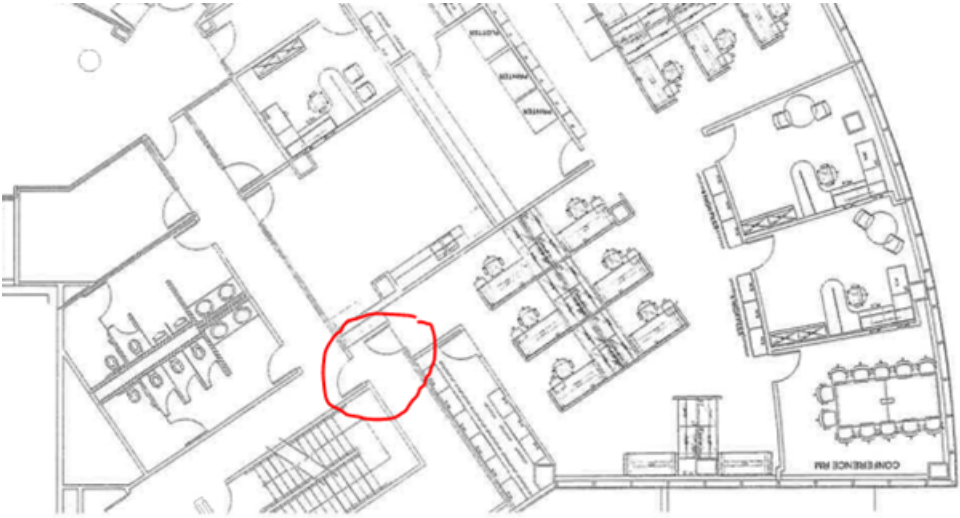
III. Exit door near the restroom leading to the exit stair is not compliant with requirements of "doors in series" per 404.2.6.

Provide directional sign pointing to the alternate accessible exit route. Or Move the office side door and partitions to the inside to allow 48 inches clearance per figure 404.2.6.

Figure 404.2.6 Doors in Series and Gates in Series 404.2.6 Doors in Series and Gates in Series: The distance between two hinged or pivoted doors in series and gates in series shall be 48 inches (1220 mm) minimum plus the width of doors or gates swinging into the space. This is also a current building code requirement. 1010.1.8 Door Arrangement Space between two doors in a series shall be 48 inches (1219 mm) minimum plus the width of a door swinging into the space. Doors in a series shall swing either in the same direction or away from the space between the doors.

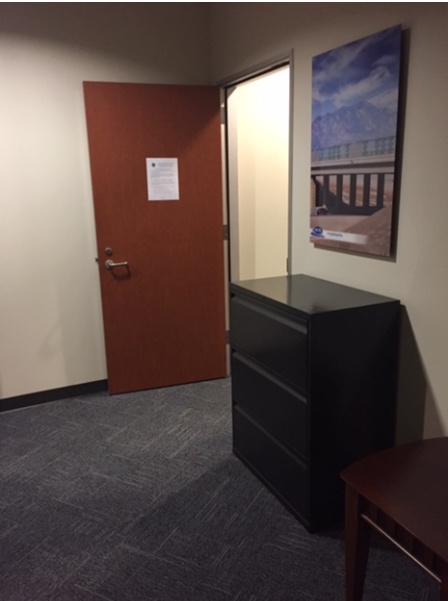
Issues/ Barriers Identified	Recommendations	Comments/ ADA Requirements
<p>IV. Required maneuvering clearances at some doors are blocked by moveable furniture such as filing cabinets, trash cans etc.</p>

<p>Review all doors on accessible routes, in common use areas, and all exit doors. Relocate furniture to allow maneuvering clearances per 404.2.4.1</p>

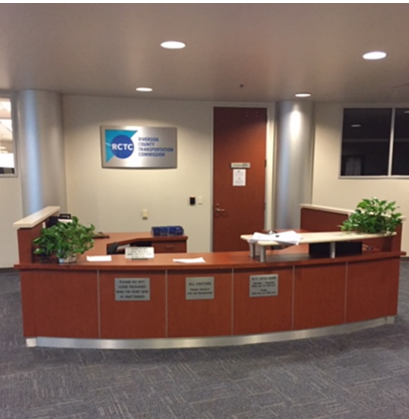
<p>Figure 404.2.4.1 Maneuvering Clearances at Manual Swinging Doors and Gates</p>
<p>3. Exterior Accessible route</p>		<p>No Issues found. Maintenance of exterior route to the building is the responsibility of County of Riverside who lease the third floor to RCTC.</p>
<p>4. Common Use Areas</p>		
<p>a. Entry Lobby</p>		
<p>i. Knee and toe clearances are not adequate at the reception desk</p>

<p>Provide accessible writing/working surface at the reception counter that is available to general public.</p>

<p>Figure 306.2 Toe Clearance</p> <p>226.1: Where work surfaces are provided for use by other than employees, at least 5 percent shall comply with 902</p>

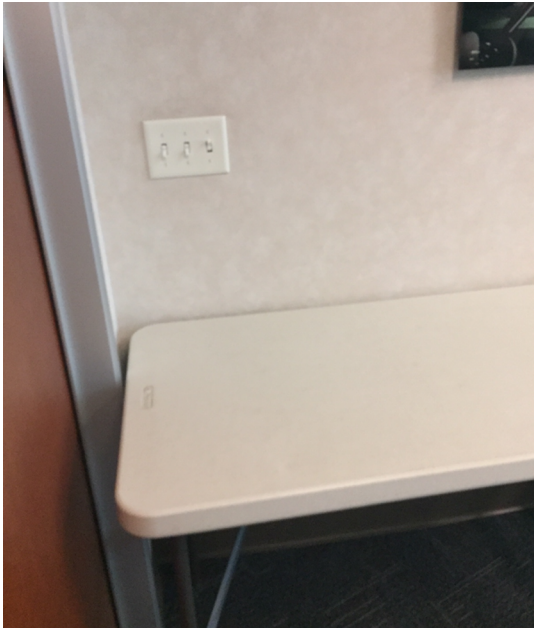
e. Controls for lighting and thermostats etc.		
i. Clear space to operate light switches in some conference rooms are blocked by chairs or tables.

Relocate furniture to provide clear space at all operable parts.

Figure 305.3 Clear Floor or Ground Space 309.2 Clear Floor Space. A clear floor or ground space complying with 305 shall be provided.

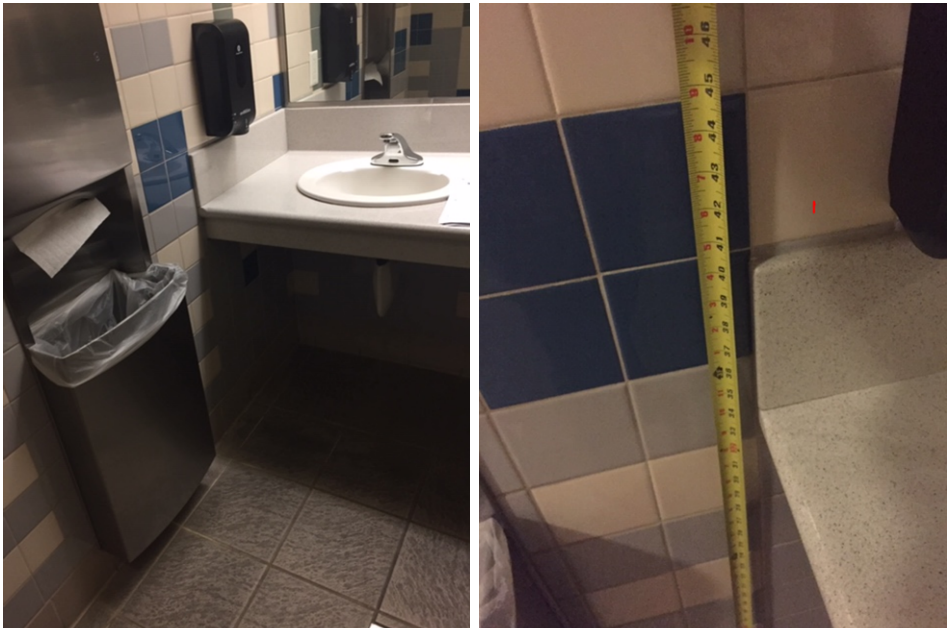
5. Restrooms		
i. Mirrors over the lavatory are half inch higher than the allowed 40 inches in both men and women restrooms.

Replace the mirror/bottom channel of mirror with clips that will allow the reflective surface to be at 40 inches max.	603.3 Mirrors. Mirrors located above lavatories or countertops shall be installed with the bottom edge of the reflecting surface 40 inches (1015 mm) maximum above the finish floor or ground.

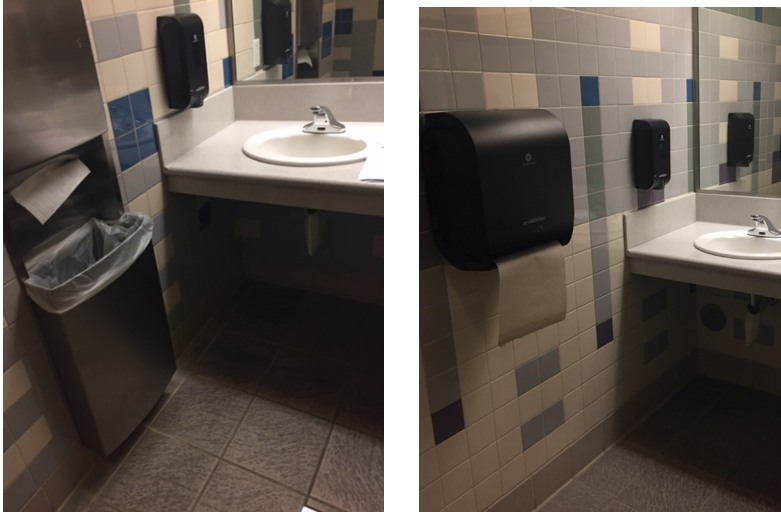
Issues/ Barriers Identified	Recommendations	Comments/ ADA Requirements
<p>ii. Clear space in front of lavatories in both restrooms is hampered by the combination paper towel dispenser/trash receptacle on one side and paper towel dispenser on the other side</p> <div data-bbox="208 292 951 780">

</div>	<p>Relocate or replace the accessory to provide clear space in front of at least one lavatory</p>	<p>606.2 Clear Floor Space. A clear floor space complying with 305, positioned for a forward approach, and knee and toe clearance complying with 306 shall be provided.</p>
<p>iii. ADA toilet stall is not 60 inches wide. It is less than 59 inches wide. The stall does not appear to meet the minimum size requirements for an ADA complaint stall</p> <div data-bbox="214 921 783 1626">

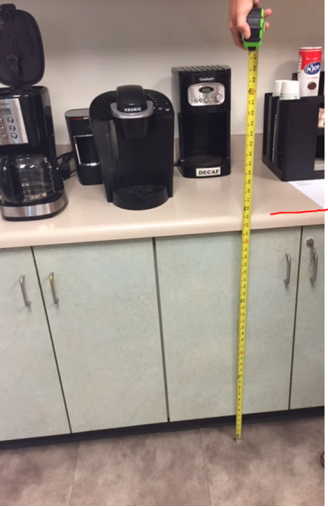
Issues/ Barriers Identified	Recommendations	Comments/ ADA Requirements
<p>6. Break Room</p>		
<p>i. Break Room and Print Room Counters: More than 34 + inch high and 24.75 inch deep counters do not comply with 308.3.2 to reach operable parts at the back of counter.</p>

<p>Modify break room and print room counters to allow compliant access to the sink faucet and operable parts/ controls that are at the back of counters .</p> <p>Alternately, provide a raised floor with beveled edges at thresholds.</p>	<p>308.3.2 Obstructed High Reach. Where a clear floor or ground space allows a parallel approach to an element and the high side reach is over an obstruction, the height of the obstruction shall be 34 inches (865 mm) maximum and the depth of the obstruction shall be 24 inches (610 mm) maximum.</p>

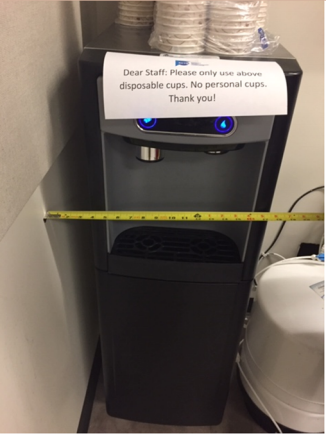
<p>308.3.2</p>
<p>ii. The ice and drinking water dispenser unit is not centered within a 30 in. x 48 in. clear space and reaching the faucet may be difficult for a person using a wheelchair.</p>

<p>Recommend relocating the dispenser to provide easy access to the faucet.</p>

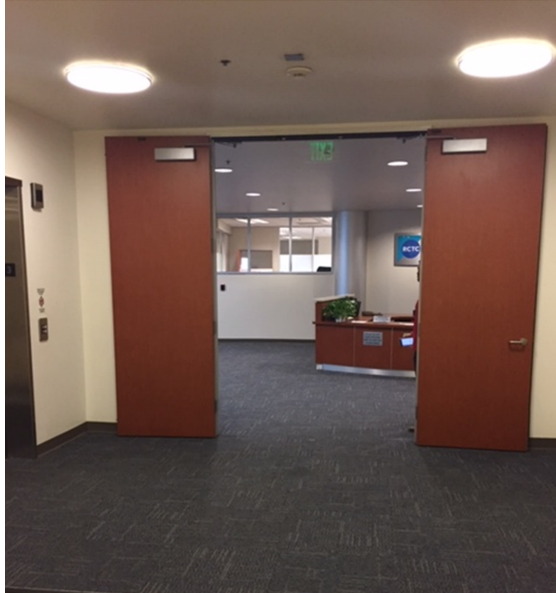
9. Signage		
<p>I. ADA compliant identification sign is missing at the main entry door.</p>

Provide ADA Compliant identification sign with visual and tactile characters	<p>216.2 Designations. Interior and exterior signs identifying permanent rooms and spaces shall comply with 703.1, 703.2, and 703.5.</p> <p>216.6 Entrances. Where not all entrances comply with 404, entrances complying with 404 shall be identified by the International Symbol of Accessibility complying with 703.7.2.1. Directional signs complying with 703.5 that indicate the location of the nearest entrance complying with 404 shall be provided at entrances that do not comply with 404.</p>
II. Interior signs on permanent rooms do not comply with 216	Provide new ADA compliant room indicator signs with visual and tactile characters at all permanent common use spaces	216.2 Designations. Interior and exterior signs identifying permanent rooms and spaces shall comply with 703.1, 703.2, and 703.5. Where pictograms are provided as designations of permanent interior, the pictograms shall comply with 703.6 and shall have text descriptors complying with 703.2 and 703.5.

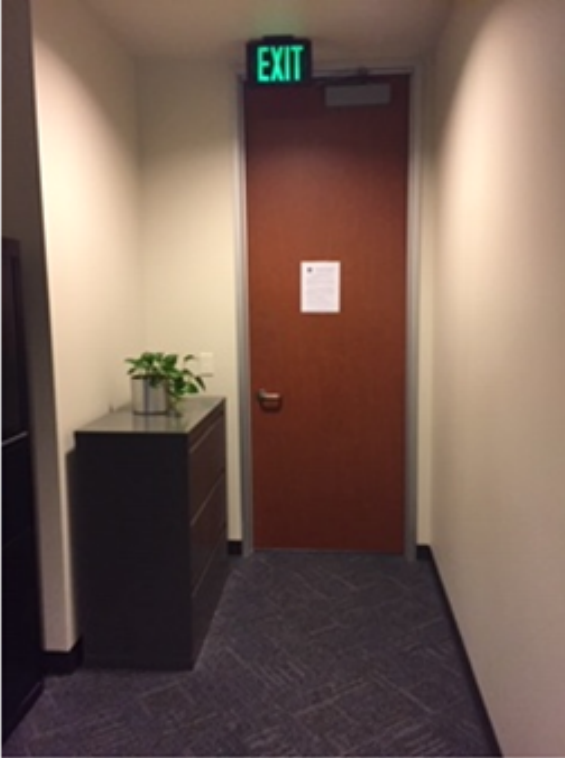
Issues/ Barriers Identified	Recommendations	Comments/ ADA Requirements
<p>III. ADA compliant signs identifying accessible means of egress doors are missing.</p>

<p>Provide ADA compliant exit signs at all accessible exit doors.</p>	<p>216.4.1 Exit Doors. Doors at exit passageways, exit discharge, and exit stairways shall be identified by tactile signs complying with 703.1, 703.2, and 703.5.</p>
<p>10. Employee Work Areas – Private offices</p>		<p>Work areas must be accessible for "approach, entry, and exit,"</p>
<p>I. Access to and exit from the Clerk of Board's office appears to be restricted due to furniture and boxes</p>
