# Evaluation of Physical Barriers – RCA Office

Address: 3403 Tenth Street, Suite 320, Riverside, 92501

Evaluation Date: 07-19-2021

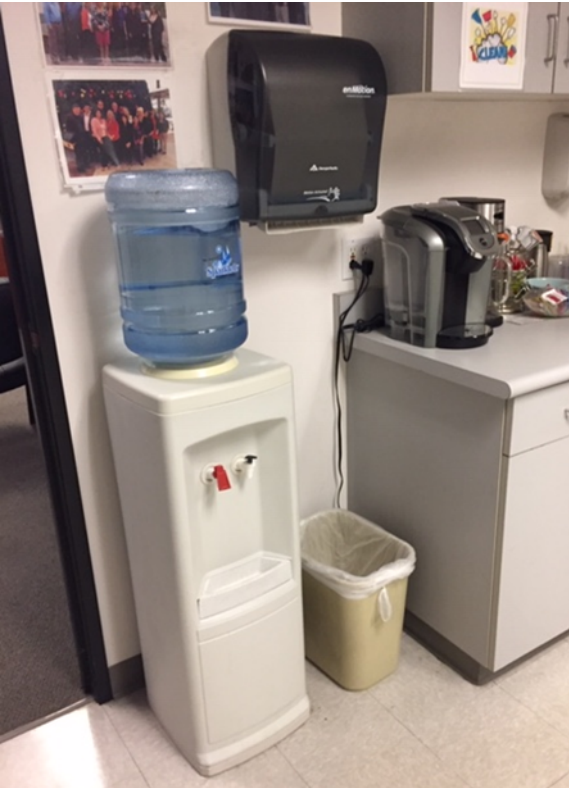
<b>2. Exit Doors</b>		
I. The accessible door with closer (near the stairs) closes too fast	Adjust door closers on all doors on the accessible route.	404.2.8 Closing Speed. Door and gate closing speed shall comply with 404.2.8. Door closers and gate closers shall be adjusted so that from an open position of 90 degrees, the time required to move the door to a position of 12 degrees from the latch is 5 seconds minimum
II. Maneuvering clearance to the breakroom door from inside is blocked by the water dispenser. Access to the paper towel dispenser is also blocked.

Relocate water dispenser to provide 18 inches on latch side per 404.2.4 for times when a closed door needs to be opened from inside.

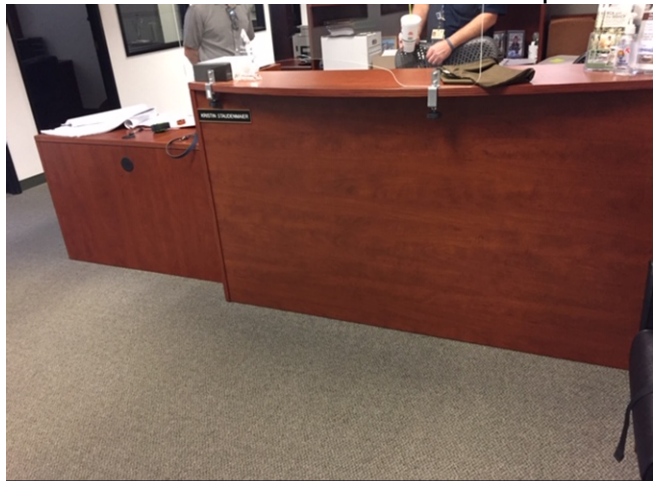
Issues/ Barriers Identified	Recommendations	Comments/ ADA Requirements
<b>4. Common Use Areas</b>		
a. Entry Lobby		
i. Knee and toe clearances are not adequate at the reception desk

Provide accessible writing/working surface at the reception counter that is available to general public.

<p>226.1: Where work surfaces are provided for use by other than employees, at least 5 percent shall comply with 902</p>
ii. Wheelchair space is not provided in the lobby

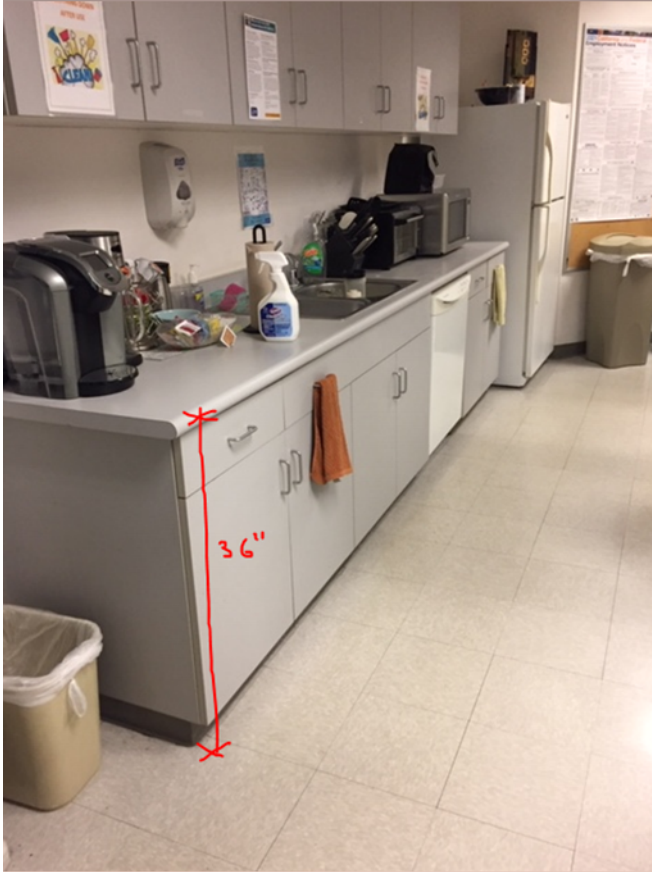
Issues/ Barriers Identified	Recommendations	Comments/ ADA Requirements
<p><b>6. Break Room</b></p> <p>i. <b>Break Room Counters:</b> Obstructed high side reach over 36 inch high and 25.5 inch deep break room counter does not comply with 308.3.2.</p>

<p>Modify break room counters to allow compliant access to the sink faucet and operable parts/ controls that are at the back of counters</p>	<p>308.3.2 Obstructed High Reach. Where a clear floor or ground space allows a parallel approach to an element and the high side reach is over an obstruction, the height of the obstruction shall be 34 inches (865 mm) maximum and the depth of the obstruction shall be 24 inches (610 mm) maximum.</p>

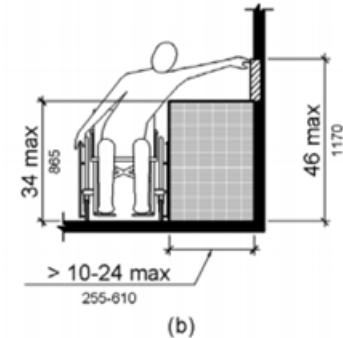
<p>308.3.2</p>
<p>ii. A 36 inches wide accessible route to the break room counter is not available due to chairs and tables.</p>	<p>Relocate furniture to provide an accessible route.</p>	
<p><b>7. Conference Meeting Rooms</b></p>		<p>No issues found</p>
