## Evaluation of Physical Barriers – FAM Warehouse

Address: 120, N Joy Street, Corona, CA 92879

Evaluation Date: 07-13-2021

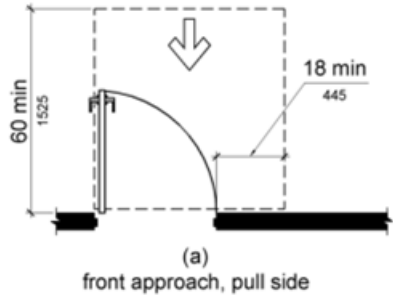
i. Fire extinguisher is mounted in the maneuvering clearance of exit door from corridor to main lobby.	Relocate the fire extinguisher to provide 18 inches on latch side of the door

<p>(a) front approach, pull side</p>
ii. Secondary exit door from office area to Kapsch area is not accessible due to incorrect hardware that needs twisting and pulling of the doorknob.	Replace current hardware with ADA compliant hardware.	Advisory 404.2.7 Door and Gate Hardware. Door hardware that can be operated with a closed fist or a loose grip accommodates the greatest range of users. Hardware that requires simultaneous hand and finger movements require greater dexterity and coordination and is not recommended.

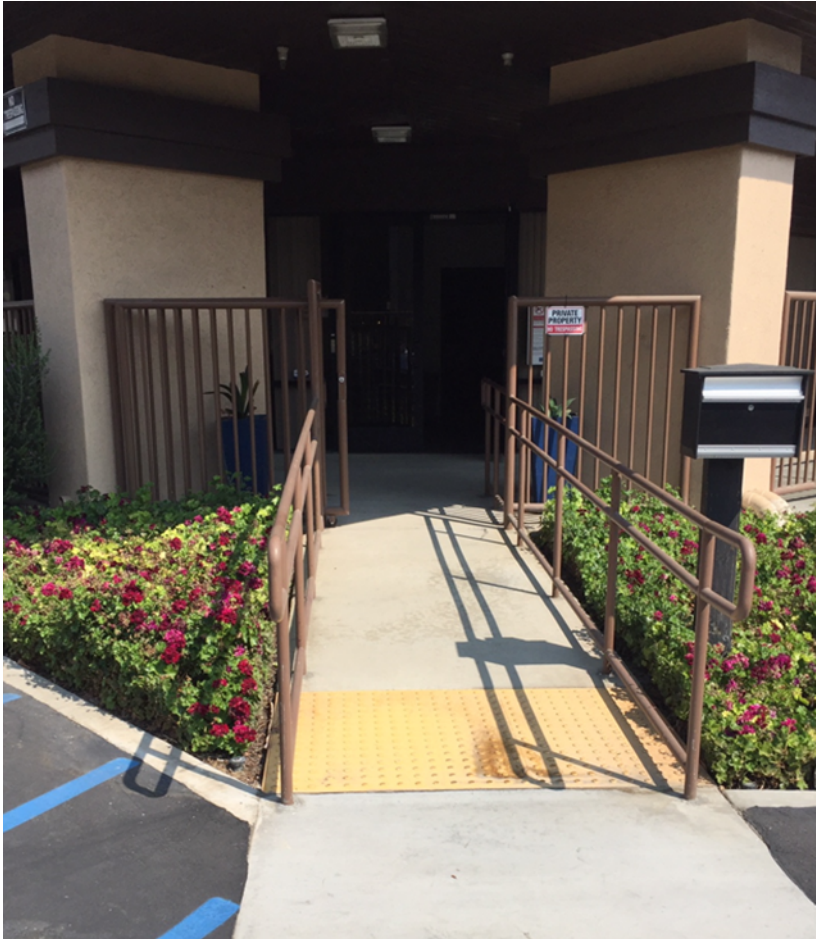
<b>3. Exterior Accessible route</b>			
i.	<p>The security gate is on the accessible entry ramp which has a gentle slope less than five percent. There is no flat landing provided to operate the sliding security gate.</p>

If the security gate is to be opened by security personnel only, then there is no action. If other employees are allowed to operate the gate, then the gate needs to be moved to a location where there is a flat landing area on each side of the door.	404.1 General. Doors, doorways, and gates that are part of an accessible route shall comply with 404. EXCEPTION: Doors, doorways, and gates designed to be operated only by security personnel shall not be required to comply with 404.2.7, 404.2.8, 404.2.9, 404.3.2 and 404.3.4 through 404.3.7. Advisory 404.1 General Exception. Security personnel must have sole control of doors that are eligible for the Exception at 404.1. It would not be acceptable for security personnel to operate the doors for people with disabilities while allowing others to have independent access.

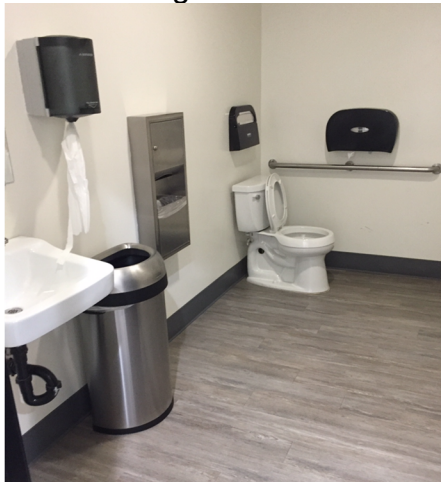
iii. There is no grab bar on the rear wall of the restrooms

Provide grab bars on the rear walls of both restrooms.	604.8.1.5 Grab Bars. Grab bars shall comply with 609. A side-wall grab bar complying with 604.5.1 shall be provided and shall be located on the wall closest to the water closet. In addition, a rear-wall grab bar complying with 604.5.2 shall be provided.
iv. Flush control is not on the open side in the women's restroom	Modify flush control to be on the open side.	604.6 Flush Controls. Flush controls shall be hand operated or automatic. Hand operated flush controls shall comply with 309. Flush controls shall be located on the open side of the water closet except in ambulatory accessible compartments complying with 604.8.2.

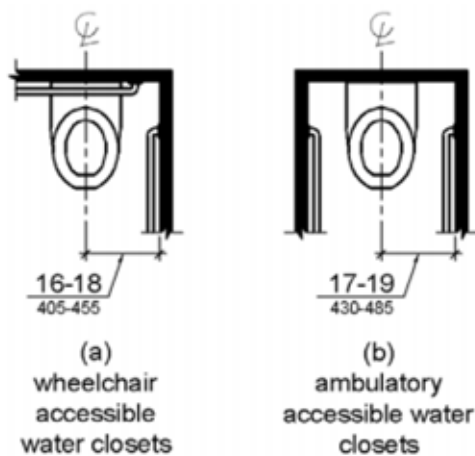
Issues/ Barriers Identified	Recommendations	Comments/ ADA Requirements
<p>v. Centerline of water closet is at 20.5 inches from the side wall. It needs to be a maximum of 18 inches and a minimum of 16 inches to comply with 2010 ADA standards, Figure 604.2</p>	<p>Reduce the distance of WC from the side wall by building out the wall and relocating the grab bar.</p>

<p style="text-align: center;"><b>Figure 604.2</b> <b>Water Closet Location</b></p>
<p>vi. The unisex toilet is not accessible and directional signage to accessible toilets are missing</p>	<p>Directional sign for accessible toilets should be provided.</p>	<p>The unisex toilet services the warehouse which is not designed for accessibility. Employee work areas within the warehouse are required to be on the accessible route, and accessible toilets are required.</p>
<p>vii. Toilet paper dispenser in the women's room is too close from the edge of seat (less than 6 inches) and does not comply with requirements of 2010 ADA standards, Figure 604.7.</p>	<p>Relocate toilet paper dispenser.</p>

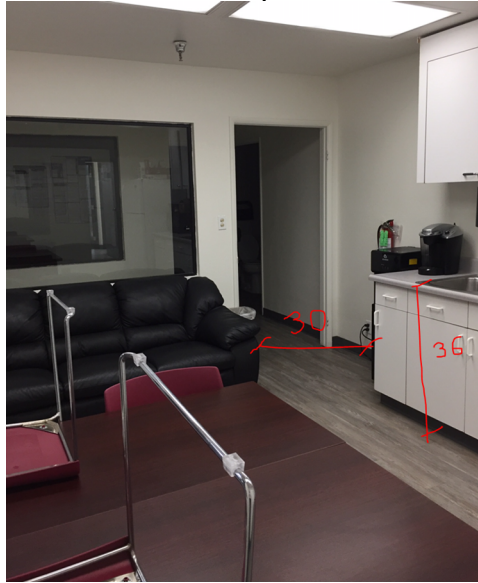
Issues/ Barriers Identified	Recommendations	Comments/ ADA Requirements
<p><b>6. Break Room\</b></p> <p>i. Break Room Counters: Obstructed high side reach over 36 inch high and 25.5 inch deep break room counter does not comply with 308.3.2.</p>

<p>Modify break room counter to allow compliant access to the sink faucet and operable parts/ controls that are at the back of counters</p>	<p>308.3.2 Obstructed High Reach. Where a clear floor or ground space allows a parallel approach to an element and the high side reach is over an obstruction, the height of the obstruction shall be 34 inches (865 mm) maximum and the depth of the obstruction shall be 24 inches (610 mm) maximum.</p>

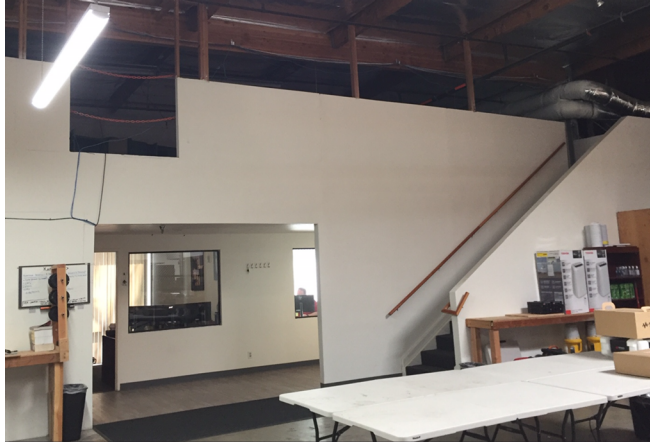
i. Kapsch area offices are not on an accessible route.	Provide accessible route	203.9 Employee Work Areas. Spaces and elements within employee work areas shall only be required to comply with 206.2.8, 207.1, and 215.3 and shall be designed and constructed so that individuals with disabilities can approach, enter, and exit the employee work area.
ii. The unoccupied upper floor is not accessible.

Access to other work areas should be provided. See Attachment 9, Action Plan for recommended action.	Advisory 203.9 Employee Work Areas. Although areas used exclusively by employees for work are not required to be fully accessible, consider designing such areas to include non-required turning spaces, and provide accessible elements whenever possible. Under the ADA, employees with disabilities are entitled to reasonable accommodations in the workplace; accommodations can include alterations to spaces within the facility. Designing employee work areas to be more accessible at the outset will avoid more costly retrofits when current employees become temporarily or permanently disabled, or when new employees with disabilities are hired. Contact the Equal Employment Opportunity Commission (EEOC) at <a href="http://www.eeoc.gov">www.eeoc.gov</a> for information about title I of the ADA prohibiting discrimination against people with disabilities in the workplace.
